SITE INFORMATION

Site Identifier : SK7LB1 **Landowner Type :** Private
Site Name : Mill Creek Slough **Landowner Name :**
WRIA : 03.0375X **Address :**
Region : NS **Address2 :**
Trib to : Mill Cr **City :**
River Mile : 45.00 **State :**
River System : Skagit R **Zipcode :**
Legal Description : NE1/4S22T35NR7E **Phone :**
County : Skagit
Habitat Type : slough

Field Survey Information

Date : 01/15/1997 **Observer :** Olis **Survey Type :** initial

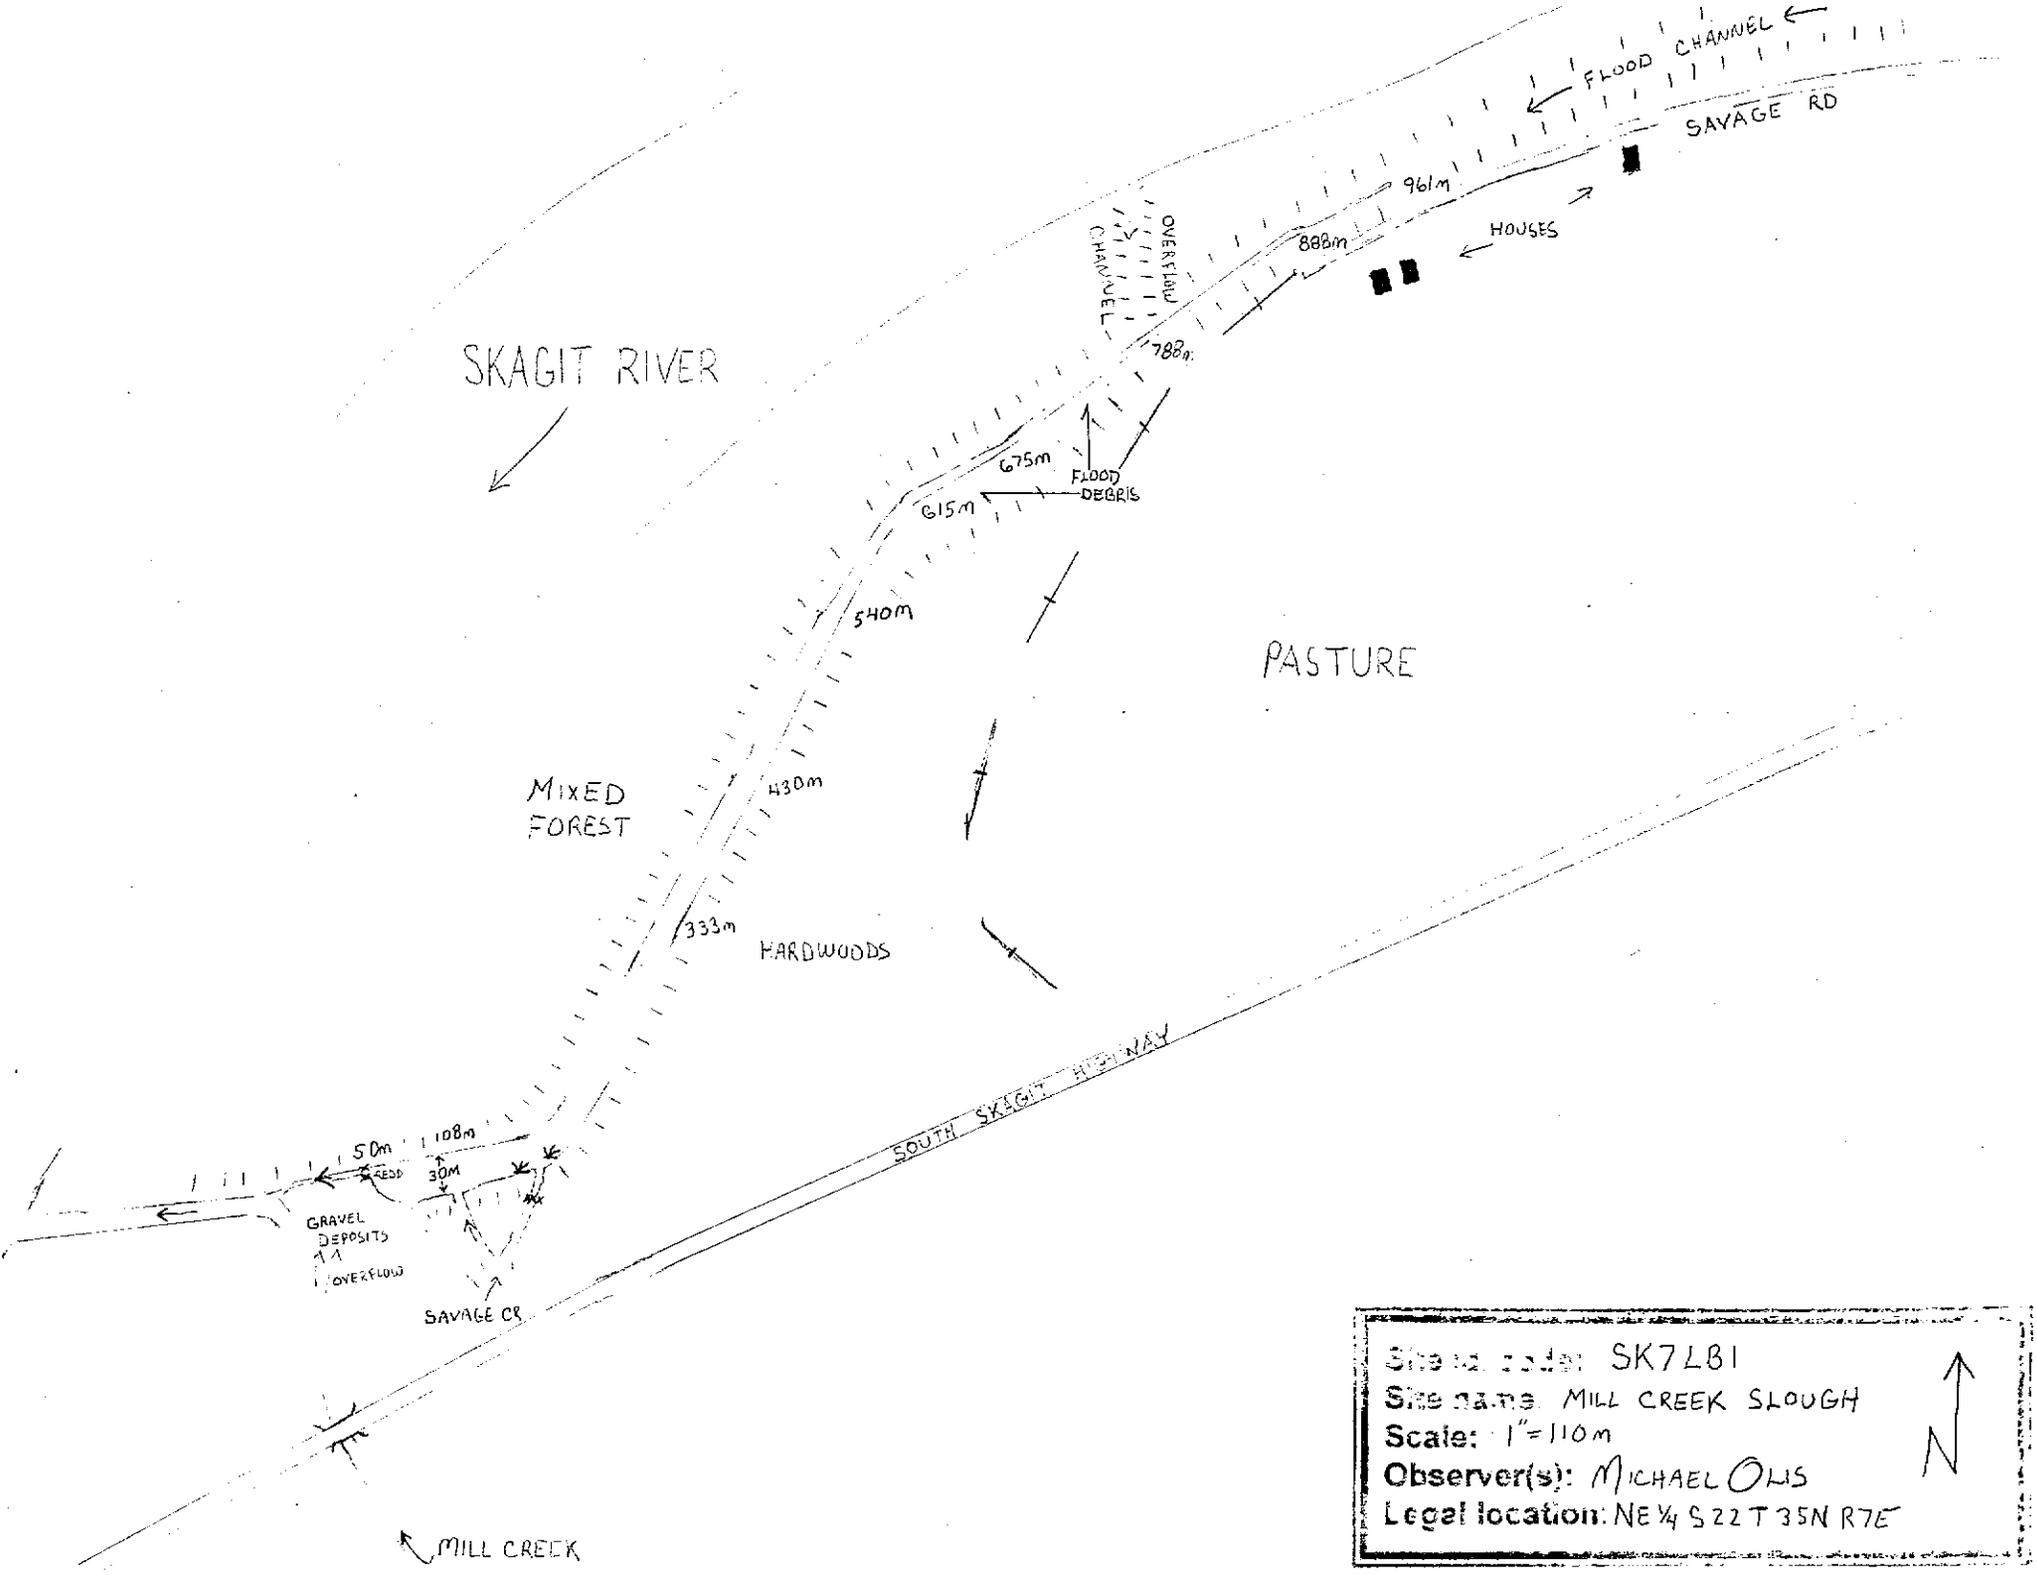
Site code: SK7LBI
 Site name: MILL CREEK SLOUGH
 Scale: 1"=110m
 Observer(s): MICHAEL OLIS
 Legal location: NE ¼ S22 T35N R7E

Describe: During flood events, the river comes over into the slough at the head end and at a flood channel at 788m. There are good amounts of debris scattered about the upper end of this slough as evidence of frequent flooding.

ADDITIONAL COMMENTS At the lower end of this slough, just above the beaver dam, Savage Creek flows into it. So this slough probably gets used by juveniles migrating from the Savage Creek system as well as ones from the Skagit and Mill Creek.

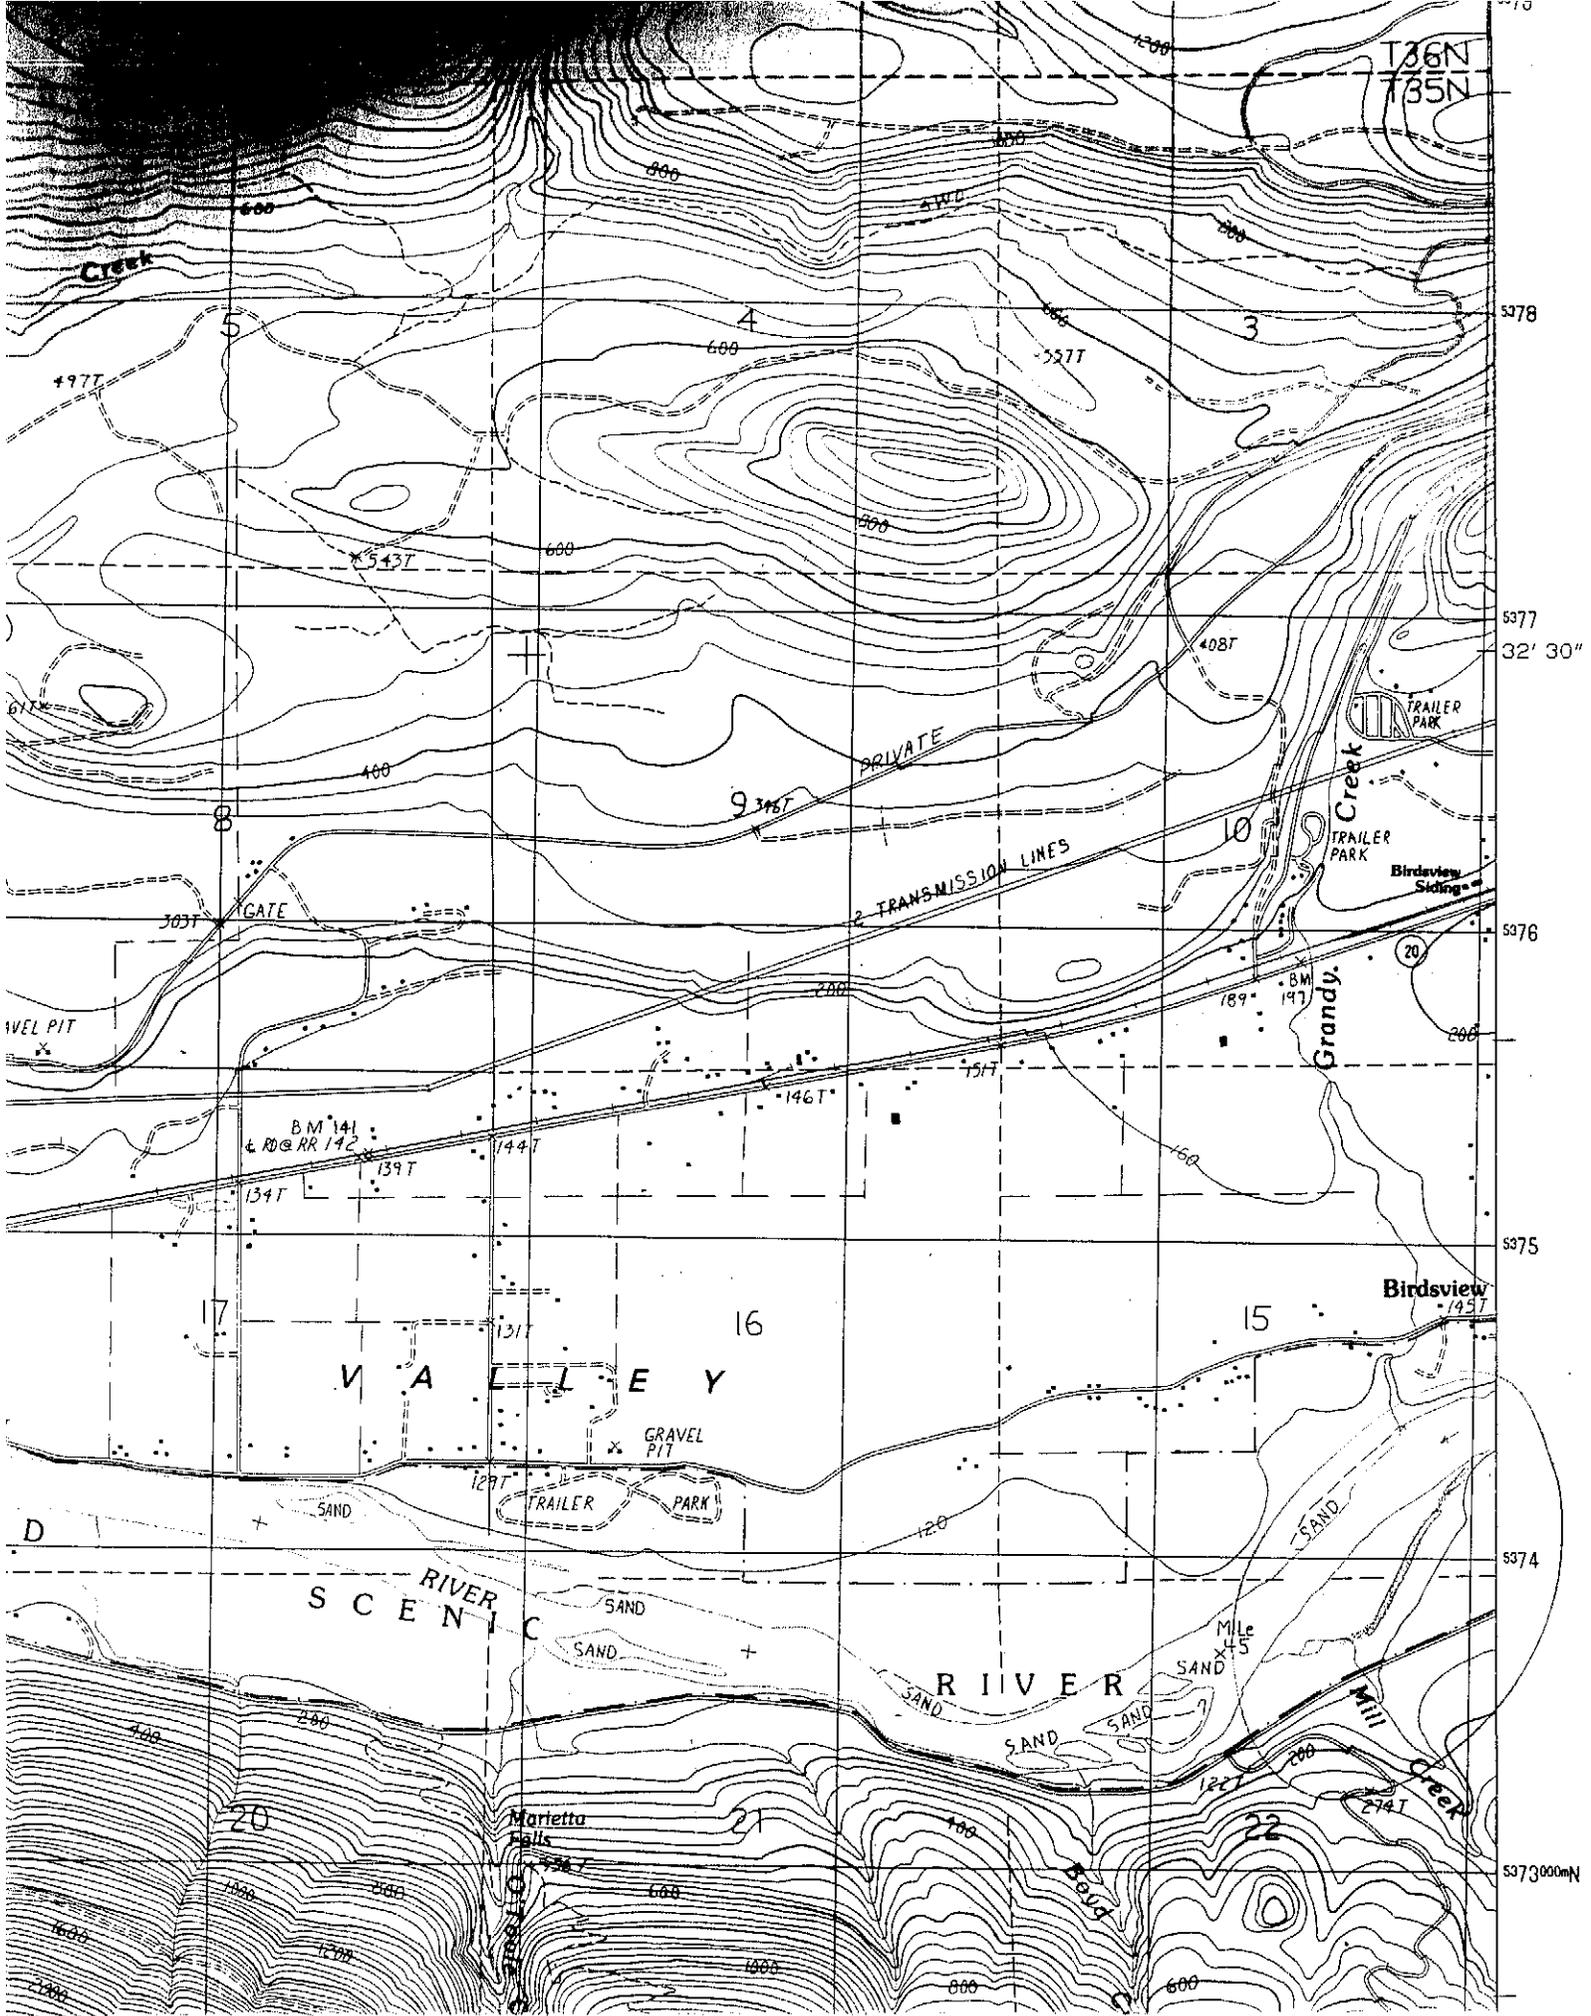
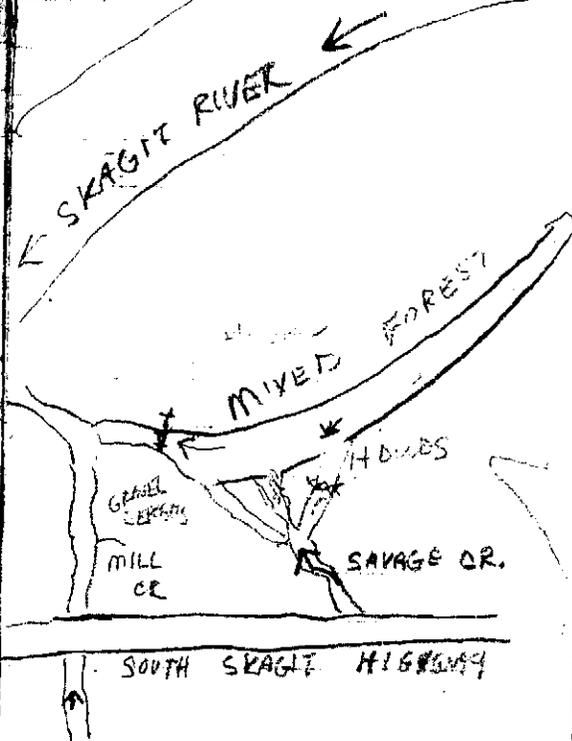
SK7LB1

- SILT GRAVEL MIX
- 8 m² SP HAB - LOTS OF DEBRIS
- 1"-4" GRAVEL
- @ 6m BVR DAM
- PASSABLE

- SILTY, MUCKY SUBSTR
- 6m² SP HAB

+ LOTS OF DEBRIS ON BANKS

AND INTO WOODED AREA

FROM RECENT FLOOD EVENTS

- VERY FLOODY, OTHERWISE
A NICE SLOUGH FOR OVER-LOW

- POSSIBLE REED JUST ABOVE
BYR DAM
