SITE IDENTIFIER:SU5RB1
LOCAL NAME:Slo-co channel

NORTH SOUND OFF CHANNEL SITE INVENTORY DATA

RIVER:Suiattle SURVEY DATE:7/30/94 OBSERVER:B.Barkdull

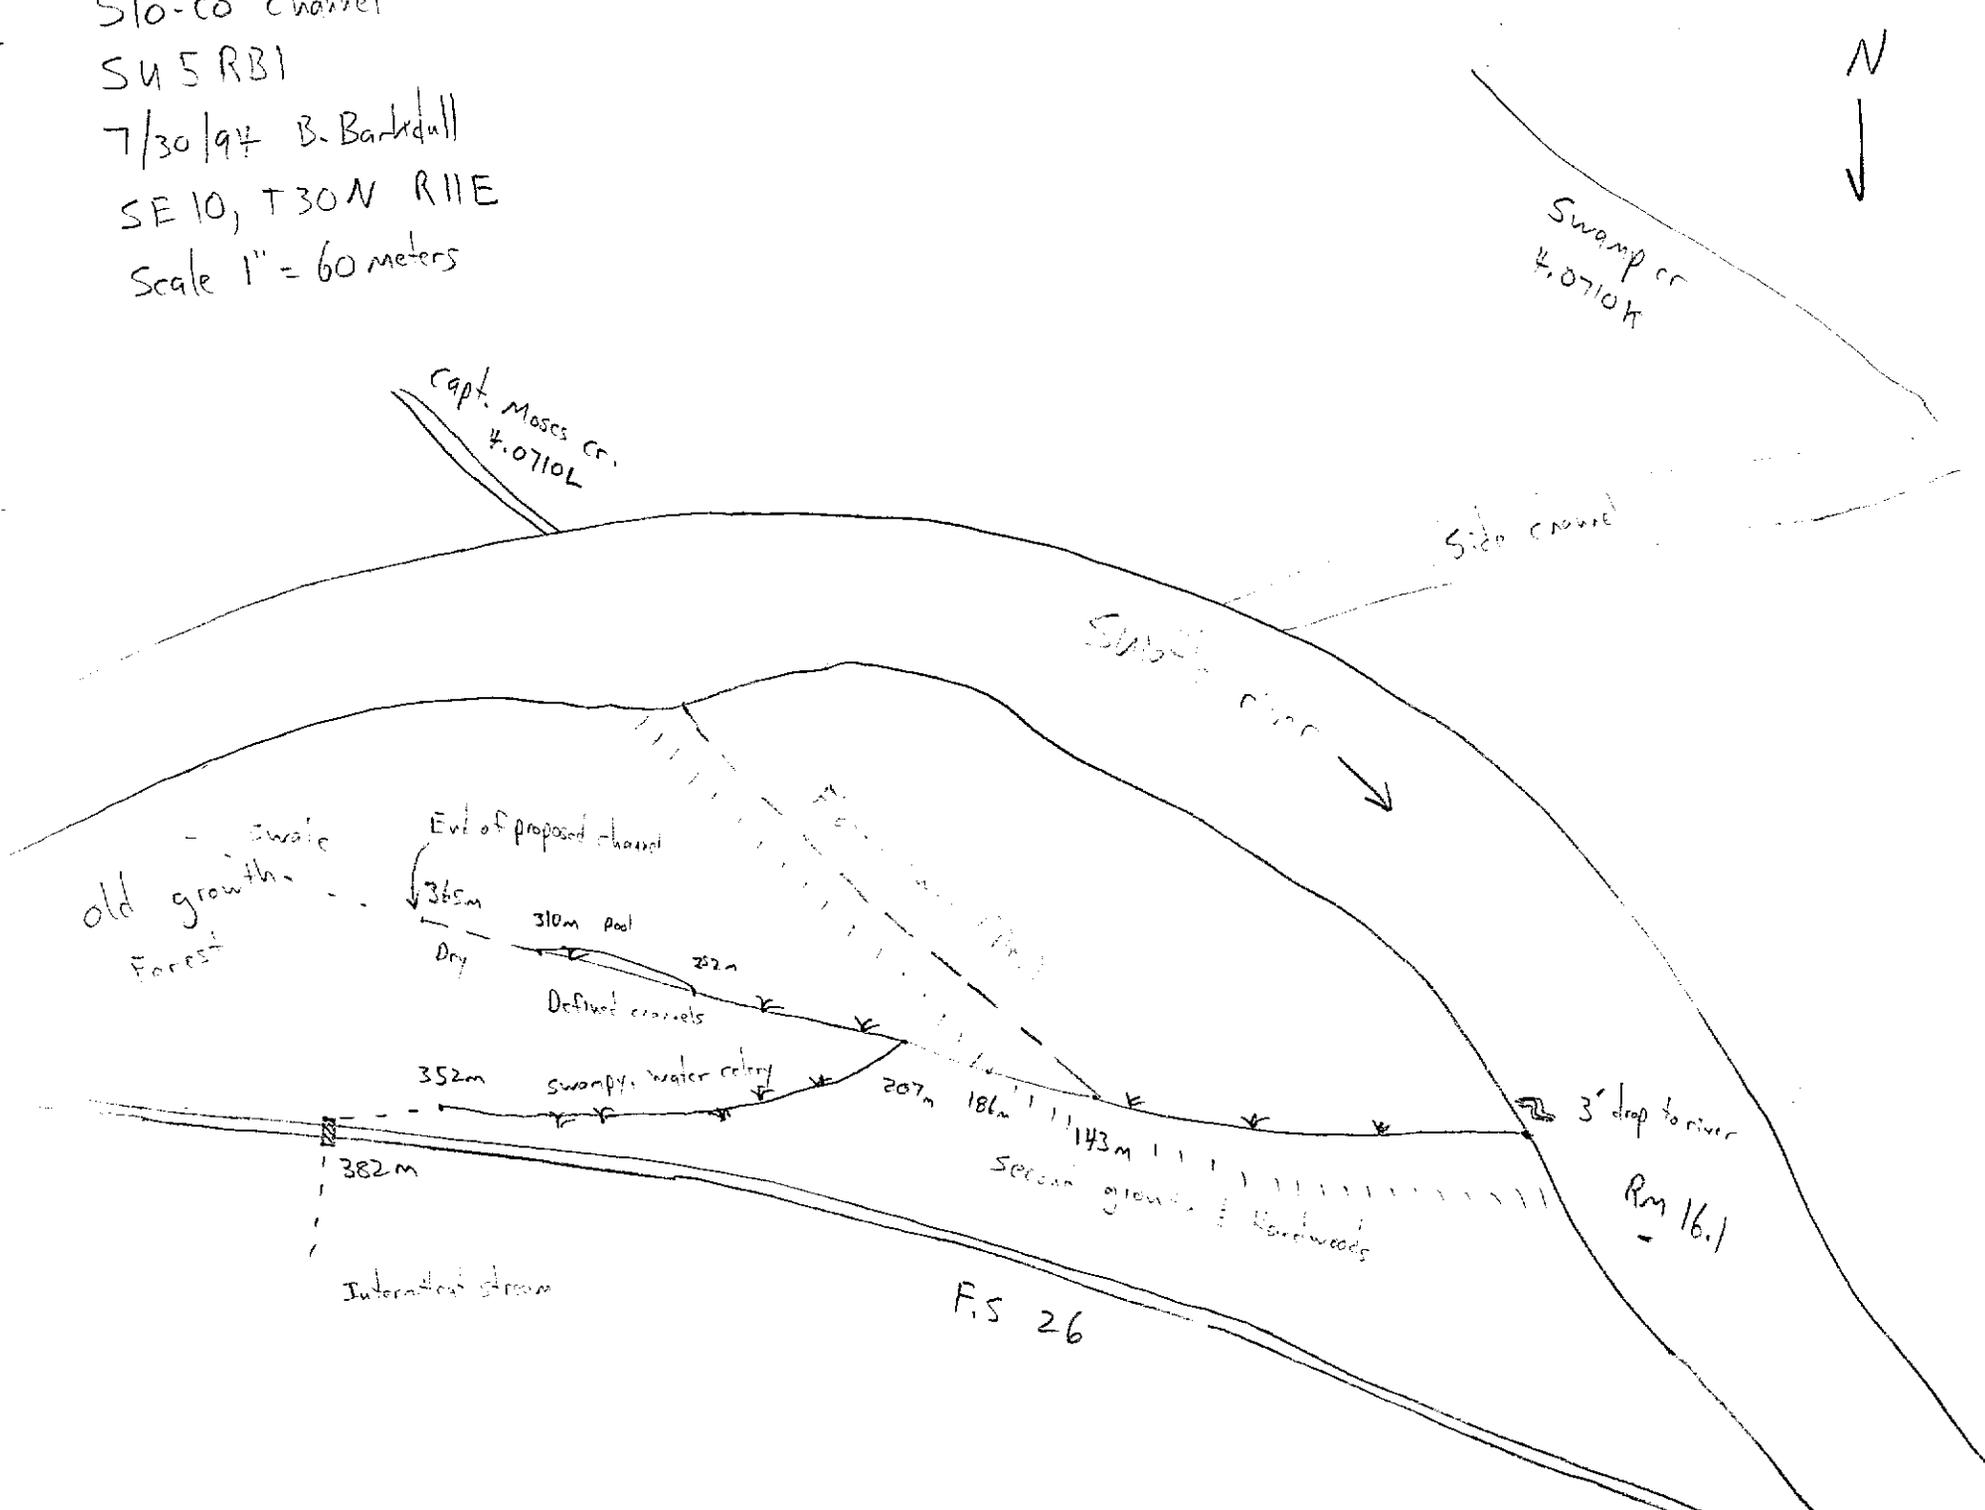
Slo-co channel
 SU 5 RB1
 7/30/94 B. Barkdull
 SE 10, T30N R11E
 Scale 1" = 60 meters

Describe: Well protected above 143 meters, below that point a very floody swale enters.

Describe: A one meter drop at normal summer flows through a root-wad.

ENHANCEMENT OPPORTUNITIES: This may be a site where a 340 meter groundwater channel could be developed. The entrance conditions could easily be improved and the rest of the channel left as is or more habitat could be created by excavating out the main channel. The lower end is very floody and solving this problem is key to developing a project. The rest of the area is relatively flood safe.
