SITE INFORMATION

Site Identifier : SU6LB1 **Landowner Type :** Federal
Site Name : Broken Cedar **Landowner Name :** USFS
WRIA : 03.0710X **Address :**
Region : NS **Address2 :**
Trib to : Suiattle R **City :**
River Mile : 22.50 **State :**
River System : Suiattle R **Zipcode :**
Legal Description : NE1/4S24T32NR12E **Phone :**
County : Snohomish
Habitat Type :

SITE IDENTIFIER:SU6LB1
LOCAL NAME:Broken Cedar

NORTH SOUND OFF CHANNEL SITE INVENTORY DATA

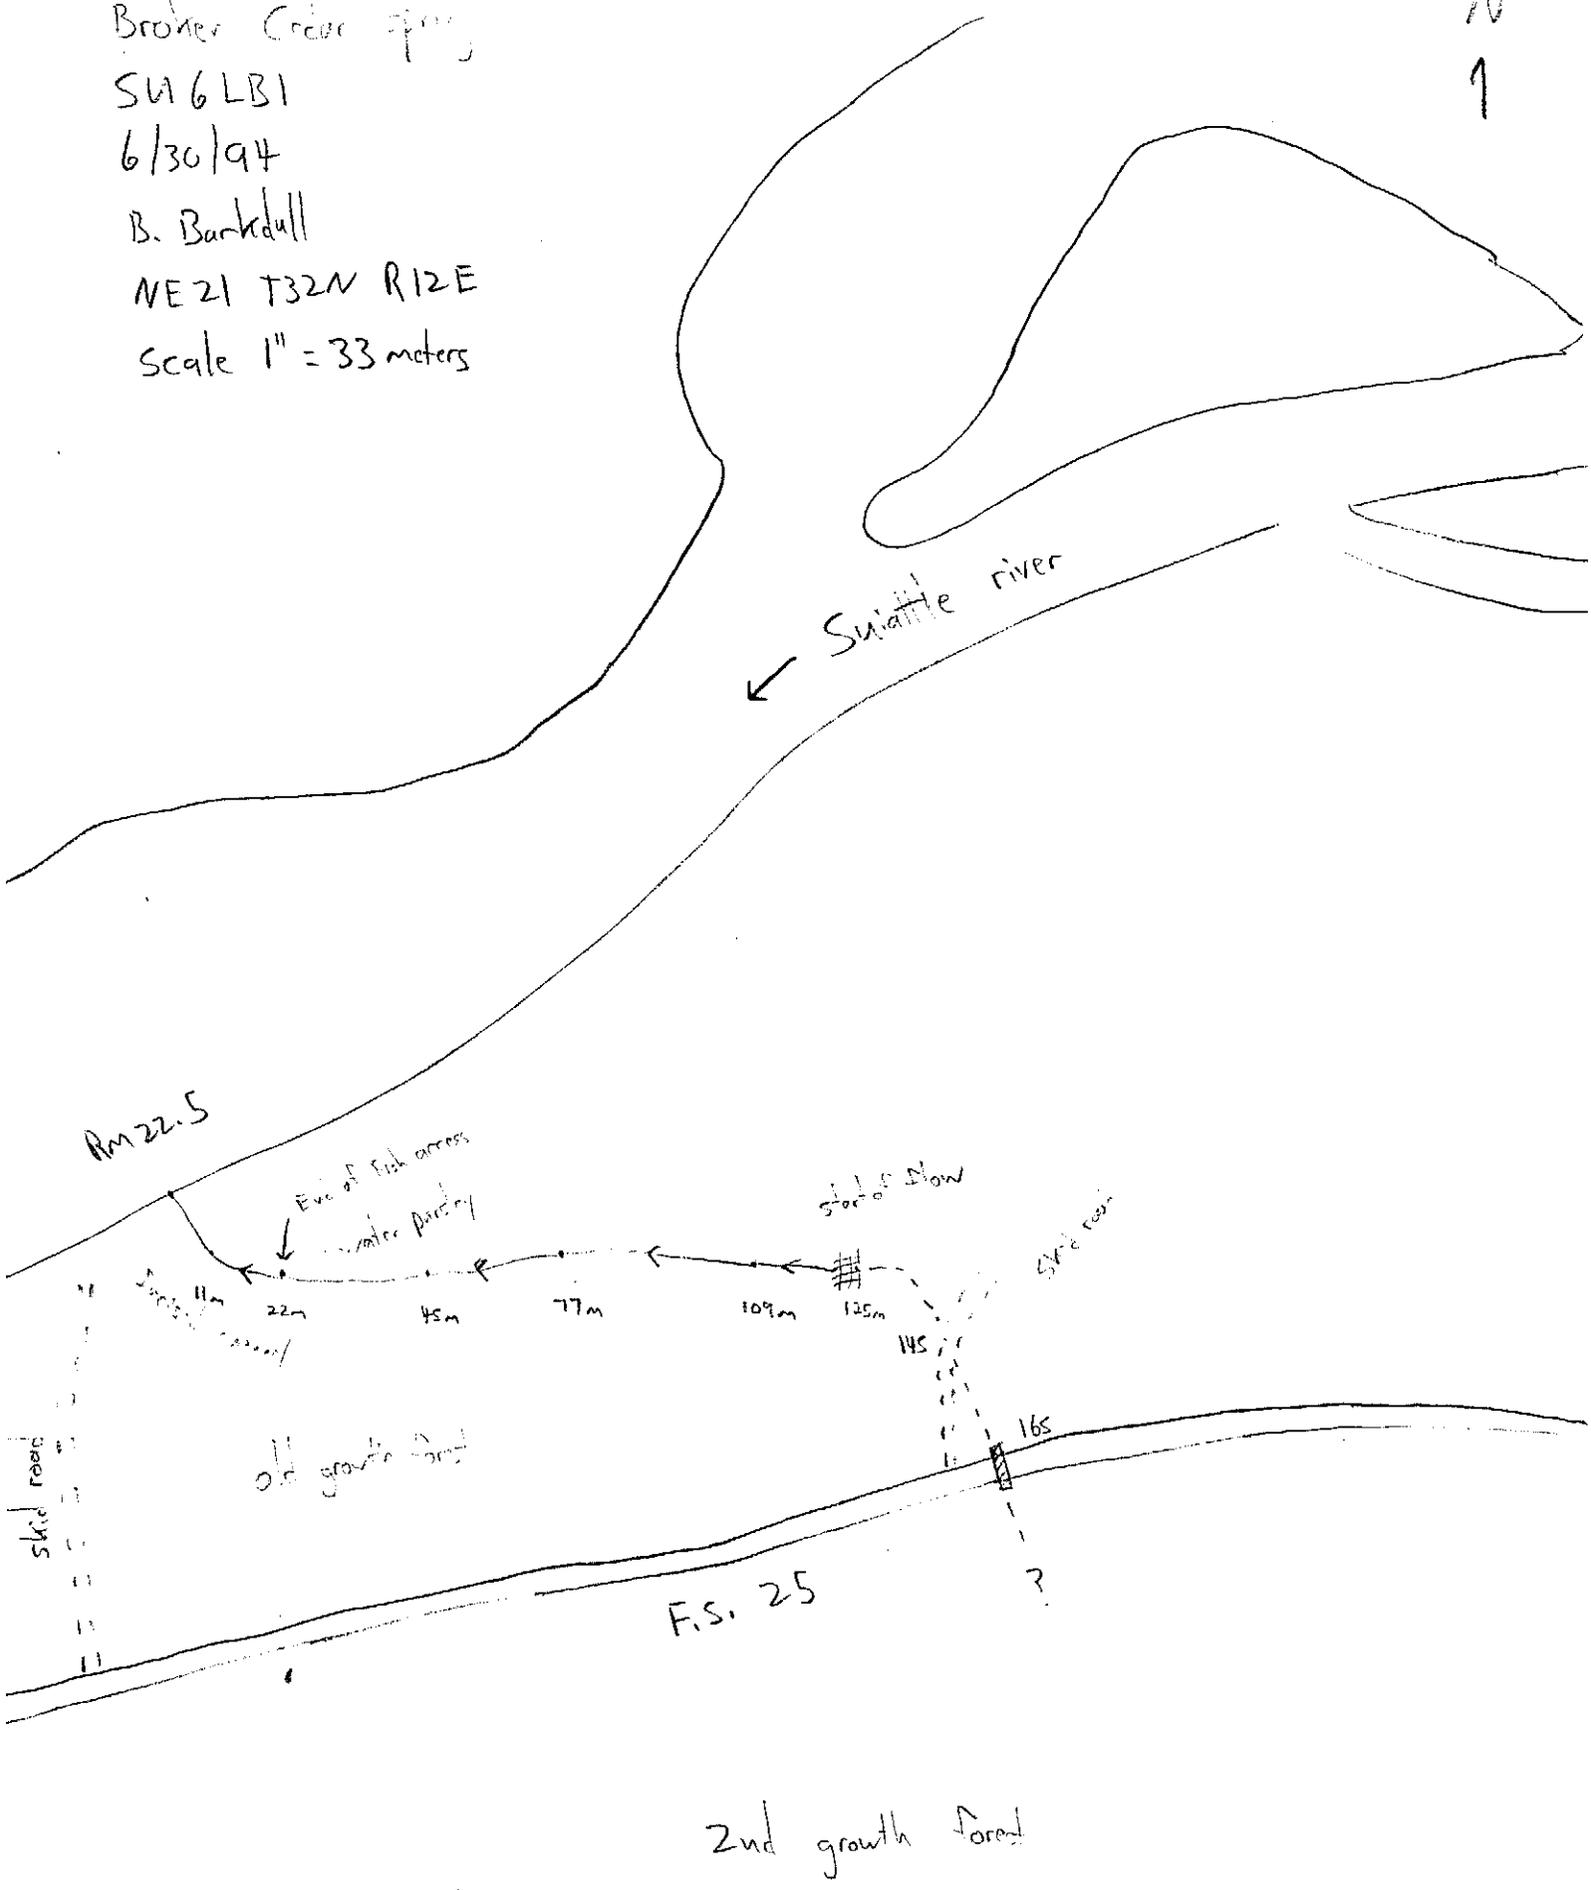
Brooker Cedar spring
SW 6 LBI
6/30/94
B. Barkdull
NE 21 T32N R12E
Scale 1" = 33 meters

Describe: There appears to be a blockage from woody debris at 22 meters. At higher flows juveniles can probably access most of area. Probably little or no adult use.
