SITE NUMBER: WD-138L-02

LOCAL NAME: Broken Arrow

NORTH COAST OFF CHANNEL SITE INVENTORY DATA

RIVER SYSTEM: W.F. Dickey

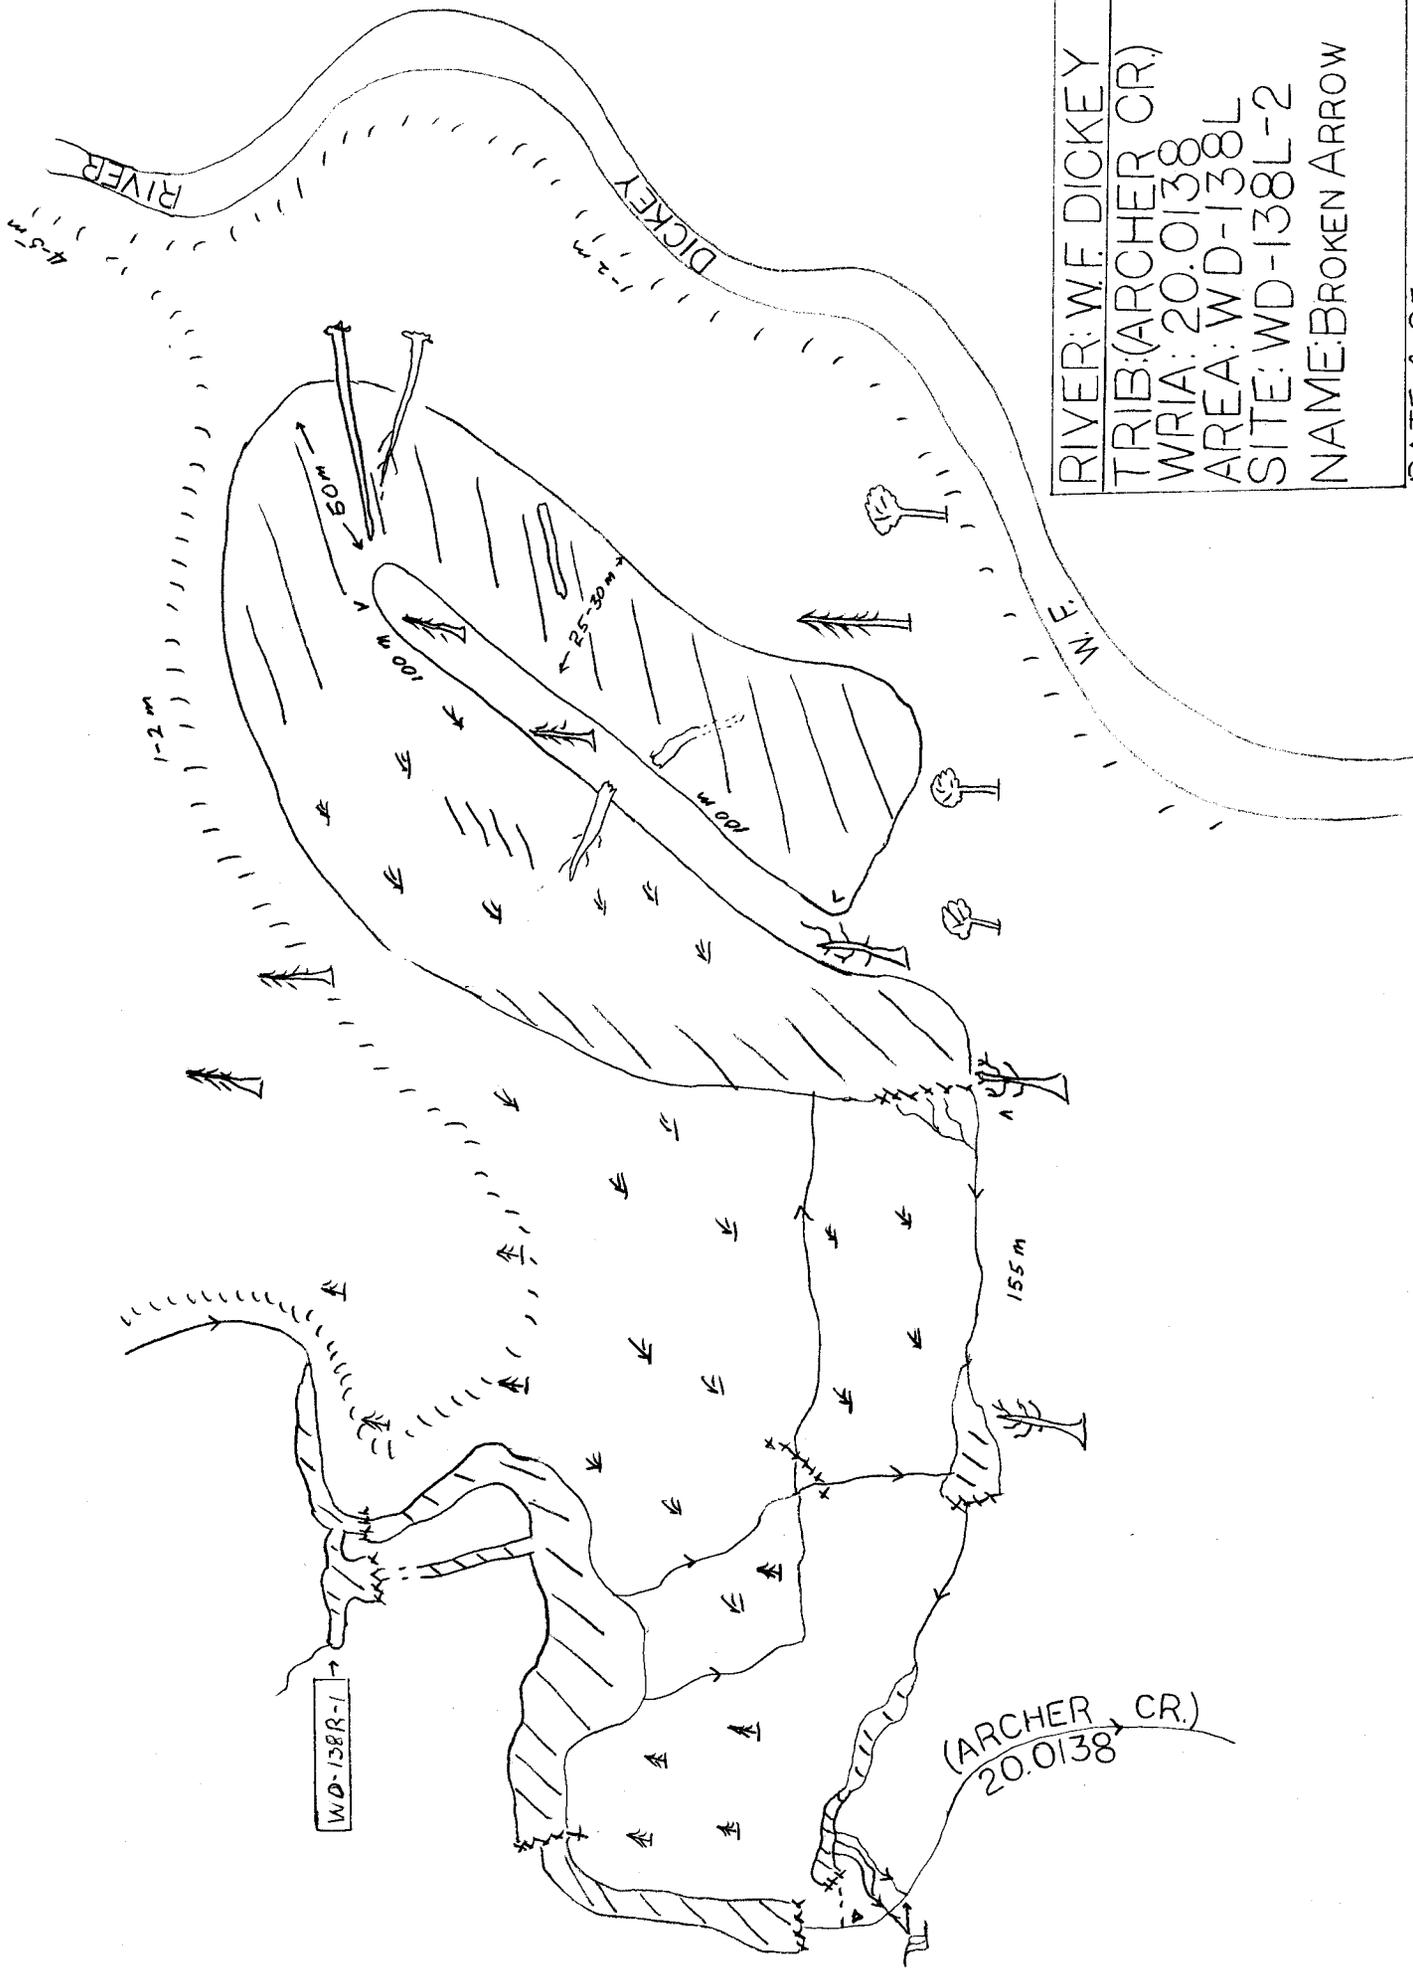
RIVER: W.F. DICKEY
 TRIB: (ARCHER CR.)
 WR/A: 20.0138
 AREA: WD-138L
 SITE: WD-138L-2
 NAME: BROKEN ARROW

- A poor egress to 20.0138 due to a beaver dam shunting the flow over a fall.
- An open marsh intermixed with 20 - 30 year old conifer.
- Dark, tea colored water.
- A low to moderate-low gradient.

WATER SOURCE: The only visible water source is a channel braid from 20.0138 which enters near the lower end. This source is dependent on two existing, but poorly maintained beaver dams to route the water in the proper direction. If either dam fails this source would be gone.

FISH ACCESS & CURRENT USE: No fish were observed. The outlet channel has a beaver dam that will impede upstream migrants. Except for high flows fry will have to go past the channel, find the braid and then come down the braided channel to the pond.

-Replace the beaver dam that is shunting water over the fall with a control.
