SITE NUMBER: WD-R1-01

NORTH COAST OFF CHANNEL SITE INVENTORY DATA

RIVER SYSTEM: W.F.Dickey

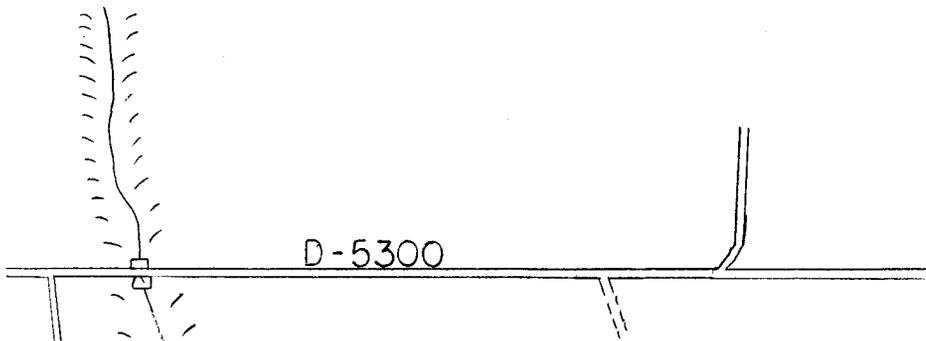
RIVER: WF DICKEY
AREA: WD-RI
CHANNEL: WD-RI-1
NAME:

- An excellent egress.
- A moderate gradient and lacks cover.
- Good shade developing from a 15 - 20 year old conifer plantation.
- High velocity flows at times.
- Good gravel production for the W.F. Dickey River.
- A woody debris jam that is causing about a one meter fall.

4' Fall

- Remove jam so gravel will migrate to the river.
- Maintain the integrity of the stream.
