**SITE INFORMATION**

**Site Identifier :** WN3LB1 **Landowner Type :** Private  
**Site Name :** **Landowner Name :**  
**WRIA :** 03.0227X **Address :**  
**Region :** NS **Address2 :**  
**Trib to :** Lake Cr **City :**  
**River Mile :** 12.60 **State :**  
**River System :** W F Nookachamps **Zipcode :**  
**Legal Description :** SE1/4S18T33NR5E **Phone :**  
**County :** Skagit  
**Habitat Type :** lower valley wall tributary

**Field Survey Information**

**Date :** 12/14/1998 **Observer :** Olis **Survey Type :** initial

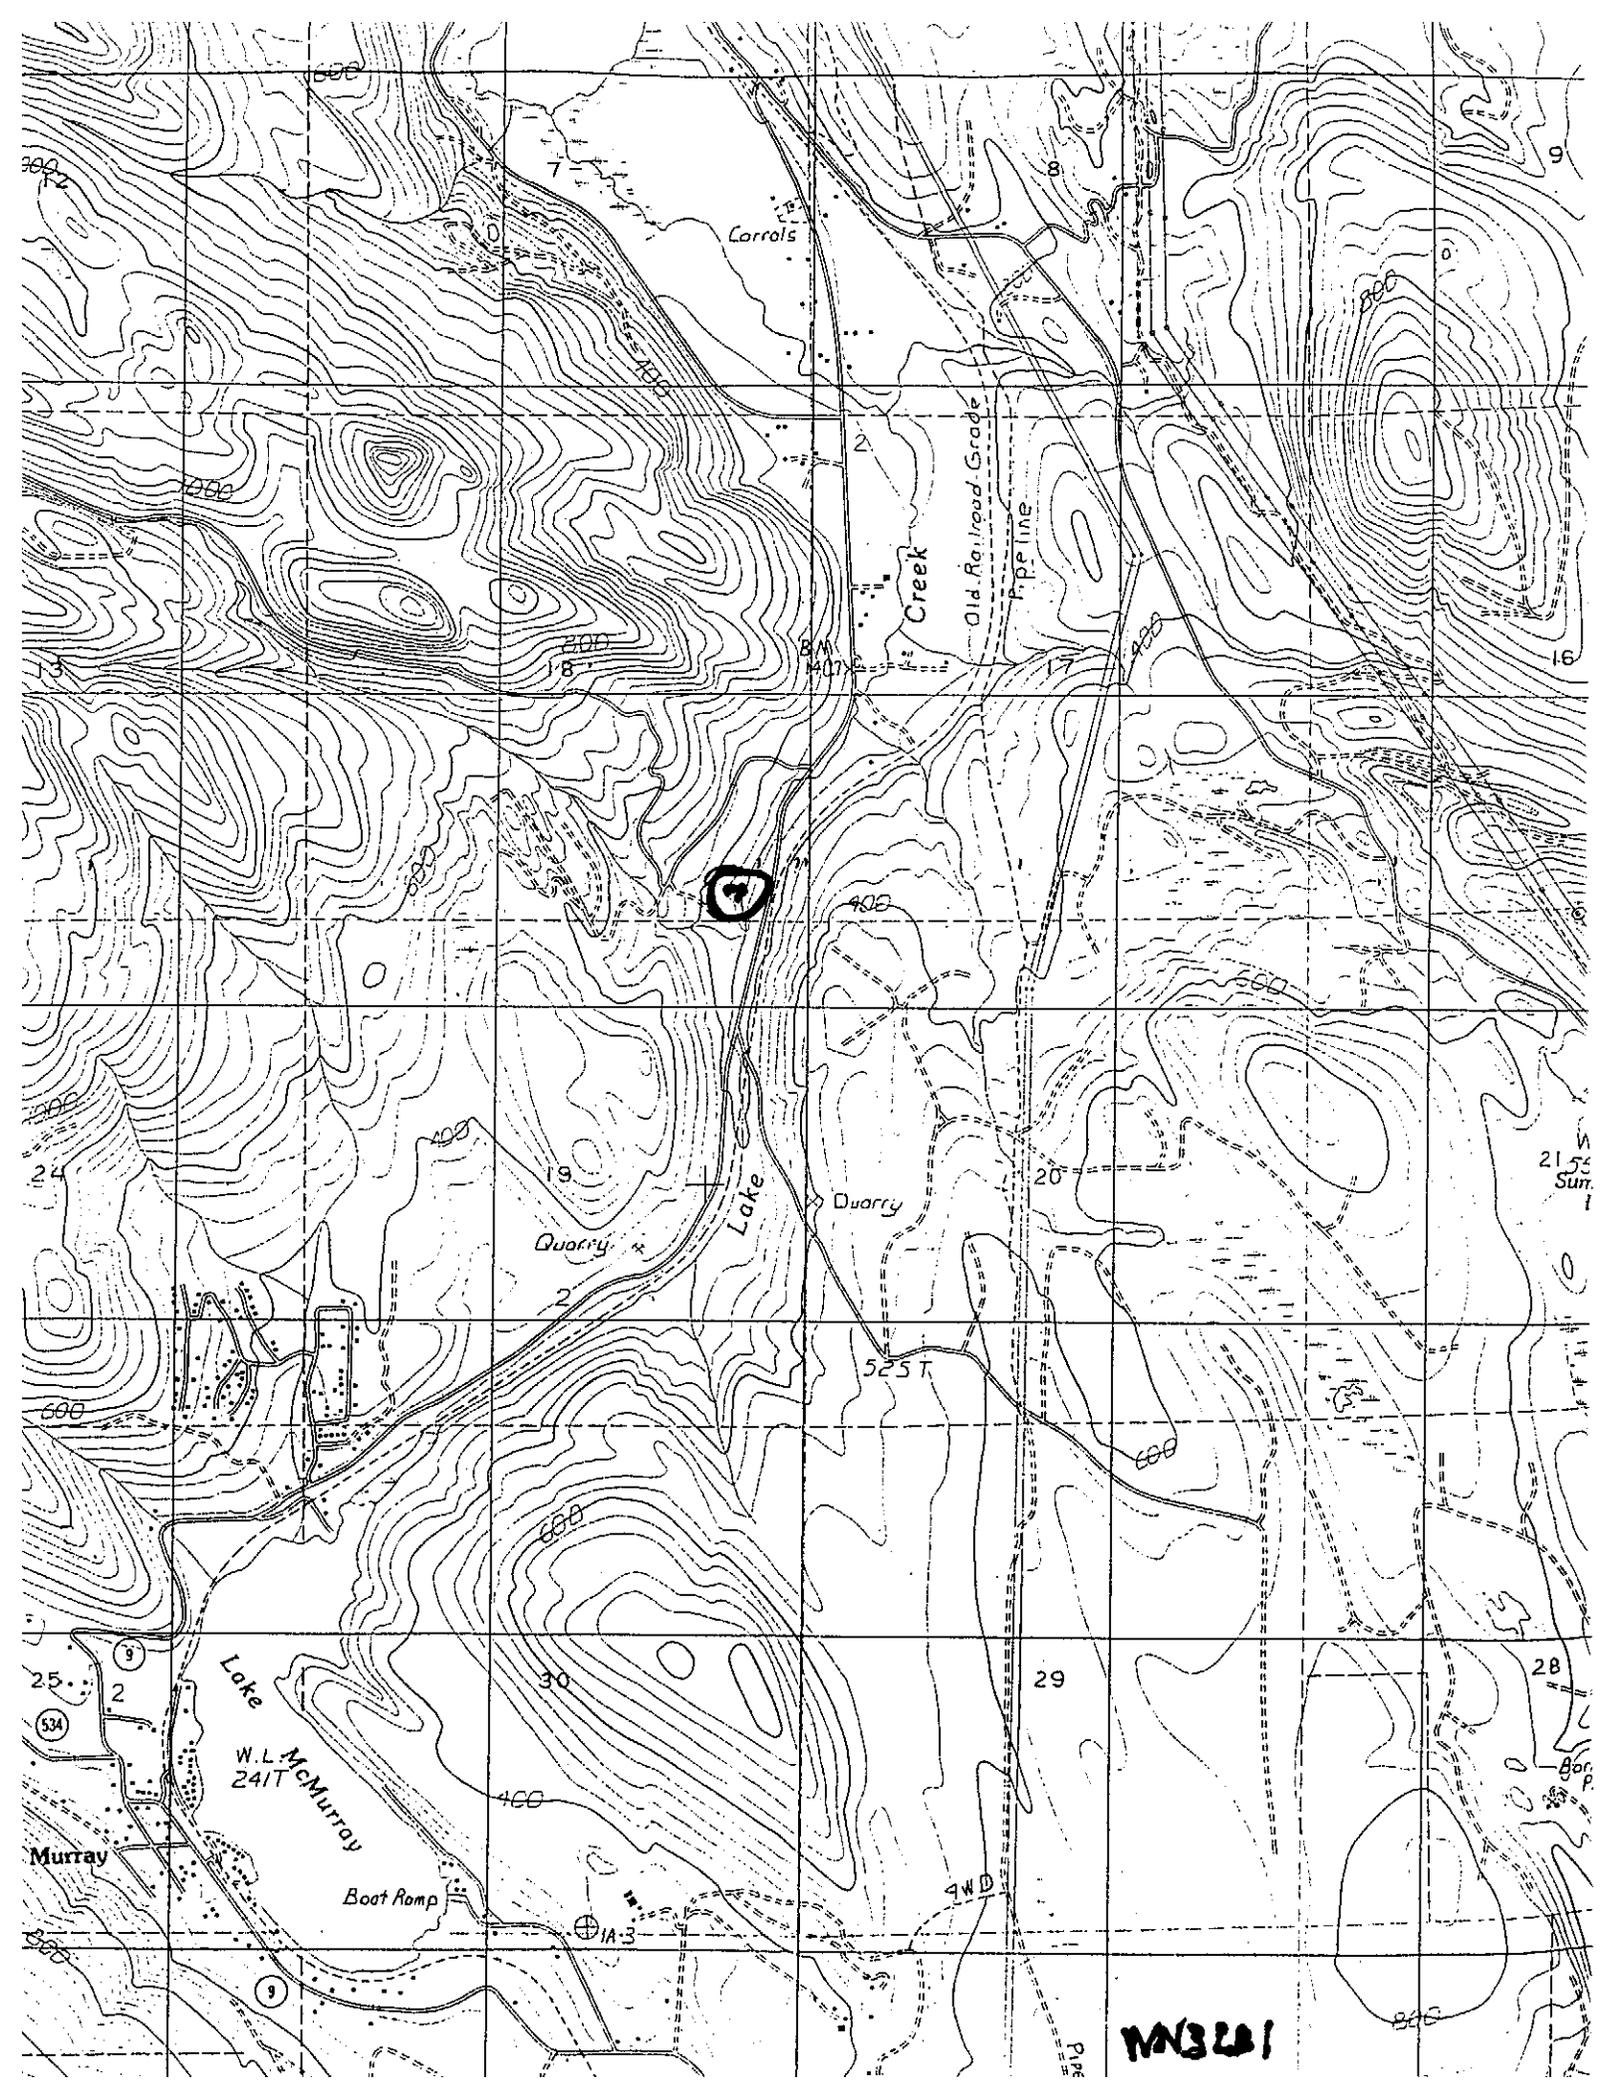
WN3LB1

9m WLL 5m

• MOSTLY PIPE  
 • @ 1.2 SR PIPE

9m? ... 1.5 DROP

12m - UPSTREAM END  
OF CULVERT

DOES NOT LOOK PASSABLE

BECAUSE OF ROOT

OVER HANG & NO

REAL PLUNGE POOL

- NO SPAWN
- FAIR REAKING
- GROUNDWATER SURF  
- INT.
- LOW FLOOD
- ACCESS PROBLEMS  
W/ CULTURE AND  
SUBSURFACE FLOW
- NO FISH

ENHANCEMENT OPPORTUNITIES: Remove the culvert at 9m as the road does not appear to have been used for quite awhile and the pipe is probably a barrier to juvenile migration. It may be necessary to install a few log weirs to adjust for the drop in elevation. It also appears that a surface connection could be made fairly easily with a shovel or two.
