**SITE INFORMATION**

**Site Identifier :** WN3LB5 **Landowner Type :** Private  
**Site Name :** **Landowner Name :**  
**WRIA :** 03.0227X **Address :**  
**Region :** NS **Address2 :**  
**Trib to :** Lake Cr **City :**  
**River Mile :** 13.35 **State :**  
**River System :** W. F. Nookachamps **Zipcode :**  
**Legal Description :** SE1/4S19T33NR5E **Phone :**  
**County :** Skagit  
**Habitat Type :** terrace tributary

**Field Survey Information**

**Date :** 01/11/1999 **Observer :** Olis **Survey Type :** initial

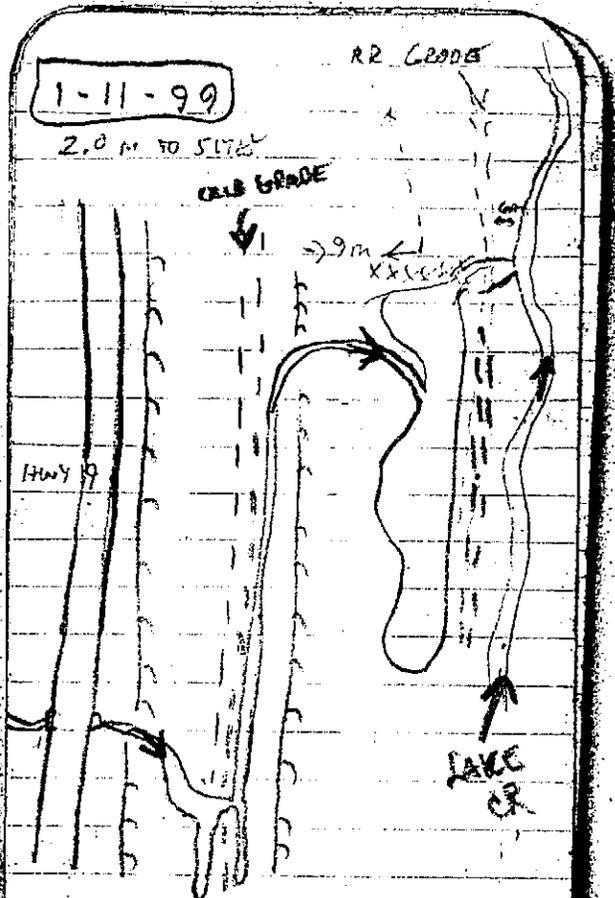
WN3LB5

O.D. ENTRY

ACCESS - POOL PRESENT  
- COUPLE OF 1 DROPS  
TO ACCESS SITE

- COUPLE OF 1 DROPS

- THROUGH ROOT MASS

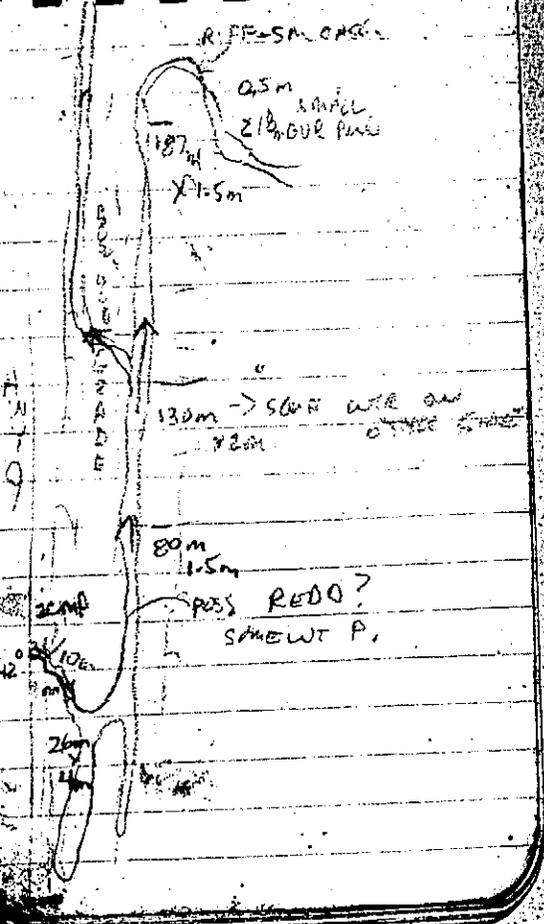
- EXCEL. CHANNEL

- LOW FLOOD

- NO FISH SEEN

- PARTS 97% WETTED  
YEAR ROUND

POSS REDD?  
SMEWT P.
