Additional Information Cover Sheet

HPA Log Number: 118926-01

Reecer Creek Channelization Repair.

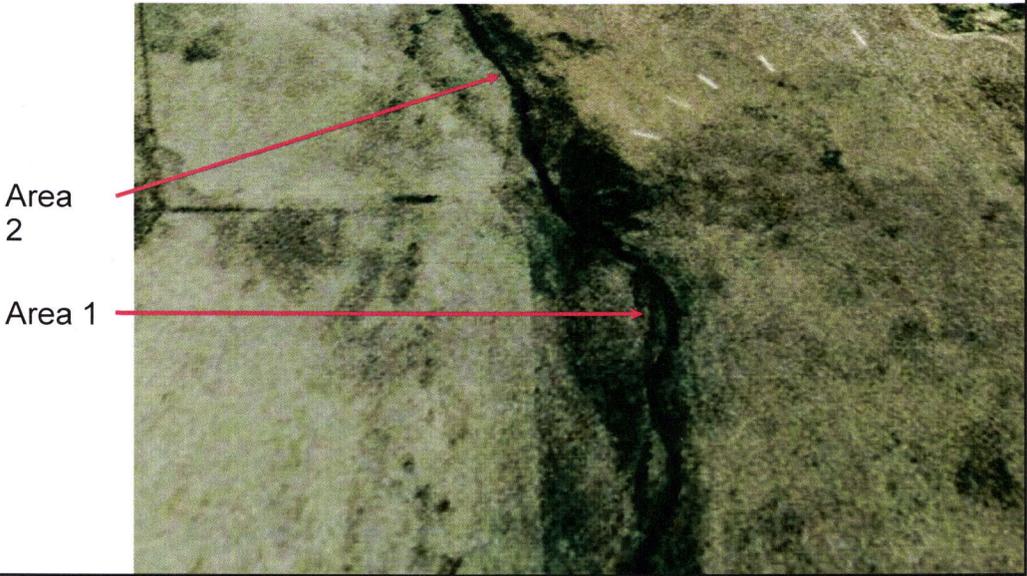
Area 2 is an alluvial fan that results in water spreading uncontrollably onto the NW corner of my grass hay field resulting in 2 acres becoming unharvestable due to continuously muddy conditions.

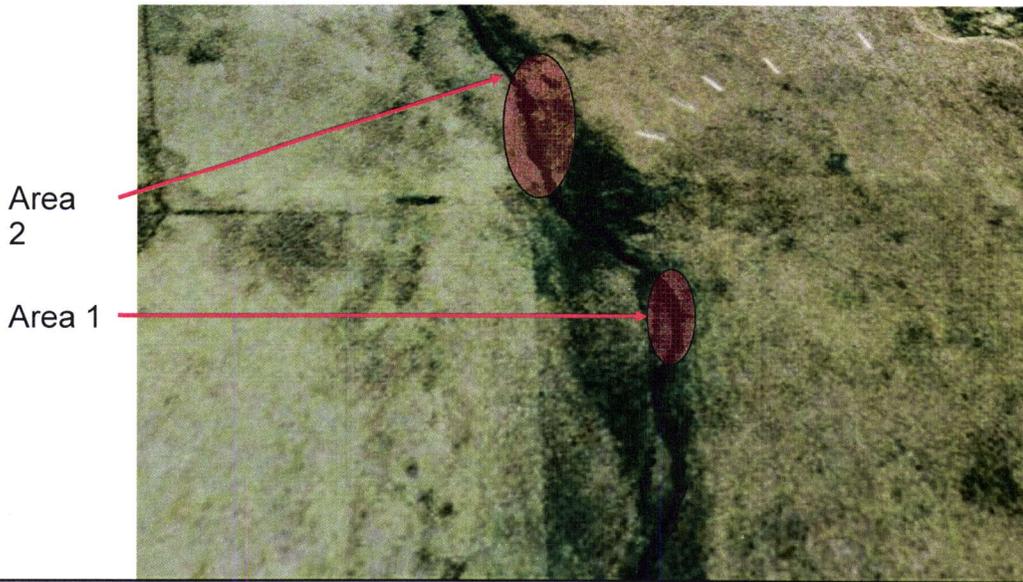
Reecer Creek Channelization Repair.

Area 1 is the most serious where the stream jumped the bank and rolled rocks of up to 18 inches diameter onto 3 acres of grass hay field.

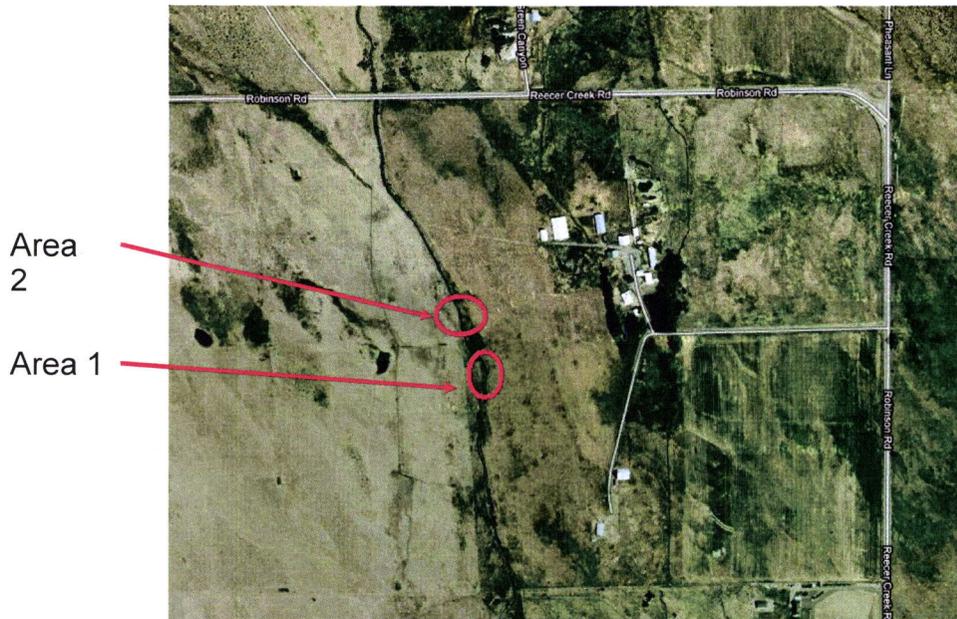
Reecer Creek Channelization Repair.

Area 1 is about 100 feet of stream on Lulofs' property.

Area 2 is about 300 feet of stream on Dr. Nelson's property.

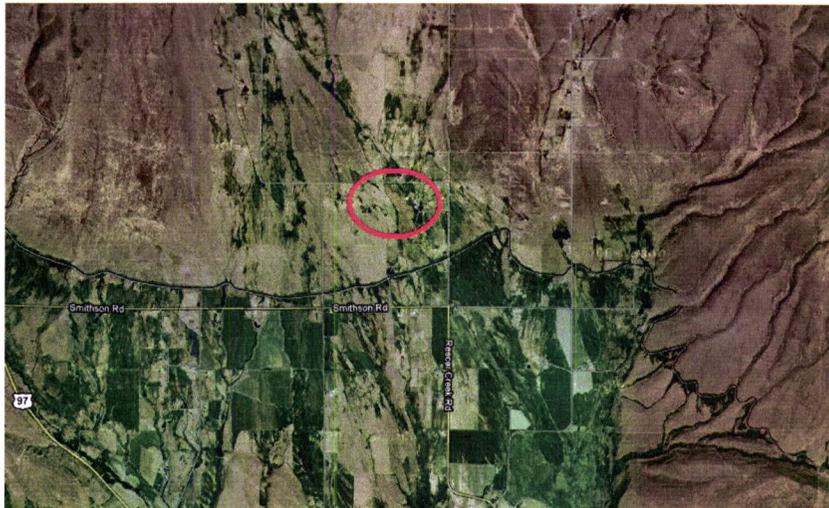
Reecer Creek Channelization Repair consists of two project areas.

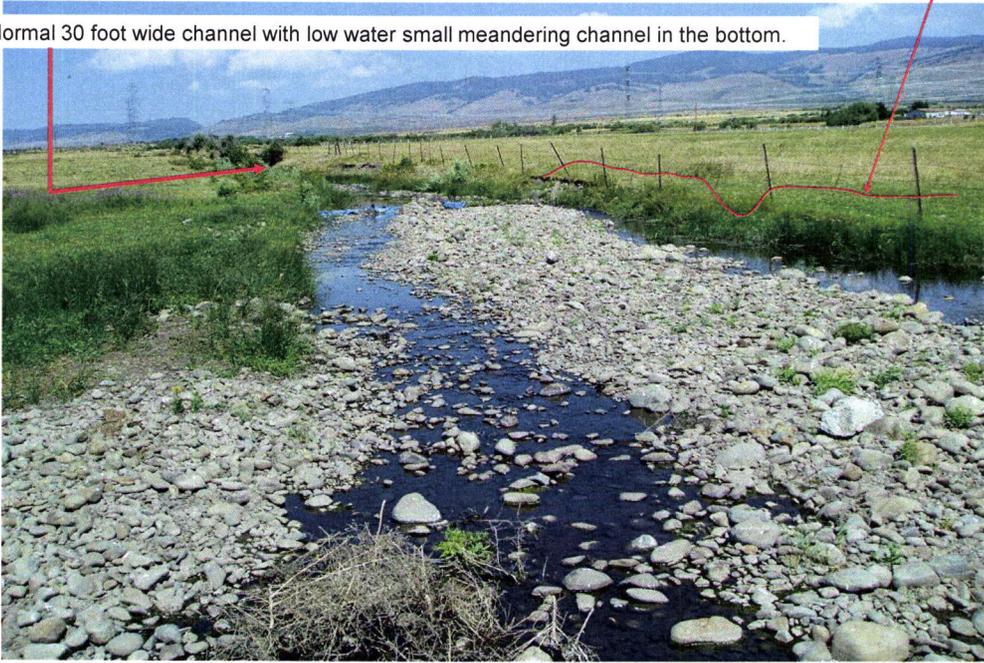
Upper 100 feet of area 2 on Nelson's property.

Normal 30 foot wide channel with low water small meandering channel in the bottom.

3 to 4 foot bank for 300 feet with gaps for flood water escape.

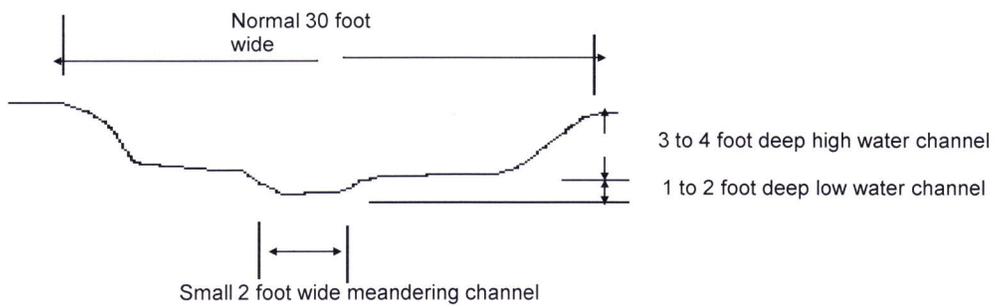
Typical Reecer Creek stream bed cross section in our area.

In both areas 1 and 2, we plan to use a track hoe to move debris rocks to restore this cross section.

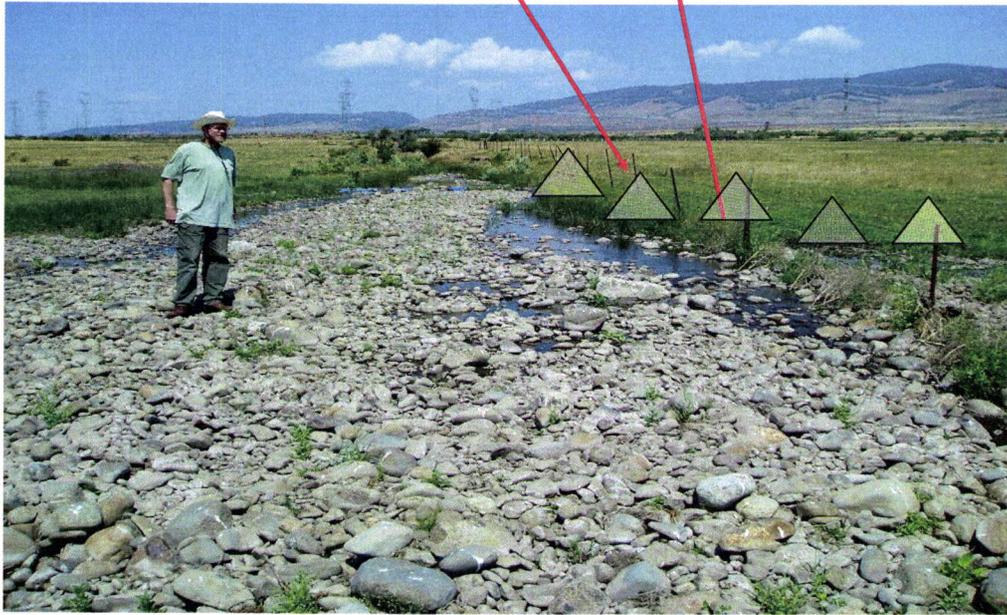
Upper 150 feet of area 2 on Nelson's property.

Creek used to flow under fence here

It is proposed to use track hoe to pull loose rocks under fence to here to rebuild bank for about 300 feet with gaps to allow floods to spread out.
