Large Wood Examples and Desired Outcomes from Structure Placement

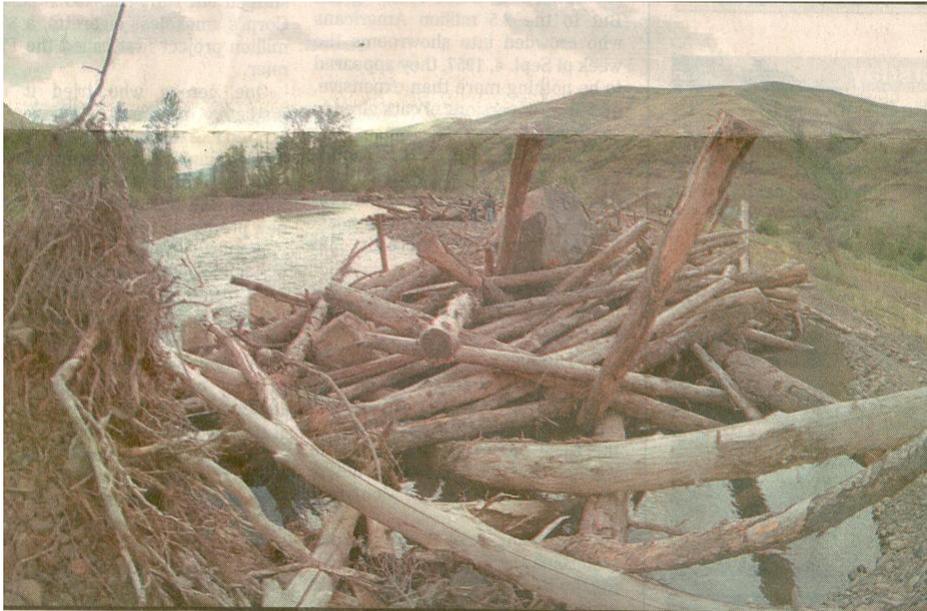
Wood Structure built in 1998 after 1996 floods. Engineered structure for this project would be modeled after this design

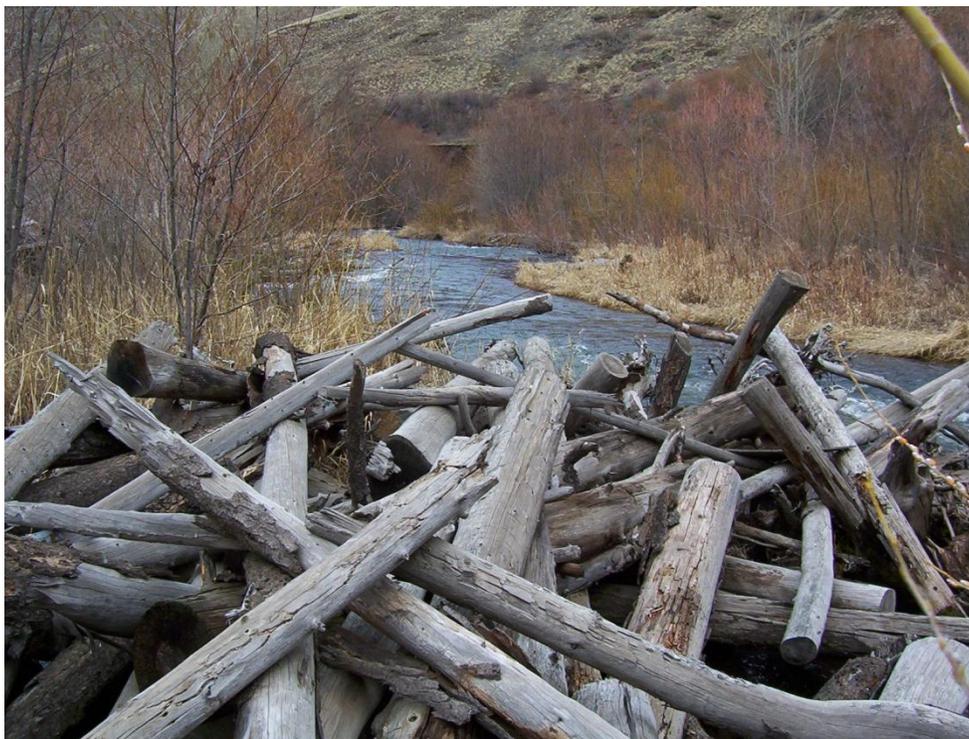
Same wood structure in 2007. Note the development of riparian habitat.

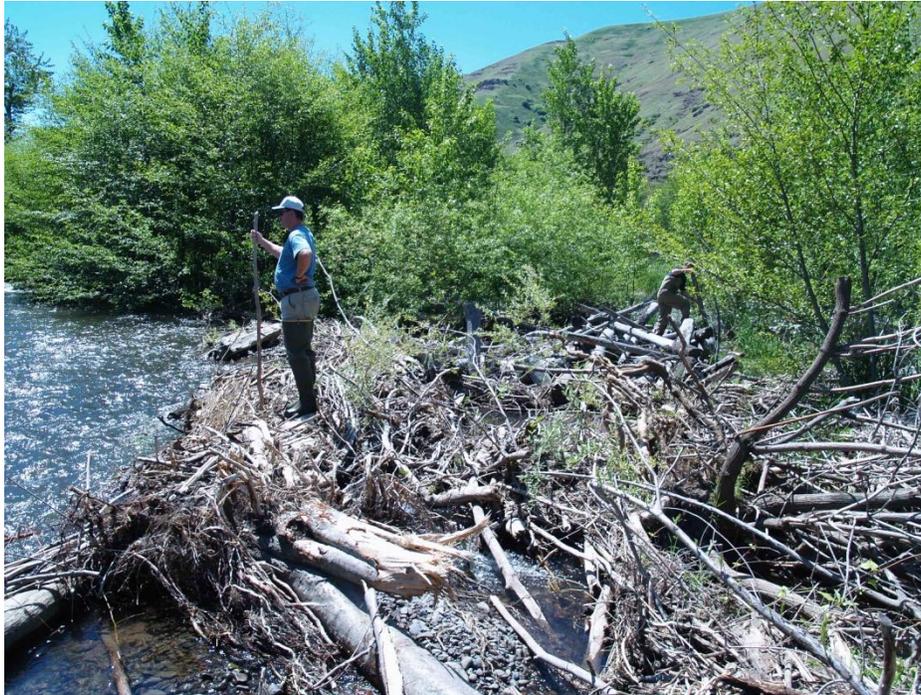
Same wood structure depicted above in 2009. Note the development of large log jam on the bar created by the log structure.

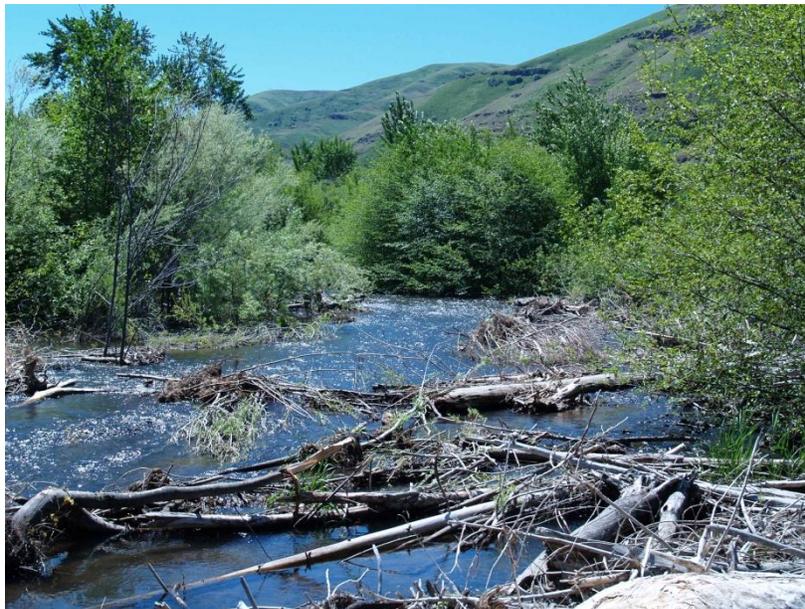
Photo 2009, immediately downstream of the 1998 log jam. The placement of the structure restored some channel stability in the reach increasing deposition and allowing riparian growth. The result with help from a large wood input by upriver fires and high water in 2008 worked with the structure to form large log jams on the new deposition bars formed off the log jam. It will be the goal of this project to develop logjams that can create natural function unique to each location.
