SITE INFORMATION

Site Identifier : BA1LB2 **Landowner Type :** Federal
Site Name : **Landowner Name :** USFS
WRIA : 03.1774X **Address :**
Region : NS **Address2 :**
Trib to : Bacon Cr **City :**
River Mile : 3.60 **State :**
River System : Bacon Cr **Zipcode :**
Legal Description : SE1/4S6T36NR11E **Phone :**
County : Skagit
Habitat Type : overflow channel

Field Survey Information

Date : 10/27/97 **Observer :** Barkdull **Survey Type :** initial

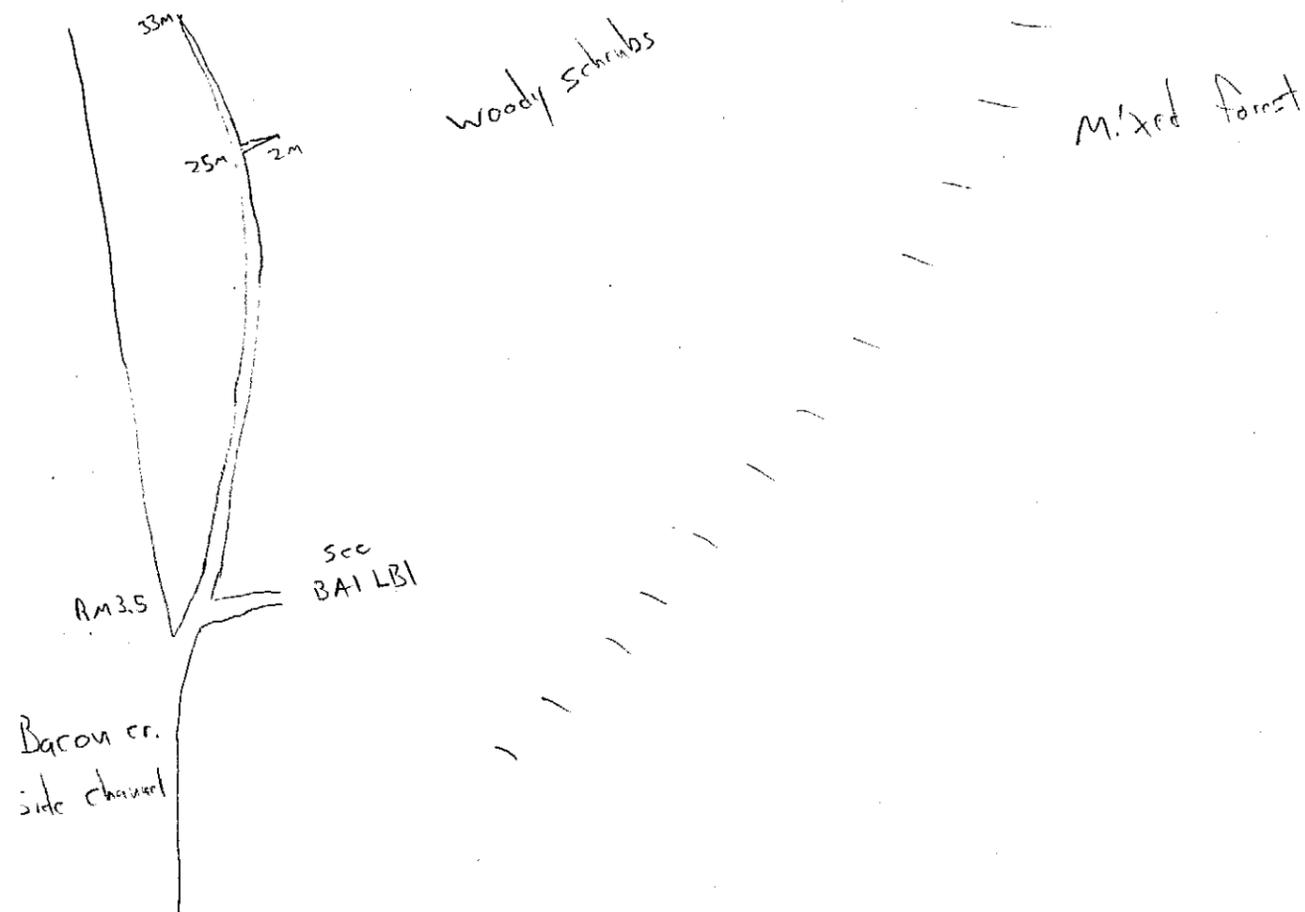
Site id. code: BA1LB2
Site name:
Scale: 1" = 10m
Observer(s): B. Barkdull
Legal location: SE6, T36N, R11E

Site is a small, very floody overflow channel to Bacon Creek that provides a little bit of rearing good rearing habitat for coho.

Describe pond and other rearing habitat: There is a small amount of low gradient, shallow, sandy bottomed channel.

Describe: This is an extremely floody site and is in danger of becoming part of the side channel it enters.

ENHANCEMENT OPPORTUNITIES: None

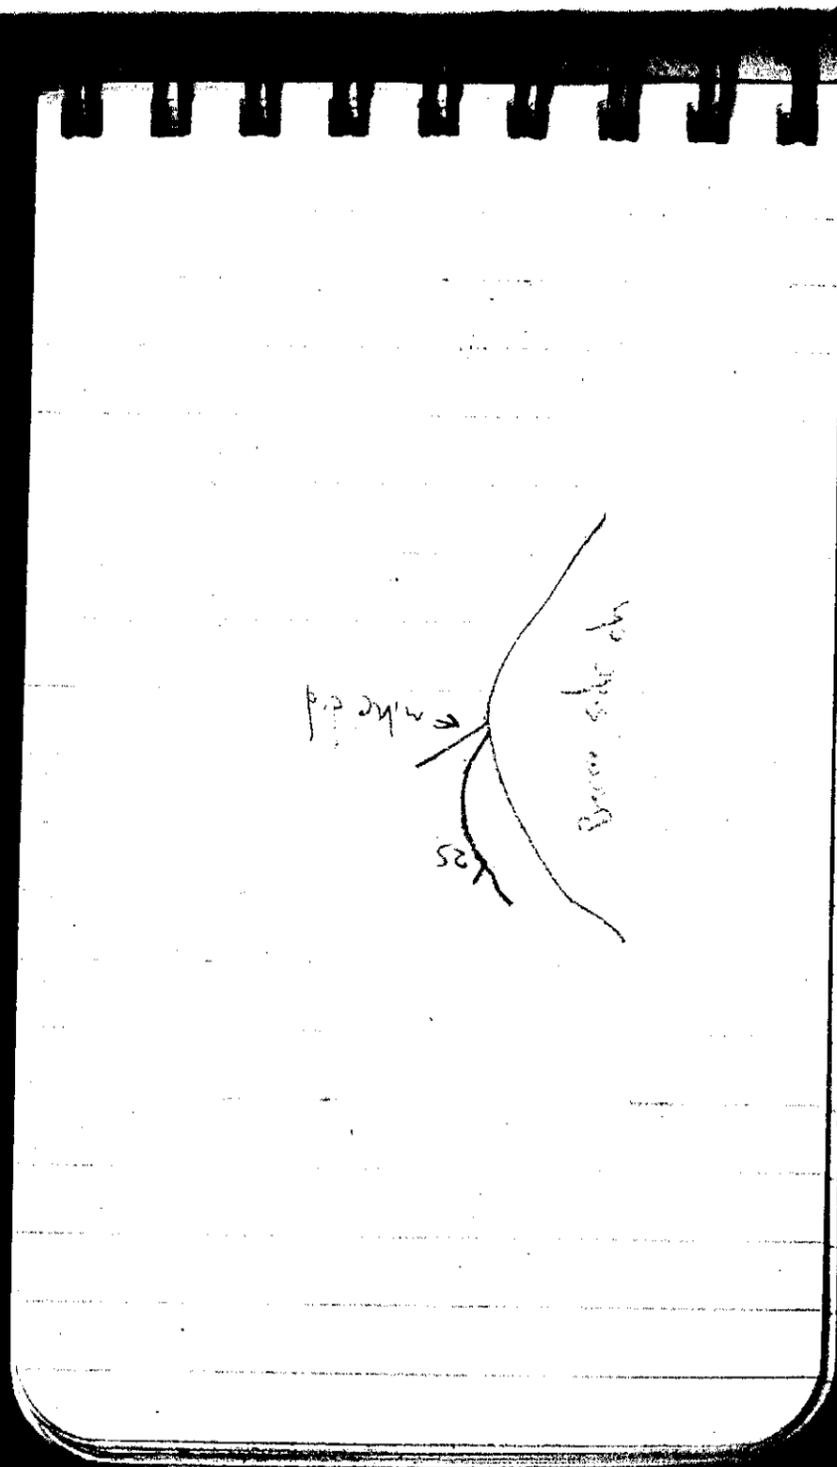
BAI LB2

10/27/47 Trib to Brown, LB, Just
below Zunder - See who he did
"twist" tub

00 0.7 47° Oil ch
25 0.5 down to a truck
LB trib 2m, 0.4
33 oil end.

Very floody, may soon
get eaten by Brown or

13.3 m²
