SITE NUMBER: C-L5-01
LOCAL NAME: Bridge View Channel
WRIA: 20.0196D

NORTH COAST OFF CHANNEL SITE INVENTORY DATA

RIVER SYSTEM: Calawah **DATE:** 4/4/90 **OBSERVER:** Young

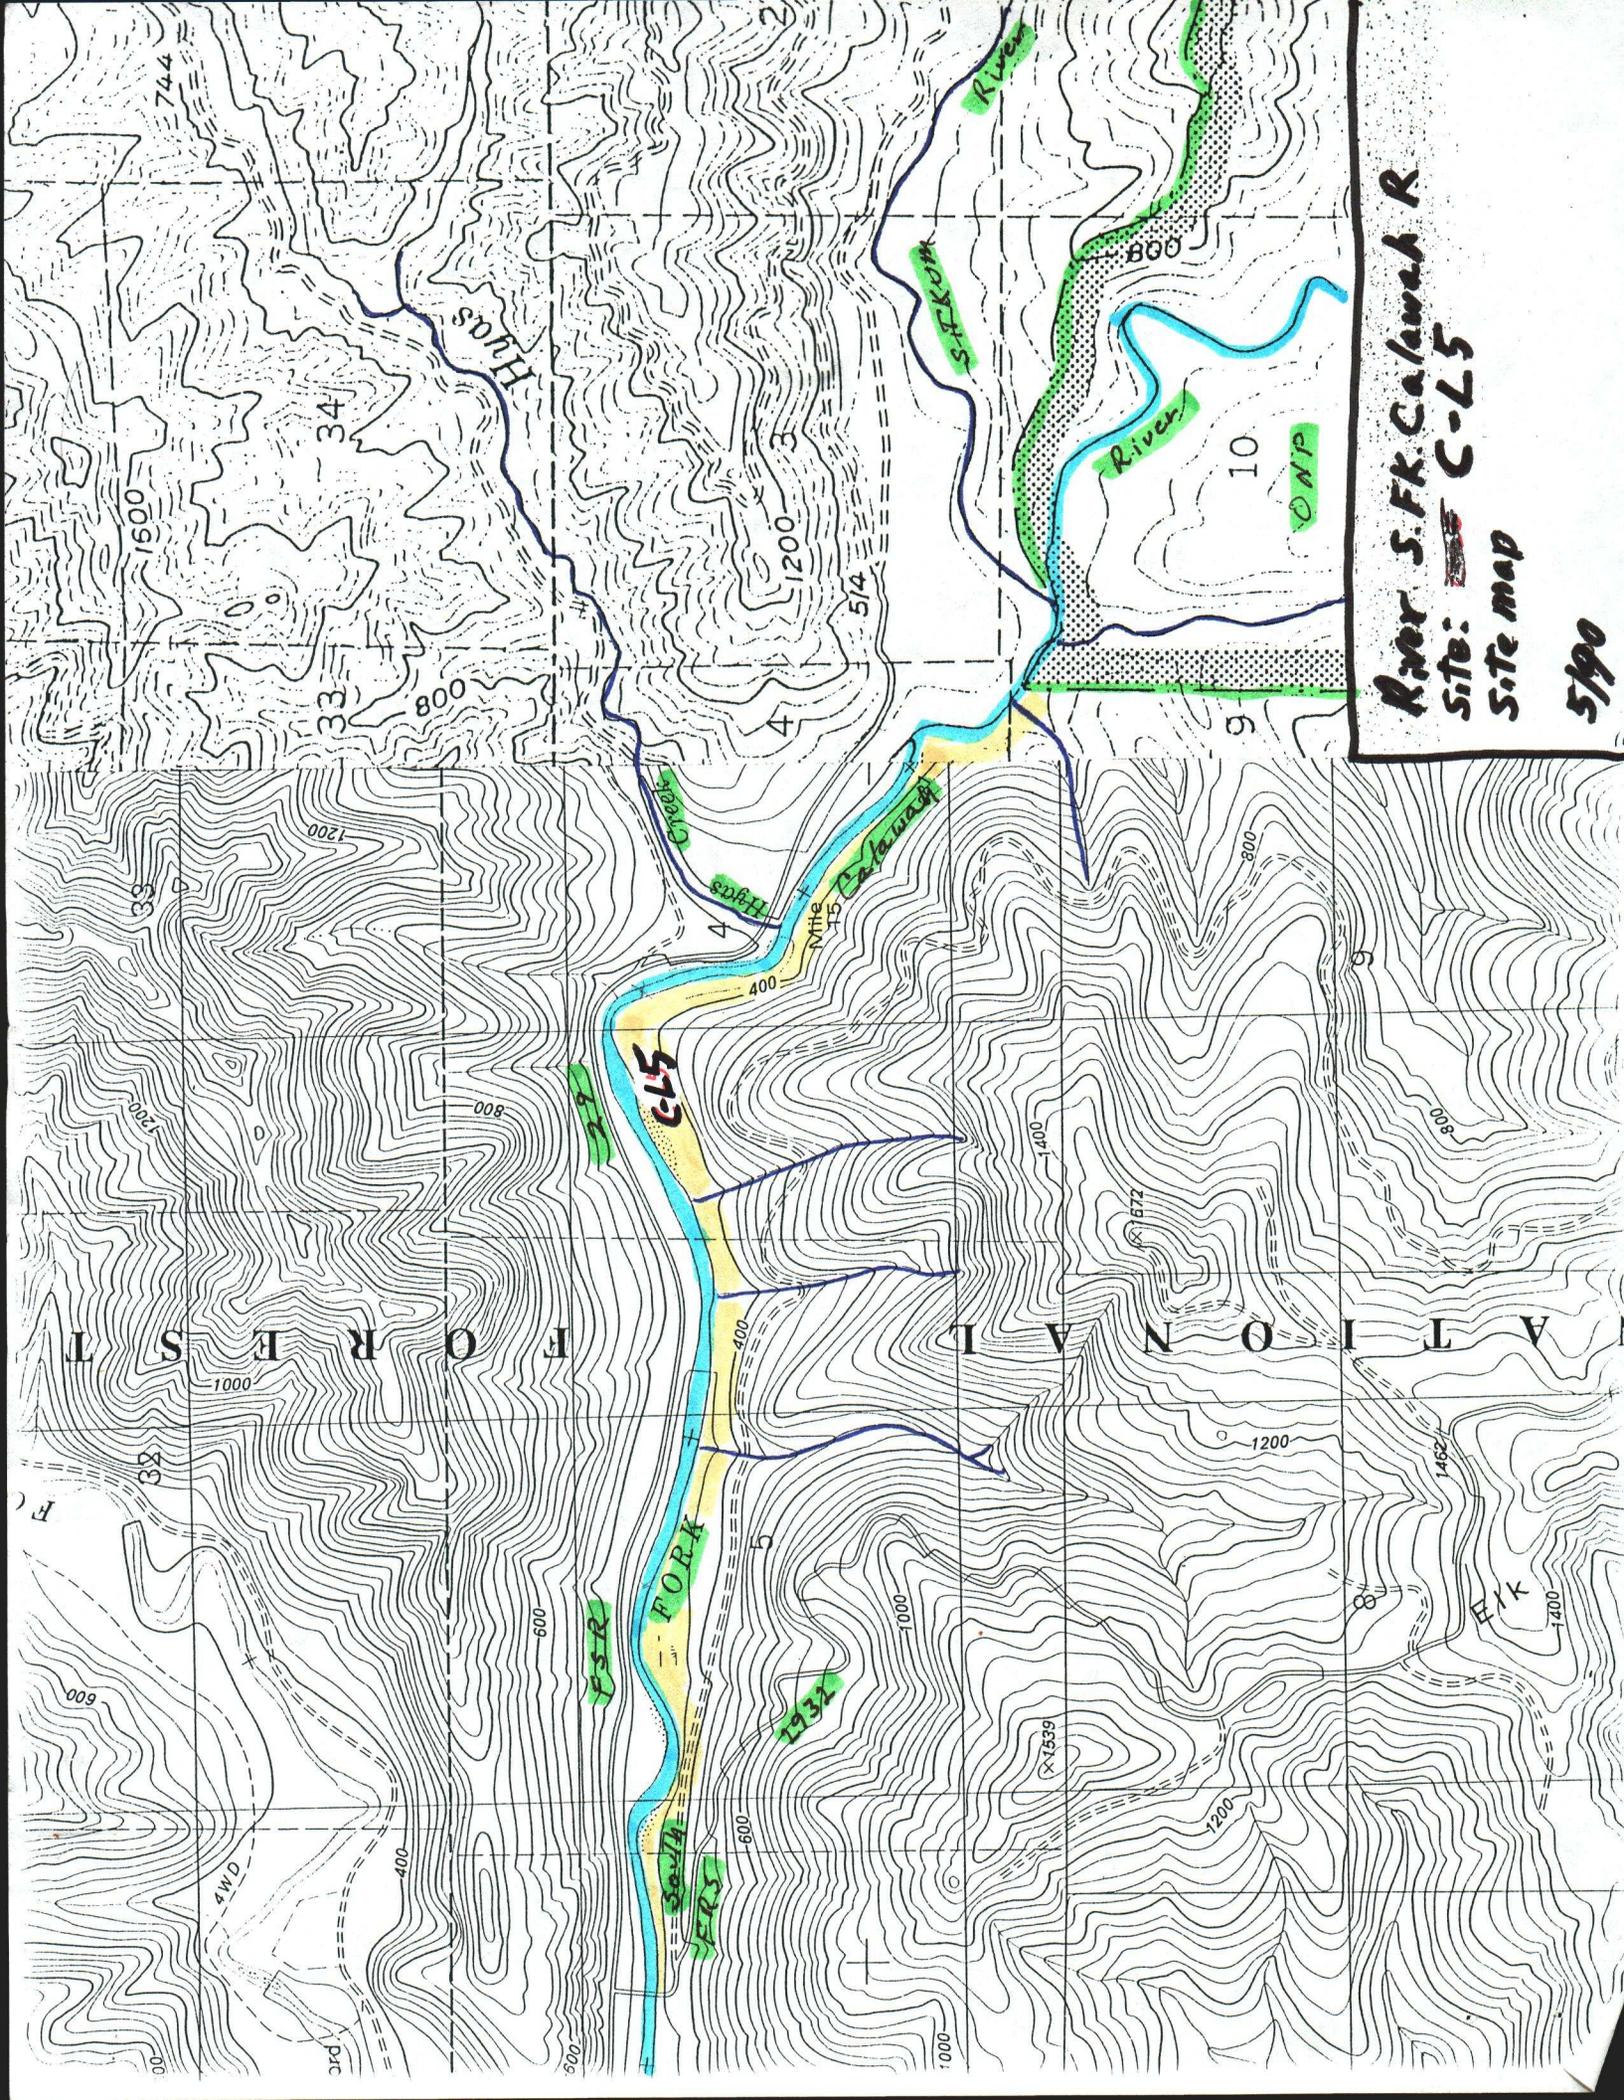
River: S.F.K. Calawah R
Site: C-L5
Site map
5190

Three small tribs, entering from the left bank, feed into C-L5-01. These tribs originate on the steep hillside to the south of USFS Rd 2923. The first trib enters 35 m above the mouth of the channel. The second enters 110 m up from the mouth at a relatively wide alluvial fan. All the usable water in C-L5-01 currently flows from these two tribs as the channel was mostly dry above the second trib. The third trib enters at the uppermost end of C-L5-01. At present this trib had a few "springy" areas but no flowing water. The third trib appear to carry a little more water at times but probably does not remain flowing throughout the winter.

A wide, shallow, mud bottomed pool was seen just upstream of the second trib. The alluvial fan helps to form this pool and presently isolates the it from the rest of C-L5-01. The pool, presently 20 m long, 5 m wide and 2 to 4 inches deep, appears to be receding in size. 1 or 2 smolt sized salmonids were seen scurrying about the pool and appeared to be trapped. At its maximum winter size the pool appears to be 10 m wide, 40 m long and 1 to 1.5 ft deep.

It may be possible to develop and enhance the habitat in C-L5-01 as a short term winter refuge area. Deepening of the channel might help to maintain water throughout the winter and reduce stranding potential. Need to see C-L5-01 during periods of heavy flow to better determine flooding potential.
