SITE NUMBER: CW-R11-01

NORTH COAST OFF CHANNEL SITE INVENTORY DATA

RIVER SYSTEM: Clearwater **DATE:** 7/7/88 **OBSERVER:** Nettin

SITE LOCATION: River mile - 27.2 R.B.

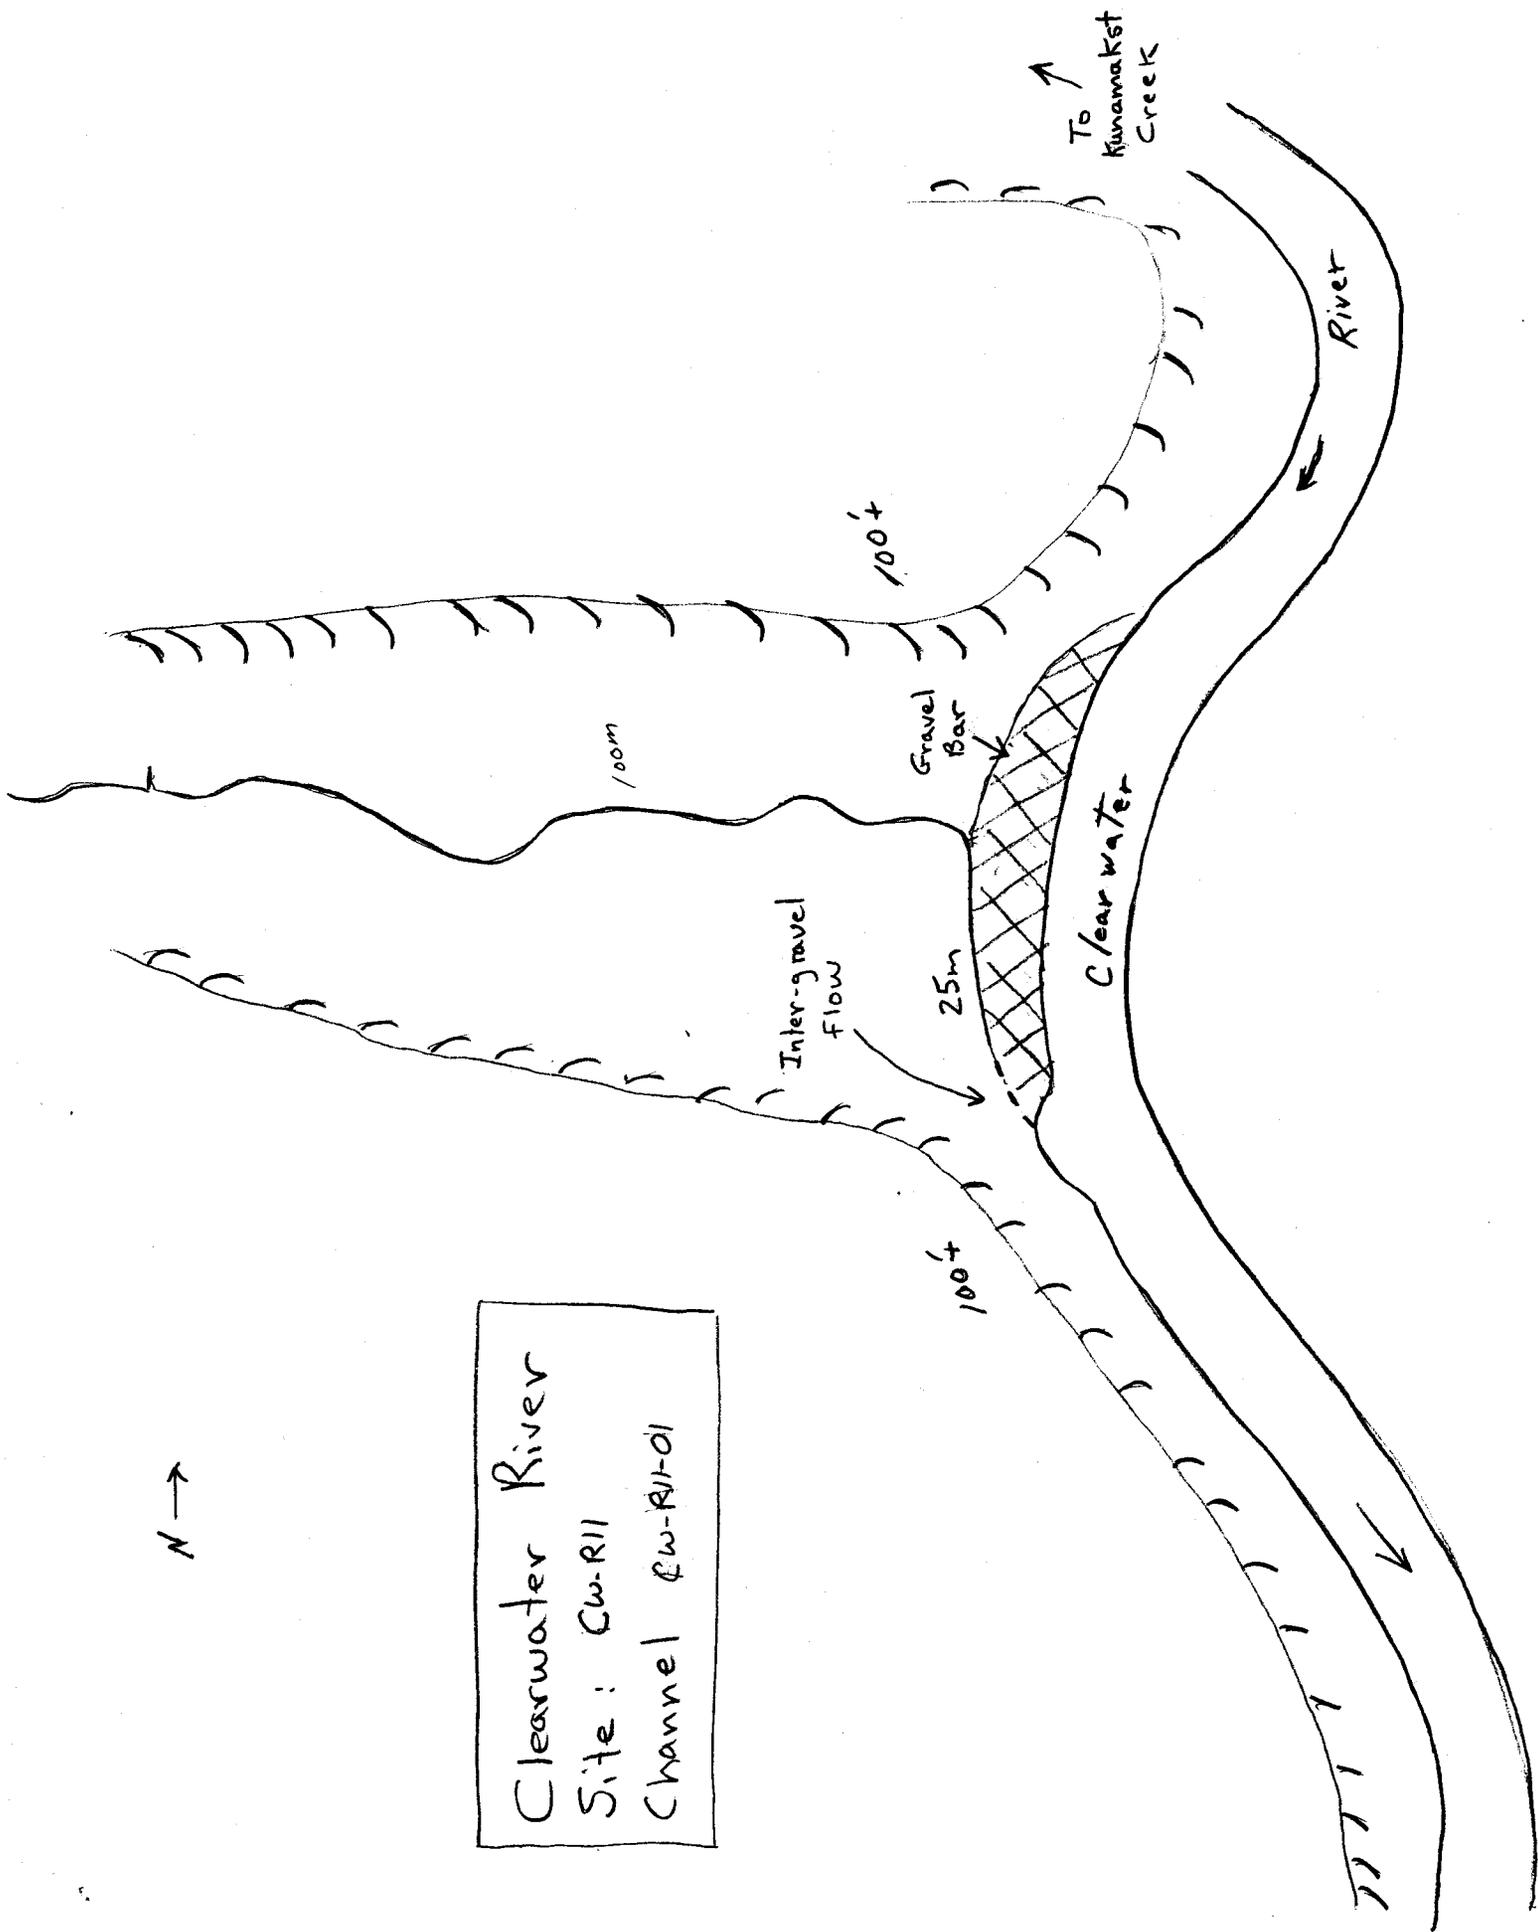
Clearwater River
Site: Cw-R11
Channel Cw-R11-d1

FISH ACCESS AND CURRENT USE: 0+ coho are using the lower end of CW-R11-01. Some small debris piles and a 6 inch falls restrict fry access but should not restrict pre-smolt movement. Enters into a nice back eddy at moderate flows. Present flow goes inter-gravel at mouth.

COMMENTS & RECOMMENDATIONS: CW-R11-01 does not appear to have very heavy winter flows. A beaded channel may be possible here. Poor access to the site greatly restricts the possibility of habitat improvements. Machine access does not appear feasible.
