**SITE INFORMATION**

**Site Identifier :** DA1RB1 **Landowner Type :** Private  
**Site Name :** **Landowner Name :**  
**WRIA :** 03.0299X **Address :**  
**Region :** NS **Address2 :**  
**Trib to :** Day Cr **City :**  
**River Mile :** 1.35 **State :**  
**River System :** Day Cr **Zipcode :**  
**Legal Description :** NW1/4S28T35NR6E **Phone :**  
**County :** Skagit  
**Habitat Type :**

**Field Survey Information**

**Date :** 02/06/1996 **Observer :** Olis **Survey Type :** initial

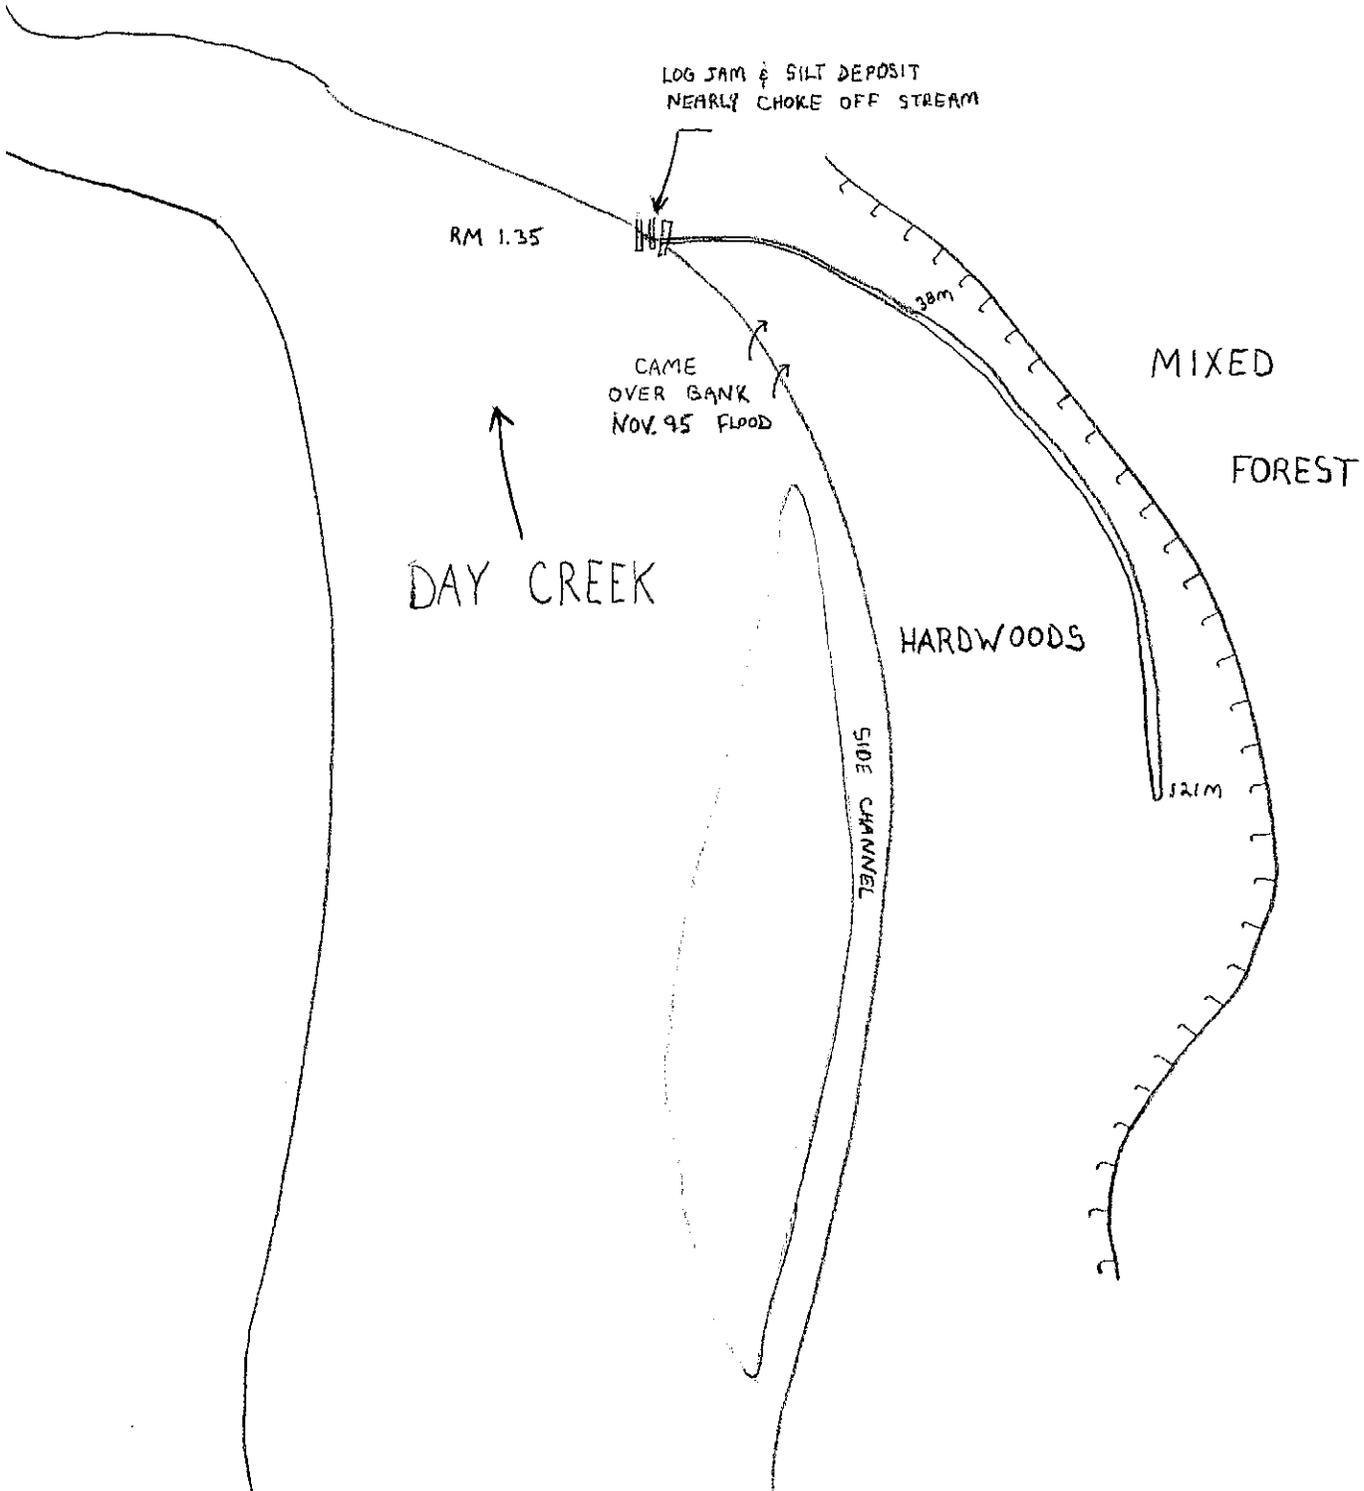
Site ID: DA1 R81

Scale: 1" = 25m

HORSE  
PASTURE

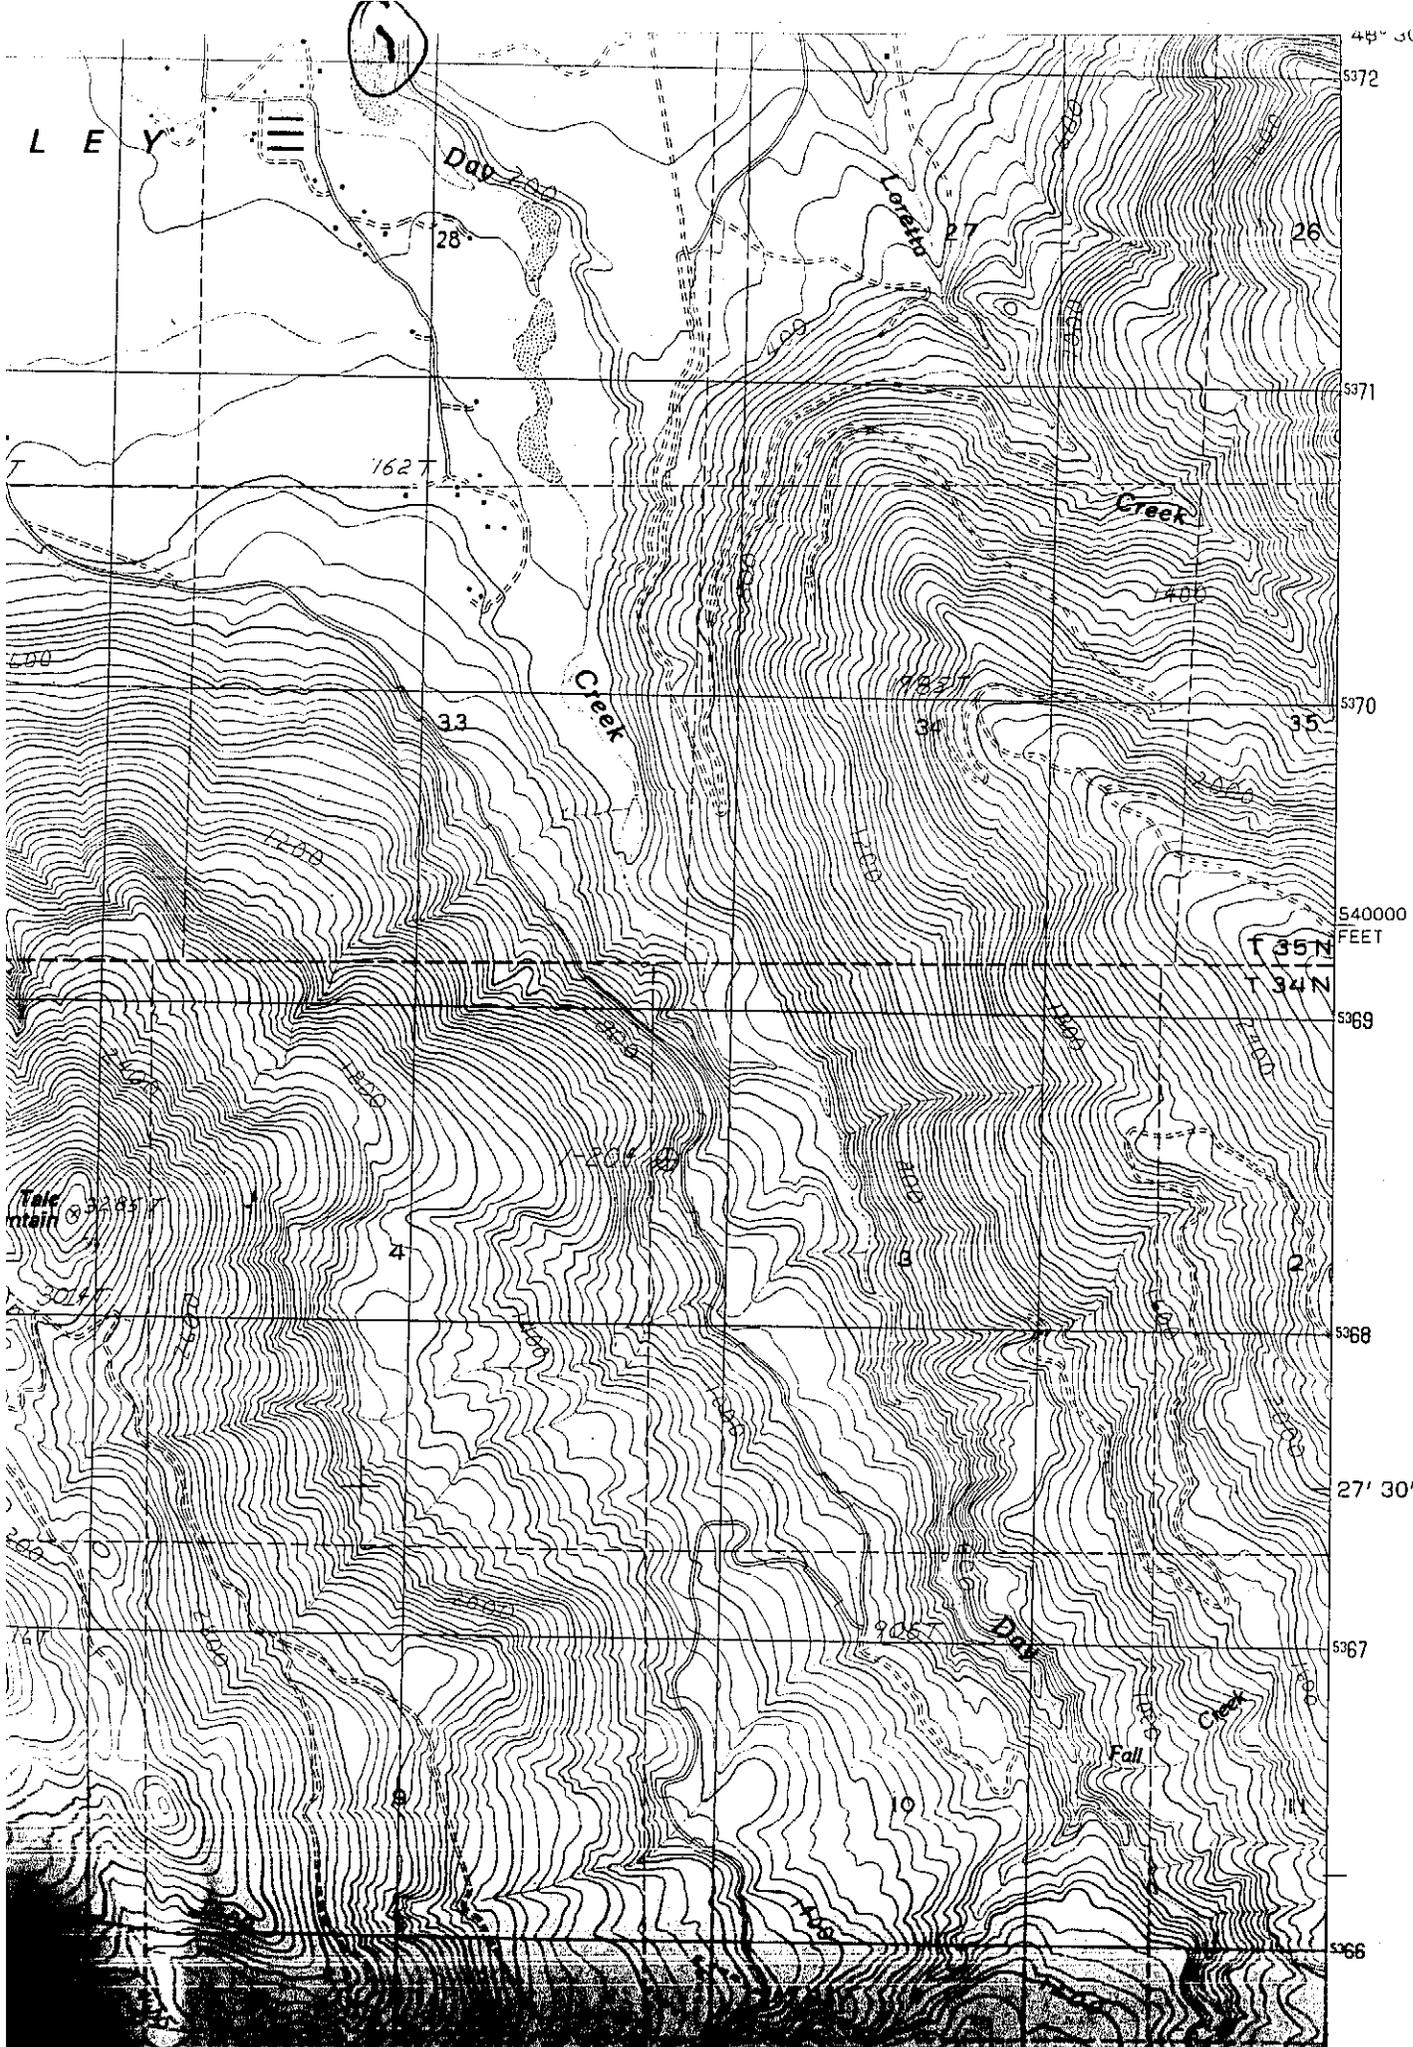
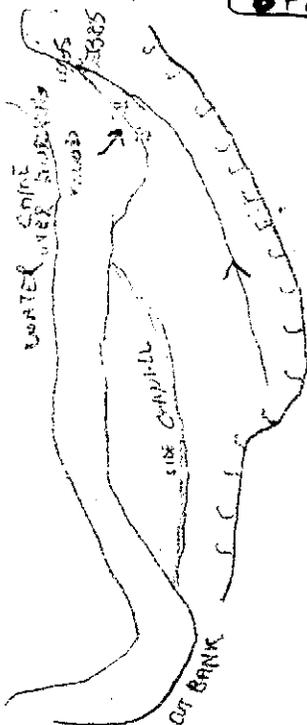
DAIRBI

0.0 ENTRY

- REC WATER TEMP 38°
  - STAIR TEMP 39°
  - FLOW → DOESN'T SEEM TO BE ANY BECAUSE OF LOGS AND WOOL ALMOST CHOKING OFF ENTRY
  - FISH ACCESS - POOR ↗
- 38m 1m ww  
VERY SLOW MOVING
- SHALLOW
  - SUBSTR. VERY SILTED UP TO THIS POINT AS WELL AS LB.
  - HIT PRETTY HARD BY FLOOD

121m WW 3m POOLS

- STRM BETTER SHAPE
- SERIES OF POOLS  
(AVG 3m WW)
- SUBSTR. ORGANIC MUDDY
- END OF WATER

- SHORT WALL BASE STRM  
PROB. ONLY WETTED  
HALF A YEAR,
- NO SPAWNING
- SMALL AMOUNT OF  
WINTER REARING, POOLS  
MAY BECOME ISOLATED
