SITE INFORMATION

Site Identifier : EN1LB1 **Landowner Type :** Private
Site Name : **Landowner Name :**
WRIA : 03.0230X **Address :**
Region : NS **Address2 :**
Trib to : EF Nookachamps Cr **City :**
River Mile : 3.50 **State :**
River System : EF Nookachamps Cr **Zipcode :**
Legal Description : NW1/4S19T34NR5E **Phone :**
County : Skagit
Habitat Type :

Field Survey Information

Date : 10/26/99 **Observer :** B. Barkdull **Survey Type :** initial

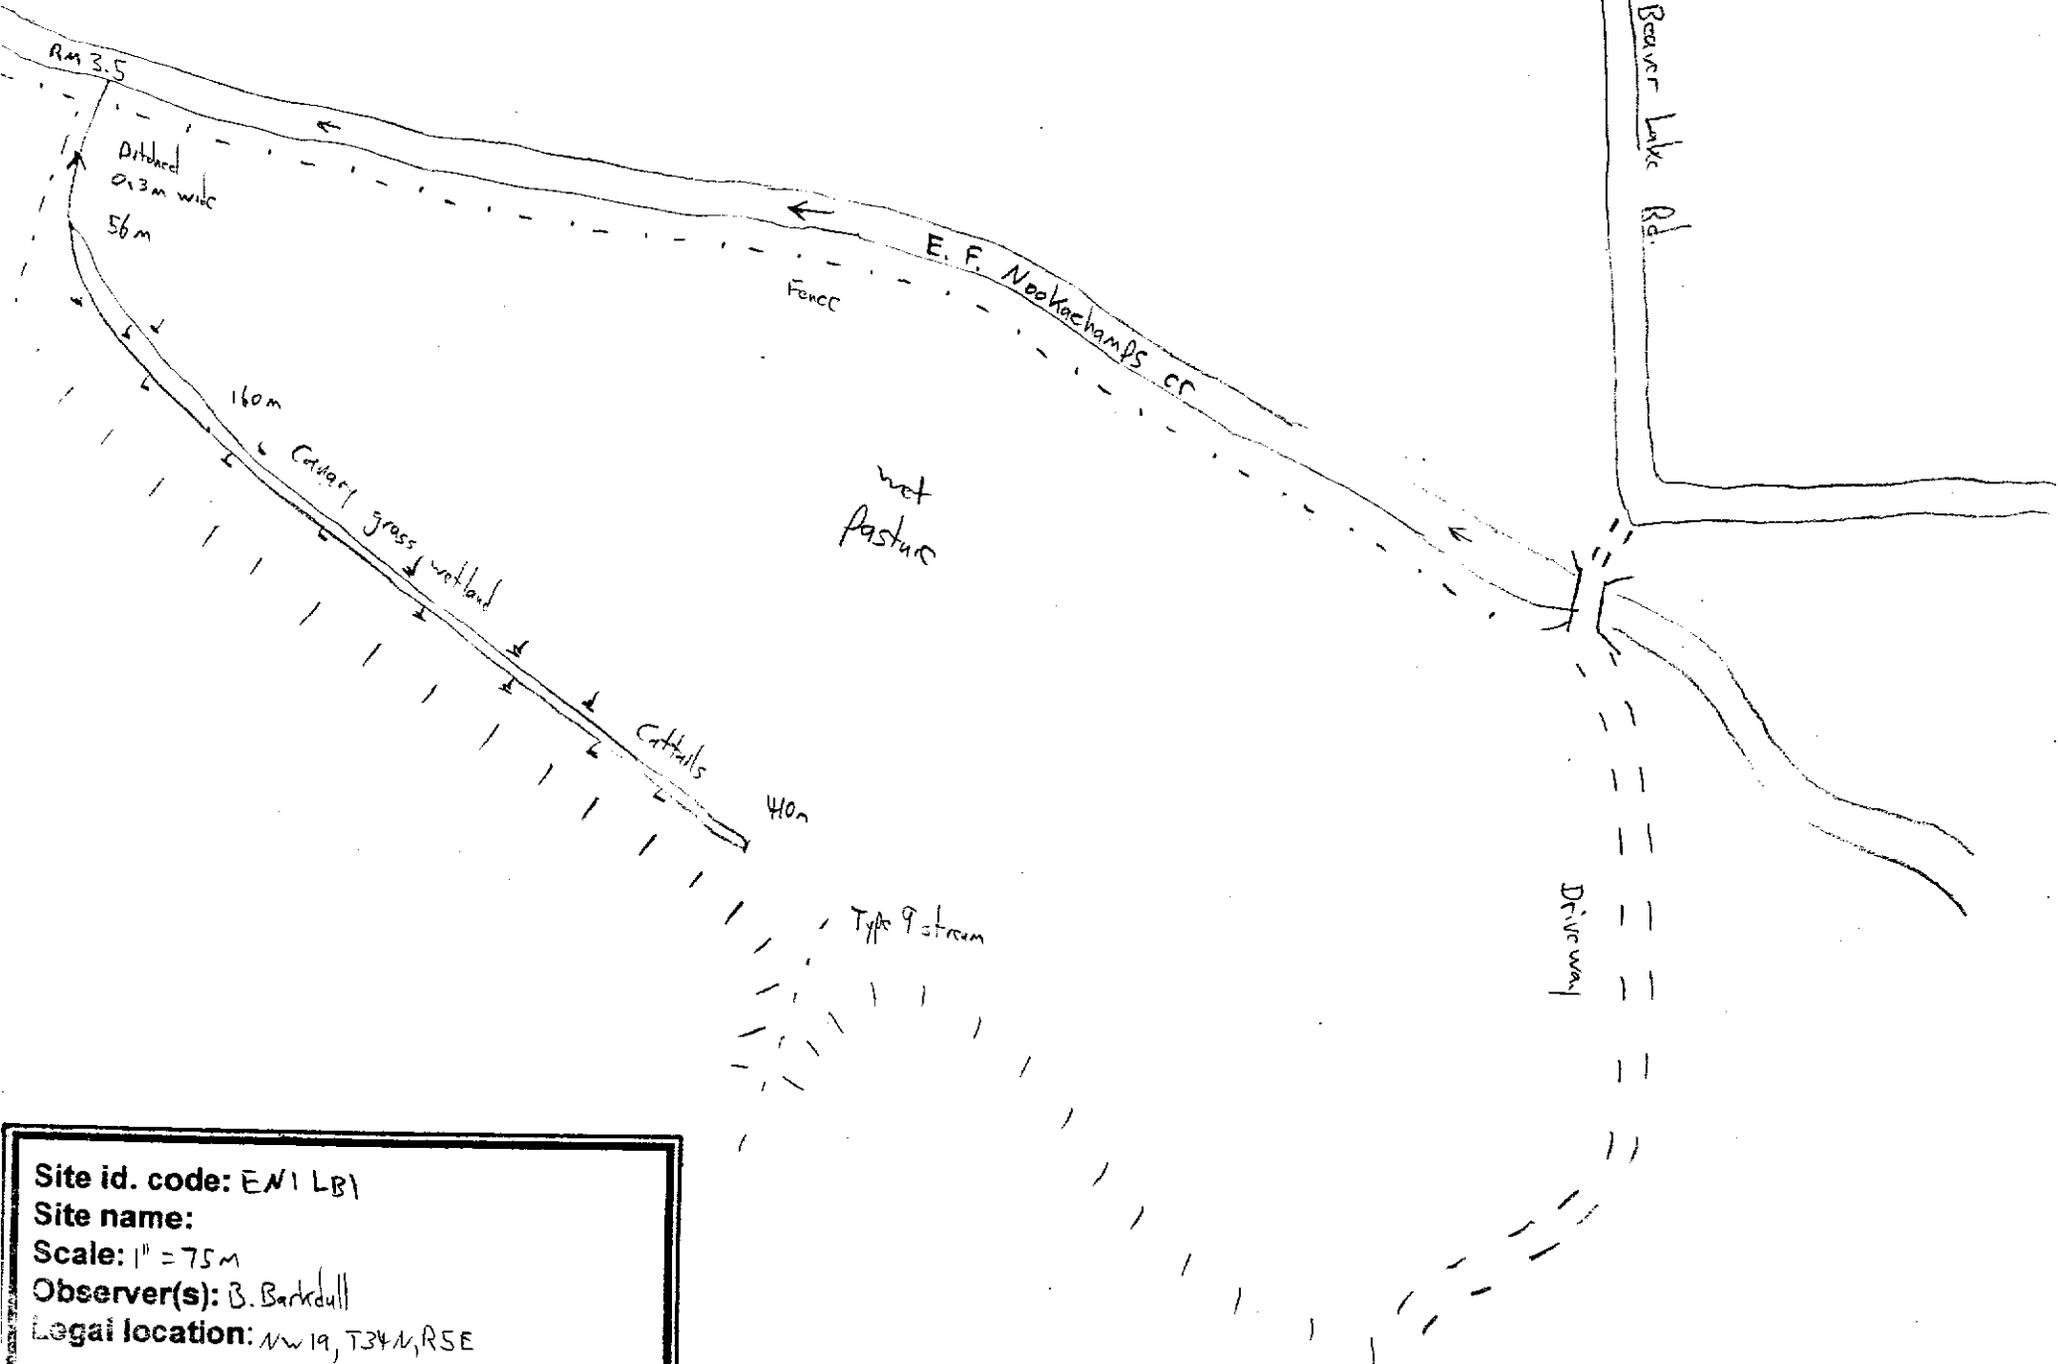
Site id. code: EM1 LB1
Site name:
Scale: 1" = 75m
Observer(s): B. Barkdull
Legal location: NW 19, T34N, R5E

10/26/99 Trub to E. Fork Nade

Trub 53, Mauston 47°

0.0 0.5 tracks of flow

11 0.3 Ditched, at fence

56 6.5 } Ditched, very abused by cattle
160 8.0 } Canary grass

400 ^{2.0} wetland mostly various stuff

last 300m cattails
