SITE NUMBER: H-L9-01
LOCAL NAME: Unnamed
WRIA: 20.0450B

NORTH COAST OFF CHANNEL SITE INVENTORY DATA

RIVER SYSTEM: Hoh **DATE:** 8/27/87 **OBSERVER:** Young/Nettnin

CHANNEL TYPE: Terrace Tributary

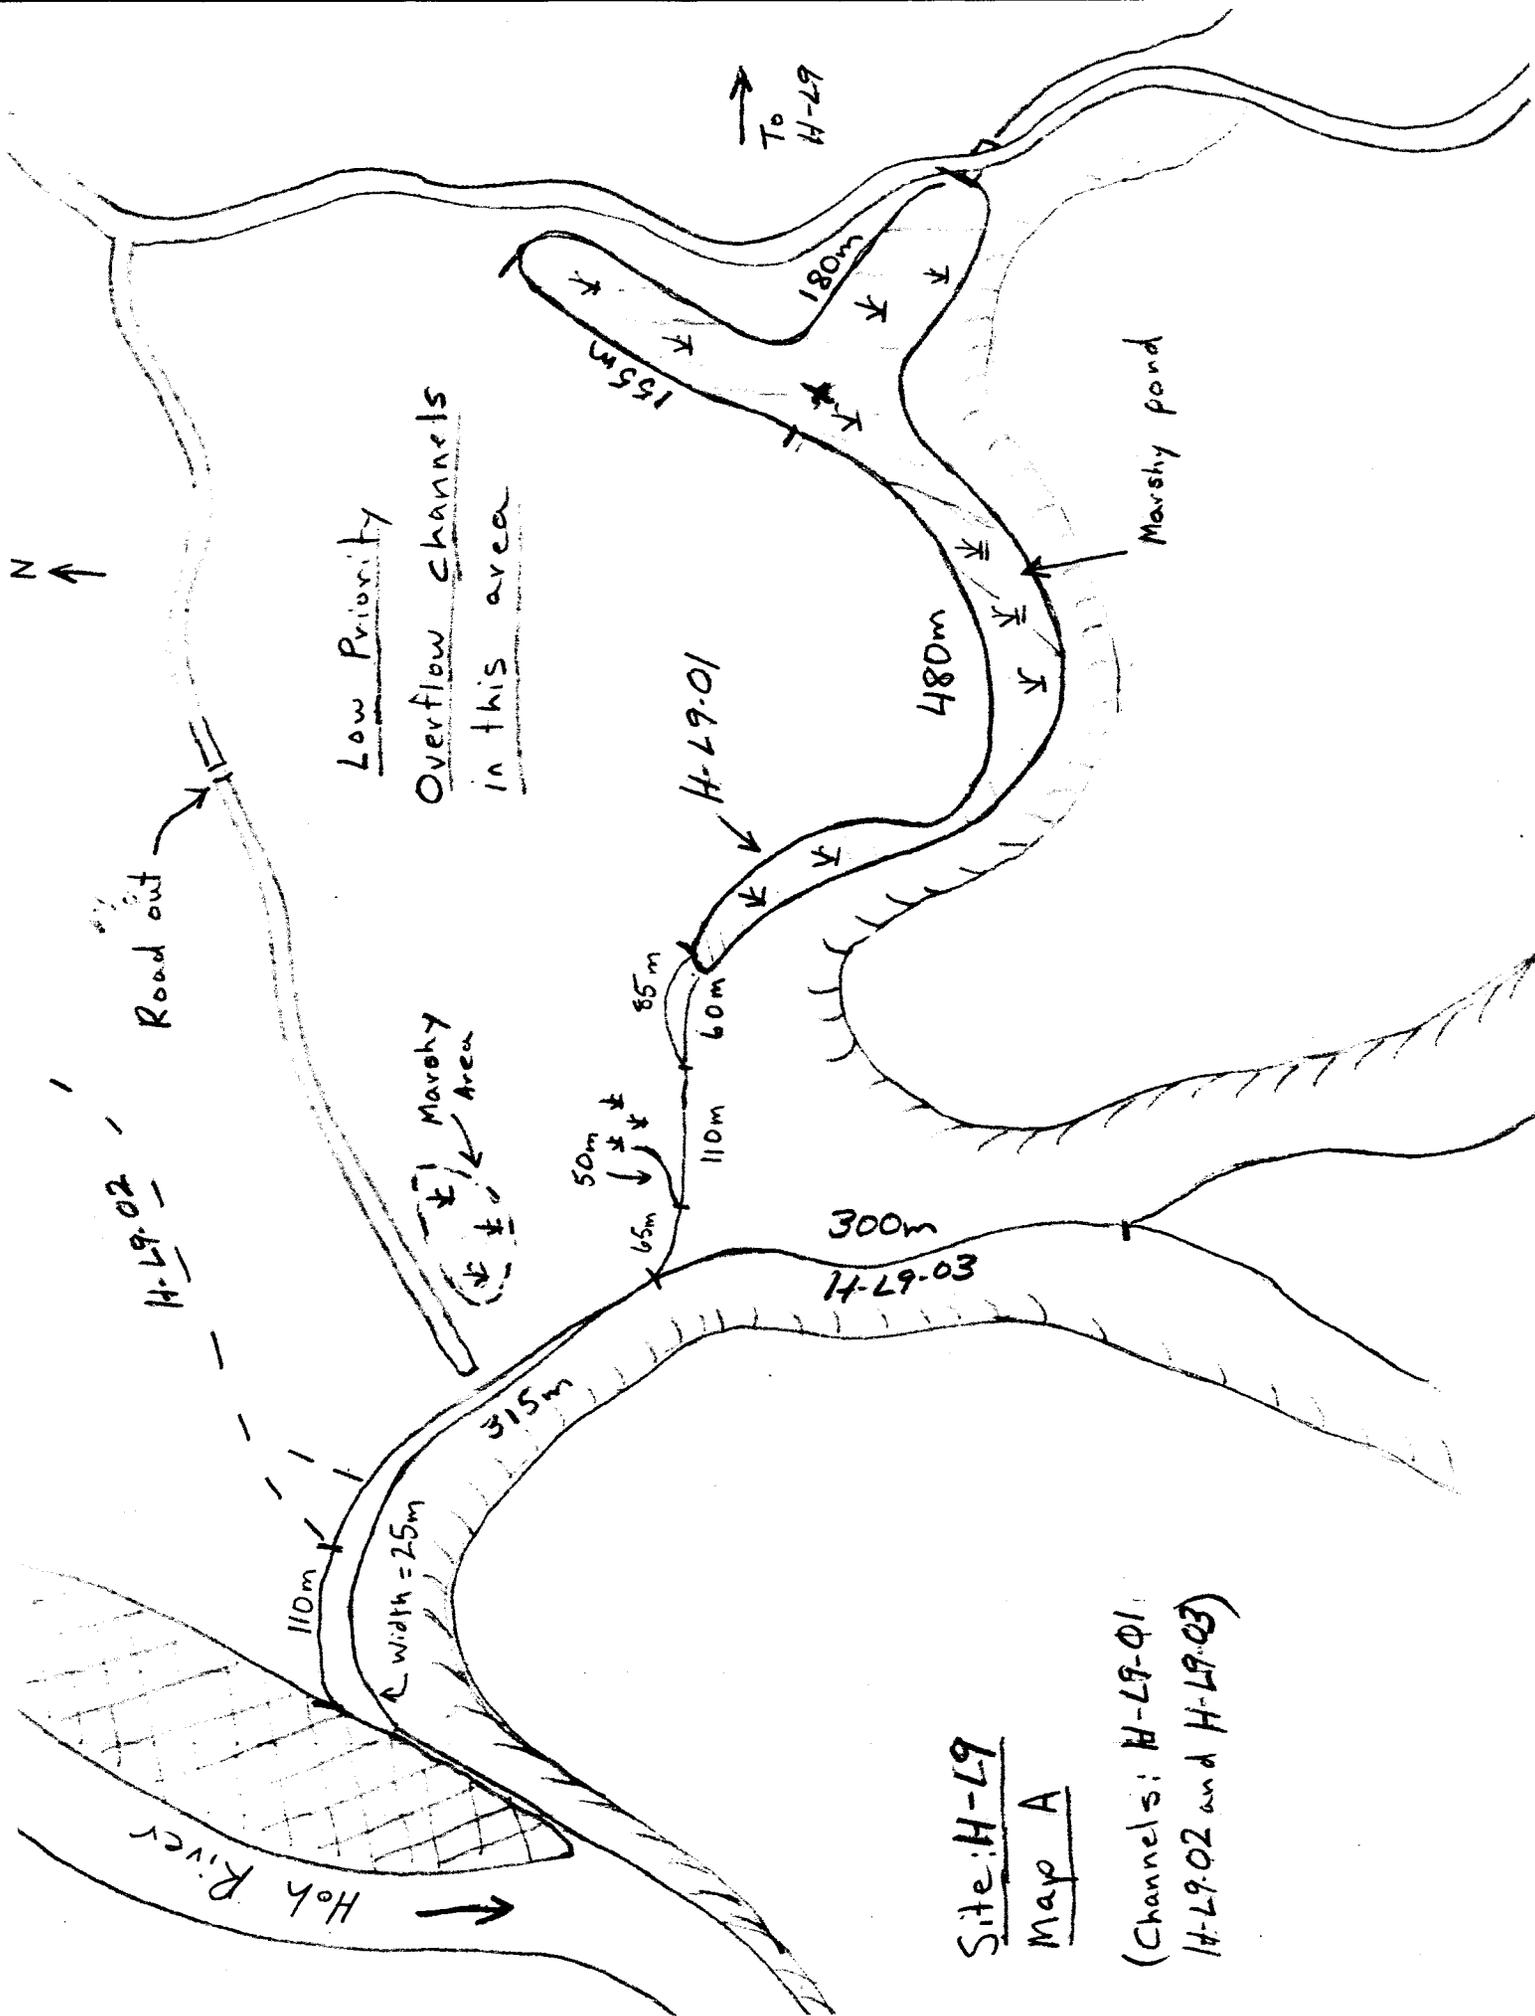
Site: H-19
Map A

Low Priority
Overflow channels
 in this area

(Channels: H-19-01,
 H-19-02 and H-19-03)

COMMENTS & RECOMMENDATIONS: H-L9-01 appears to act as a secondary overflow channel for the Hoh R. during extreme floods. Water appears to flow across the clearcut area east of H-L9-01 and north of H-L9-05 via poorly defined and well vegetated channels (see map). Roads in this area have no culverts. The lower 450 m of H-L9-01 is wide, deep and slough-like.
