SITE NUMBER: H-R10-03

NORTH COAST OFF CHANNEL SITE INVENTORY DATA

RIVER SYSTEM: Hoh **DATE:** 1/5/88 **OBSERVER:** Nettin

NORTH COAST OFF CHANNEL SURVEY
SUBSEQUENT SITE EVALUATION FORM

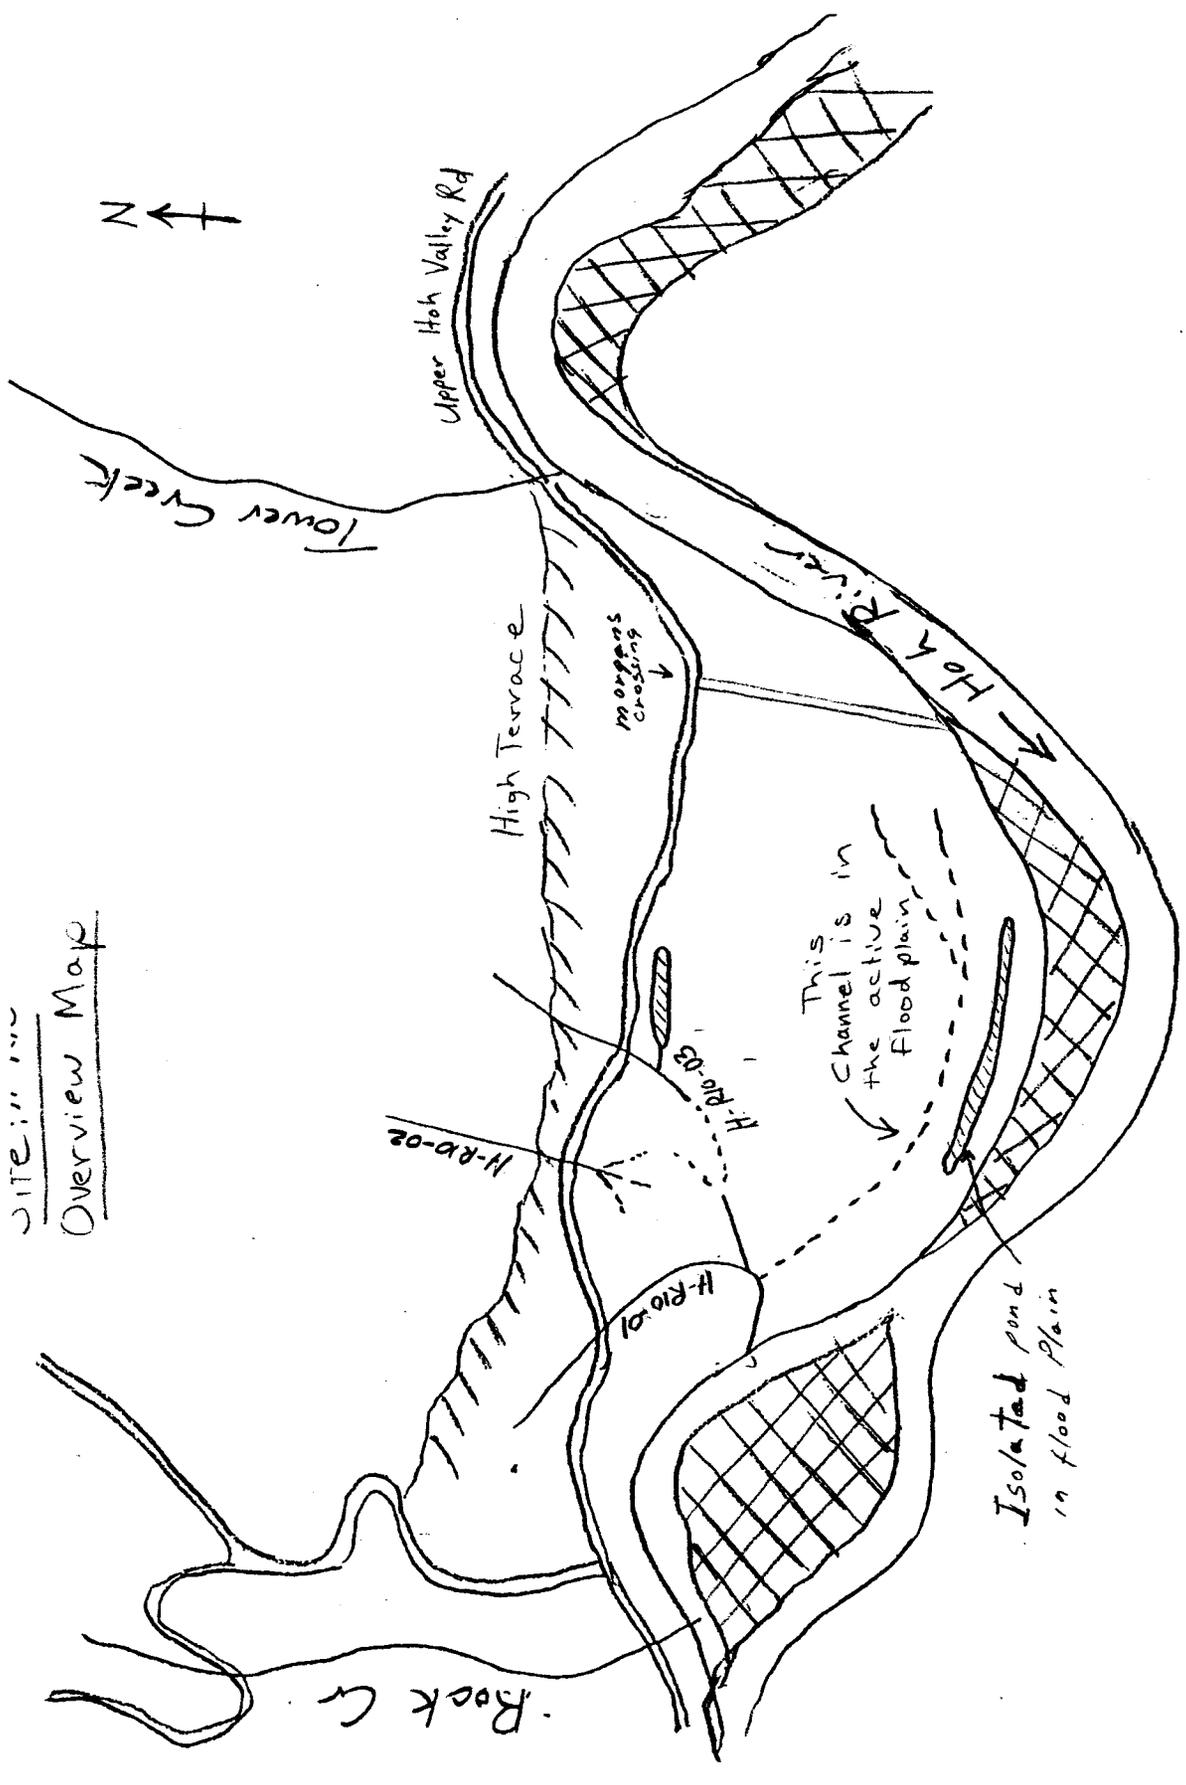
SITE: " "
Overview Map

COMMENTS: Water flows into this pond from tributary H-R10-03. The pond does not have a visible outlet (see map).

A minnow trap was set along the right bank of the upper pond (see map). The trap was baited with cluster eggs which were laid loose inside the trap. It was set in about 14 inches of water near some small woody debris and overhanging vegetation.
