**SITE NUMBER:** H-R3-02  
**LOCAL NAME:** Unnamed  
**WRIA:**

**NORTH COAST OFF CHANNEL SITE INVENTORY DATA**

**RIVER SYSTEM:** Hoh River    **DATE:** 7/1/87    **OBSERVER:** Young/Nettnin

**NORTH COAST OFF CHANNEL SURVEY**  
**SUBSEQUENT SITE EVALUATION FORM**

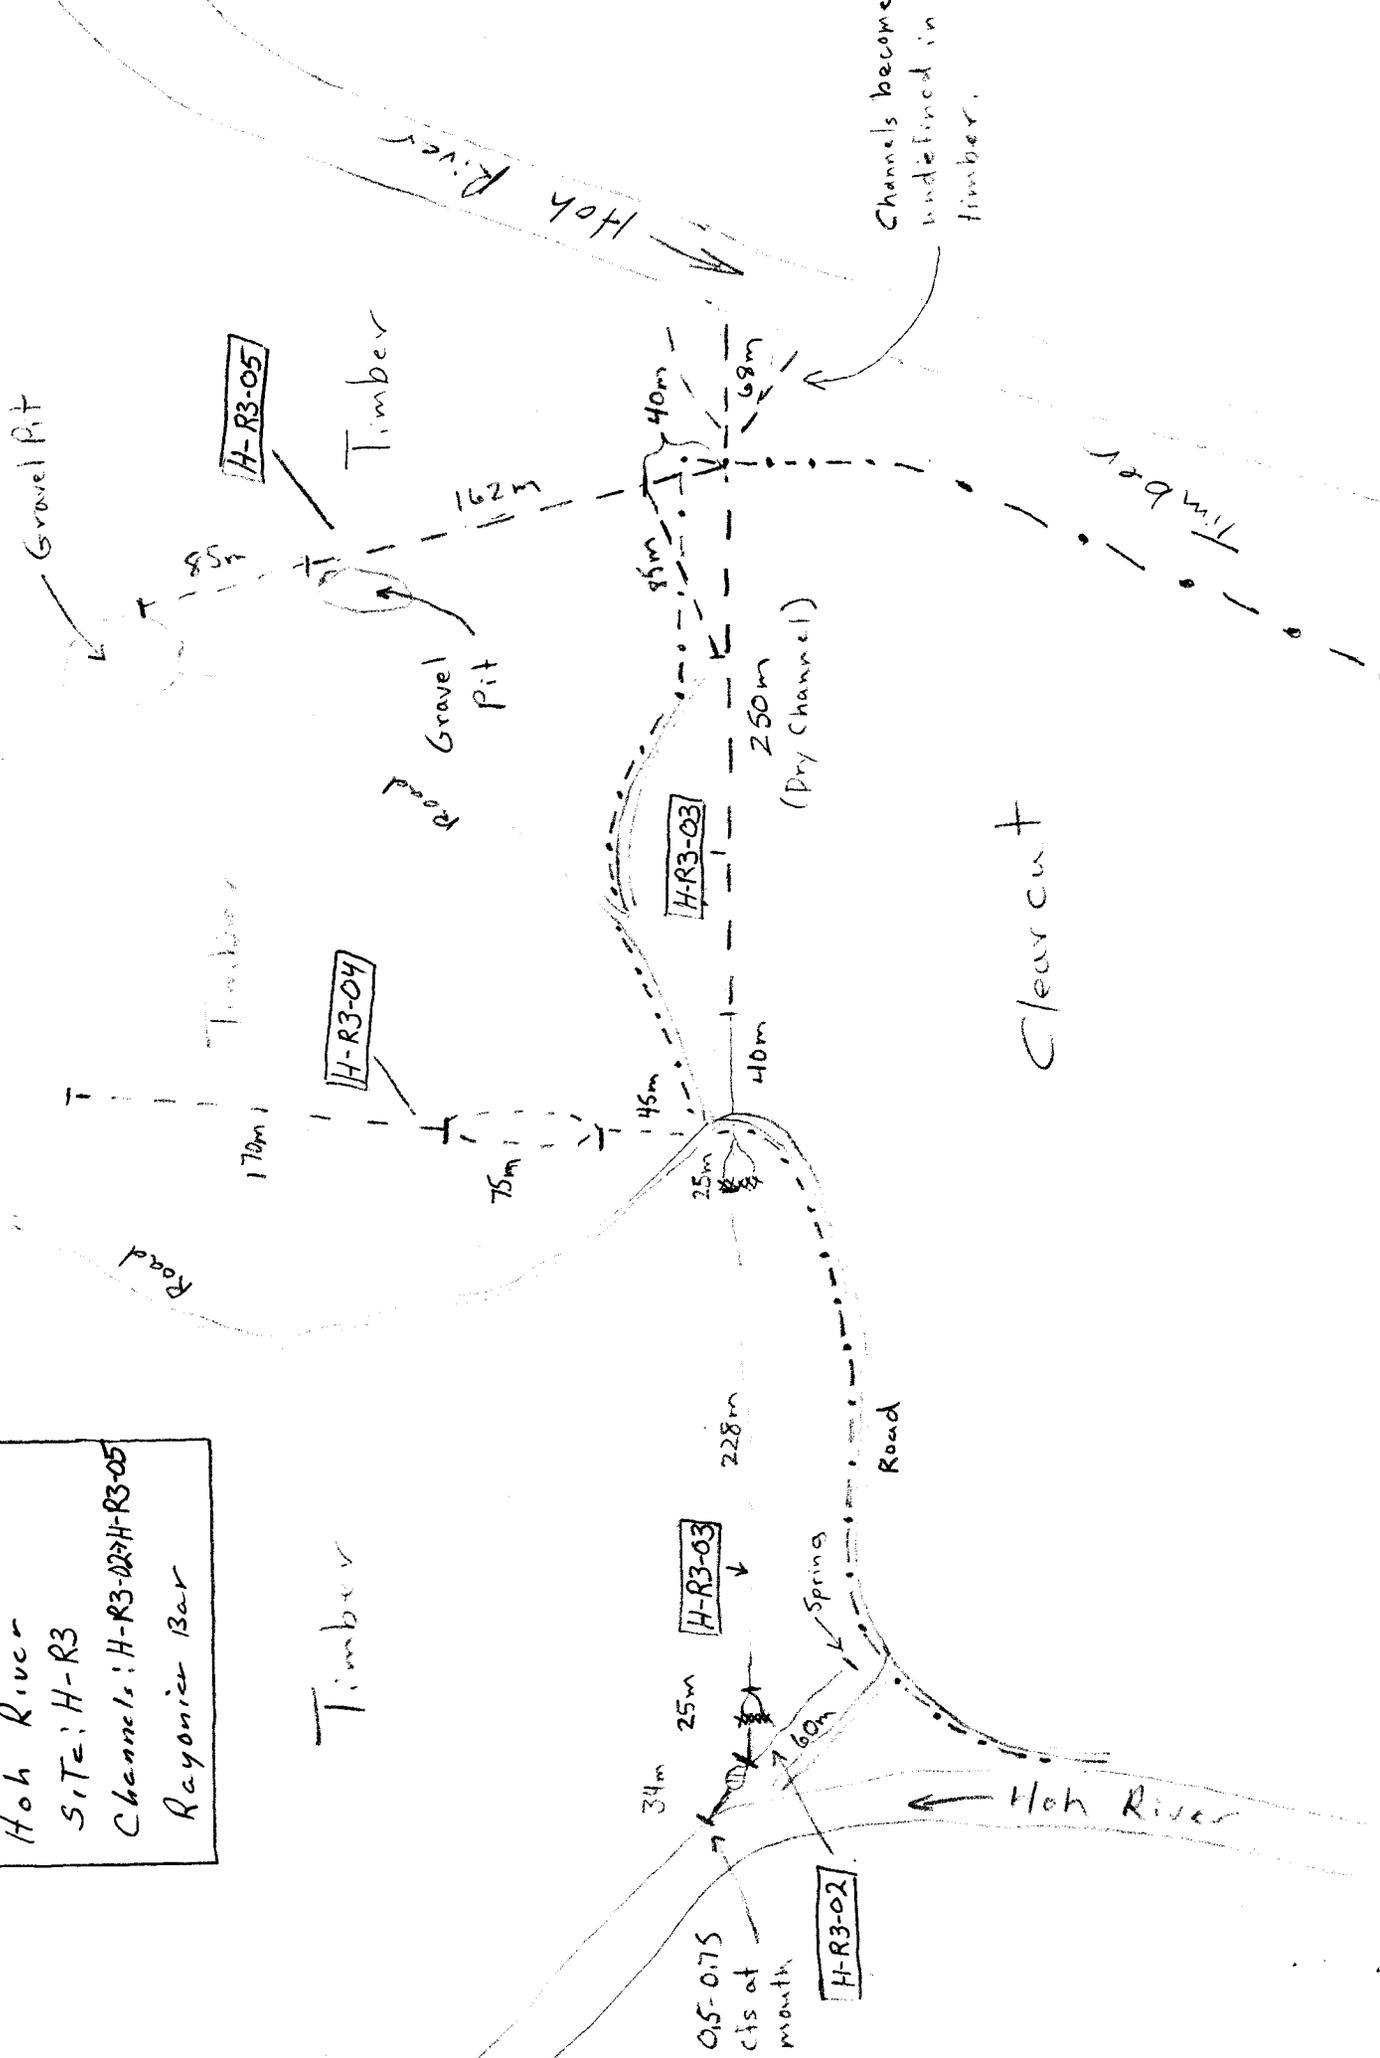
Hoh River  
 SITE: H-R3  
 Channels: H-R3-02 → H-R3-05  
 Rayonier Bar

Channels become undefined in timber.

OS-07S  
 cts at  
 mouth
