SITE INFORMATION

Site Identifier :	HN2LB8	Landowner Type :	Private
Site Name :		Landowner Name :	
WRIA :	03.0271X	Address :	
Region :	NS	Address2 :	
Trib to :	03.0271	City :	
River Mile :	1.90	State :	
River System :	Hansen Cr	Zipcode :	
Legal Description :	NW1/4S5T35NR5E	Phone :	
County :	Skagit	Coordinates	
Habitat Type :	lower valley wall tributary	East:	1,588,345.85 North: 1,180,081.33

Field Survey Information

Date : 3/5/98 **Observer :** Barkdull **Survey Type :** initial

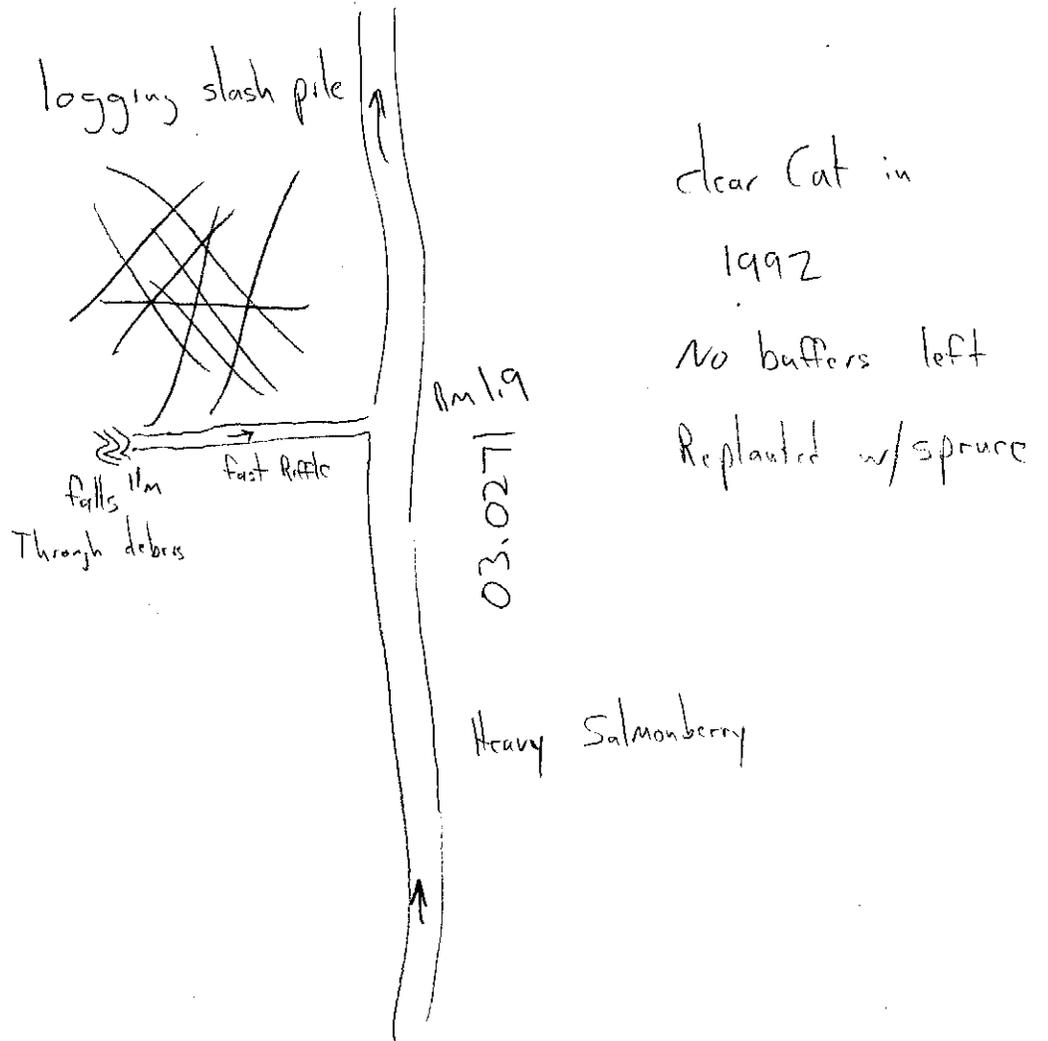
Site id. code: HW2LBE

Site is a moderately steep small surface stream only accessible for 11 meters.

Describe pond and other rearing habitat: Site is a steep (10% gradient) stream that is mostly cascades

Scale: 1" = 8 m

Observer(s): B. Barkdull

Legal location: NW1/4S5, T35N, R5E
