STATE OF WASHINGTON
DEPARTMENT OF FISH & WILDLIFE
HABITAT PROGRAM
Salmonid Screening, Habitat Enhancement &
Restoration Division (SSHEAR)

OFF-CHANNEL SITE INVENTORY DATA

Region: North Coast	Observer: Nettnin
River System: M.F. Dickey	Date: 3/29/95
Site Identifier: MD-R1-01	WRIA: 20.0145 E
River Mile Location: 1.0 mi.	RB/LB: RB
Local Name: Pseudo Springs	Trib. to: M.F. Dickey (20.0145)
Legal Description: SW¼ Sec 22 T30N R14W	County: Clallam
Habitat Type: Terrace tributary	
Landowner: () Federal (X) State () County () Other Government () Private Dept of Natural Resources

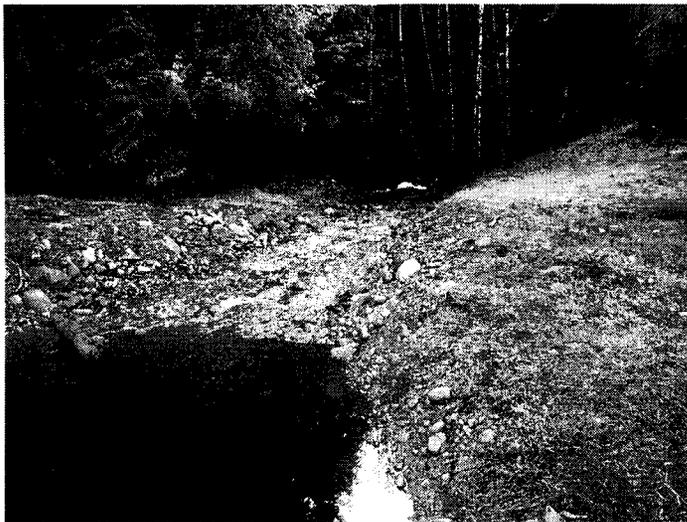
The WDFW construction crew removed an undersized plugged culvert from an old logging road and installed a series of wooden streambed controls where the channel crosses the grade. The uppermost control was set at the elevation of the existing water surface of the pond that had formed upstream from the grade when the culvert plugged many years ago. The other controls were spaced evenly downstream at one foot drops. A mix of boulders, cobble, gravel, sand and silt was placed in the area between the controls to create a roughened channel so fish could migrate upstream through this steep section.
