Site id. code: NS1LB6  
 Site name:  
 Scale: 1" = 80m  
 Observer(s): OLB  
 Legal location: SEY4S19T32NR6E

→ N F STILLAGUAMISH RIVER →

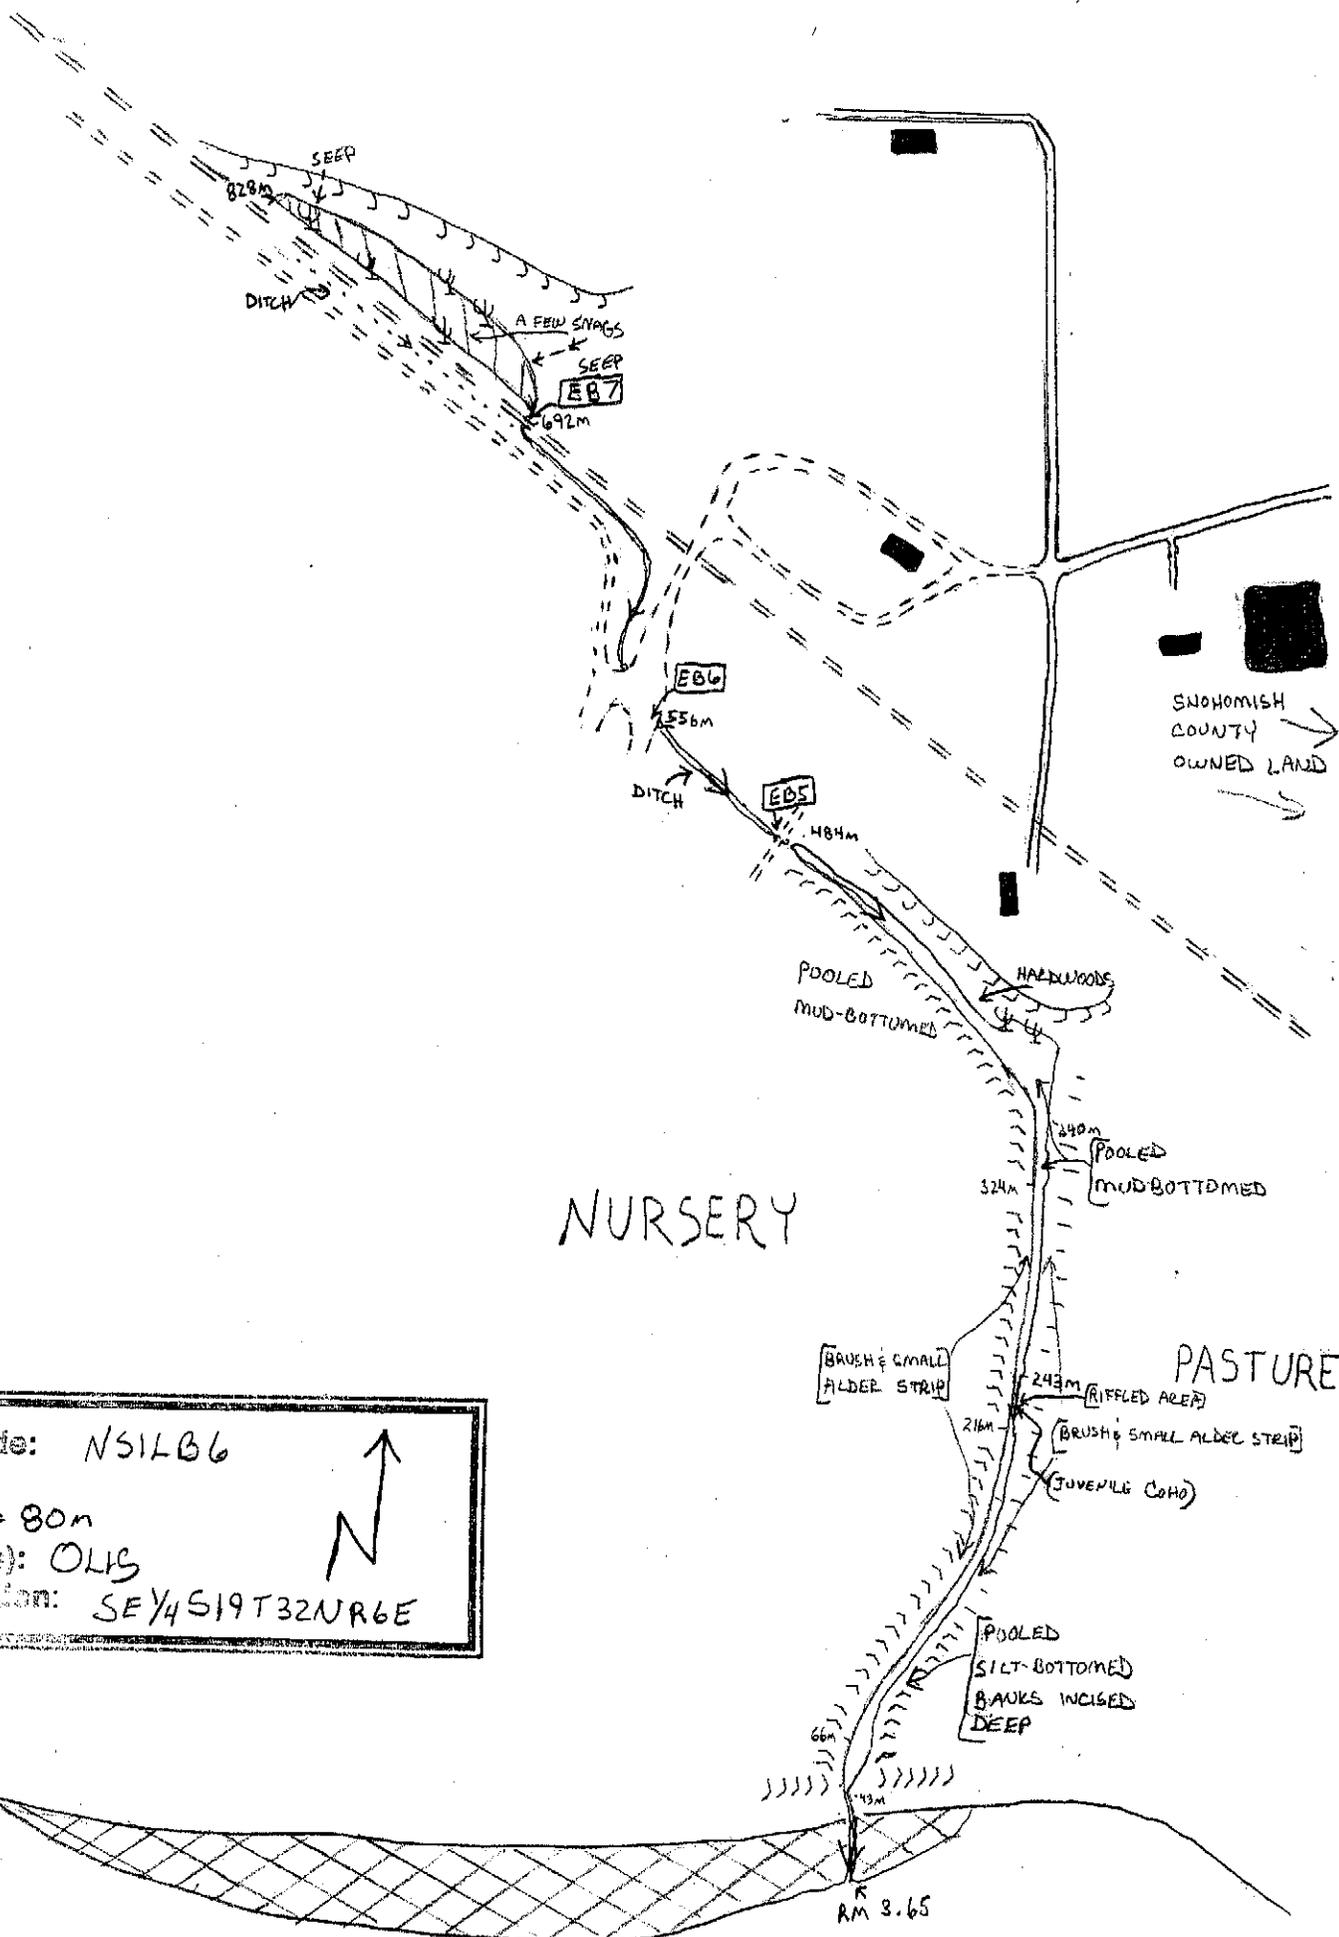
Describe pond and other rearing habitat: The initial 448 meters of this site is slough-like with sluggish moving water and a mud substrate. The wetted width ranges from 1.2 meters to 23 meters. The next 200 meters upstream of this point is in a ditch through a nursery and there are three culvert crossings in this section (EB5,EB6,EB7). The upper most section of this site is a swampy area upstream of the railroad grade as water gets impounded by the grade.

Describe: This site at the very least gets backwatered during flood events and the bench that it sits on may get over-topped during the major flood events.

Describe: Fish access is fair when the flows are moderate as there is an exposed gravel bar that this site flows through and there is a small drop that fish need to negotiate. Fish access improves as flows increase.

Describe: There were juvenile coho observed in the site at the lower end.

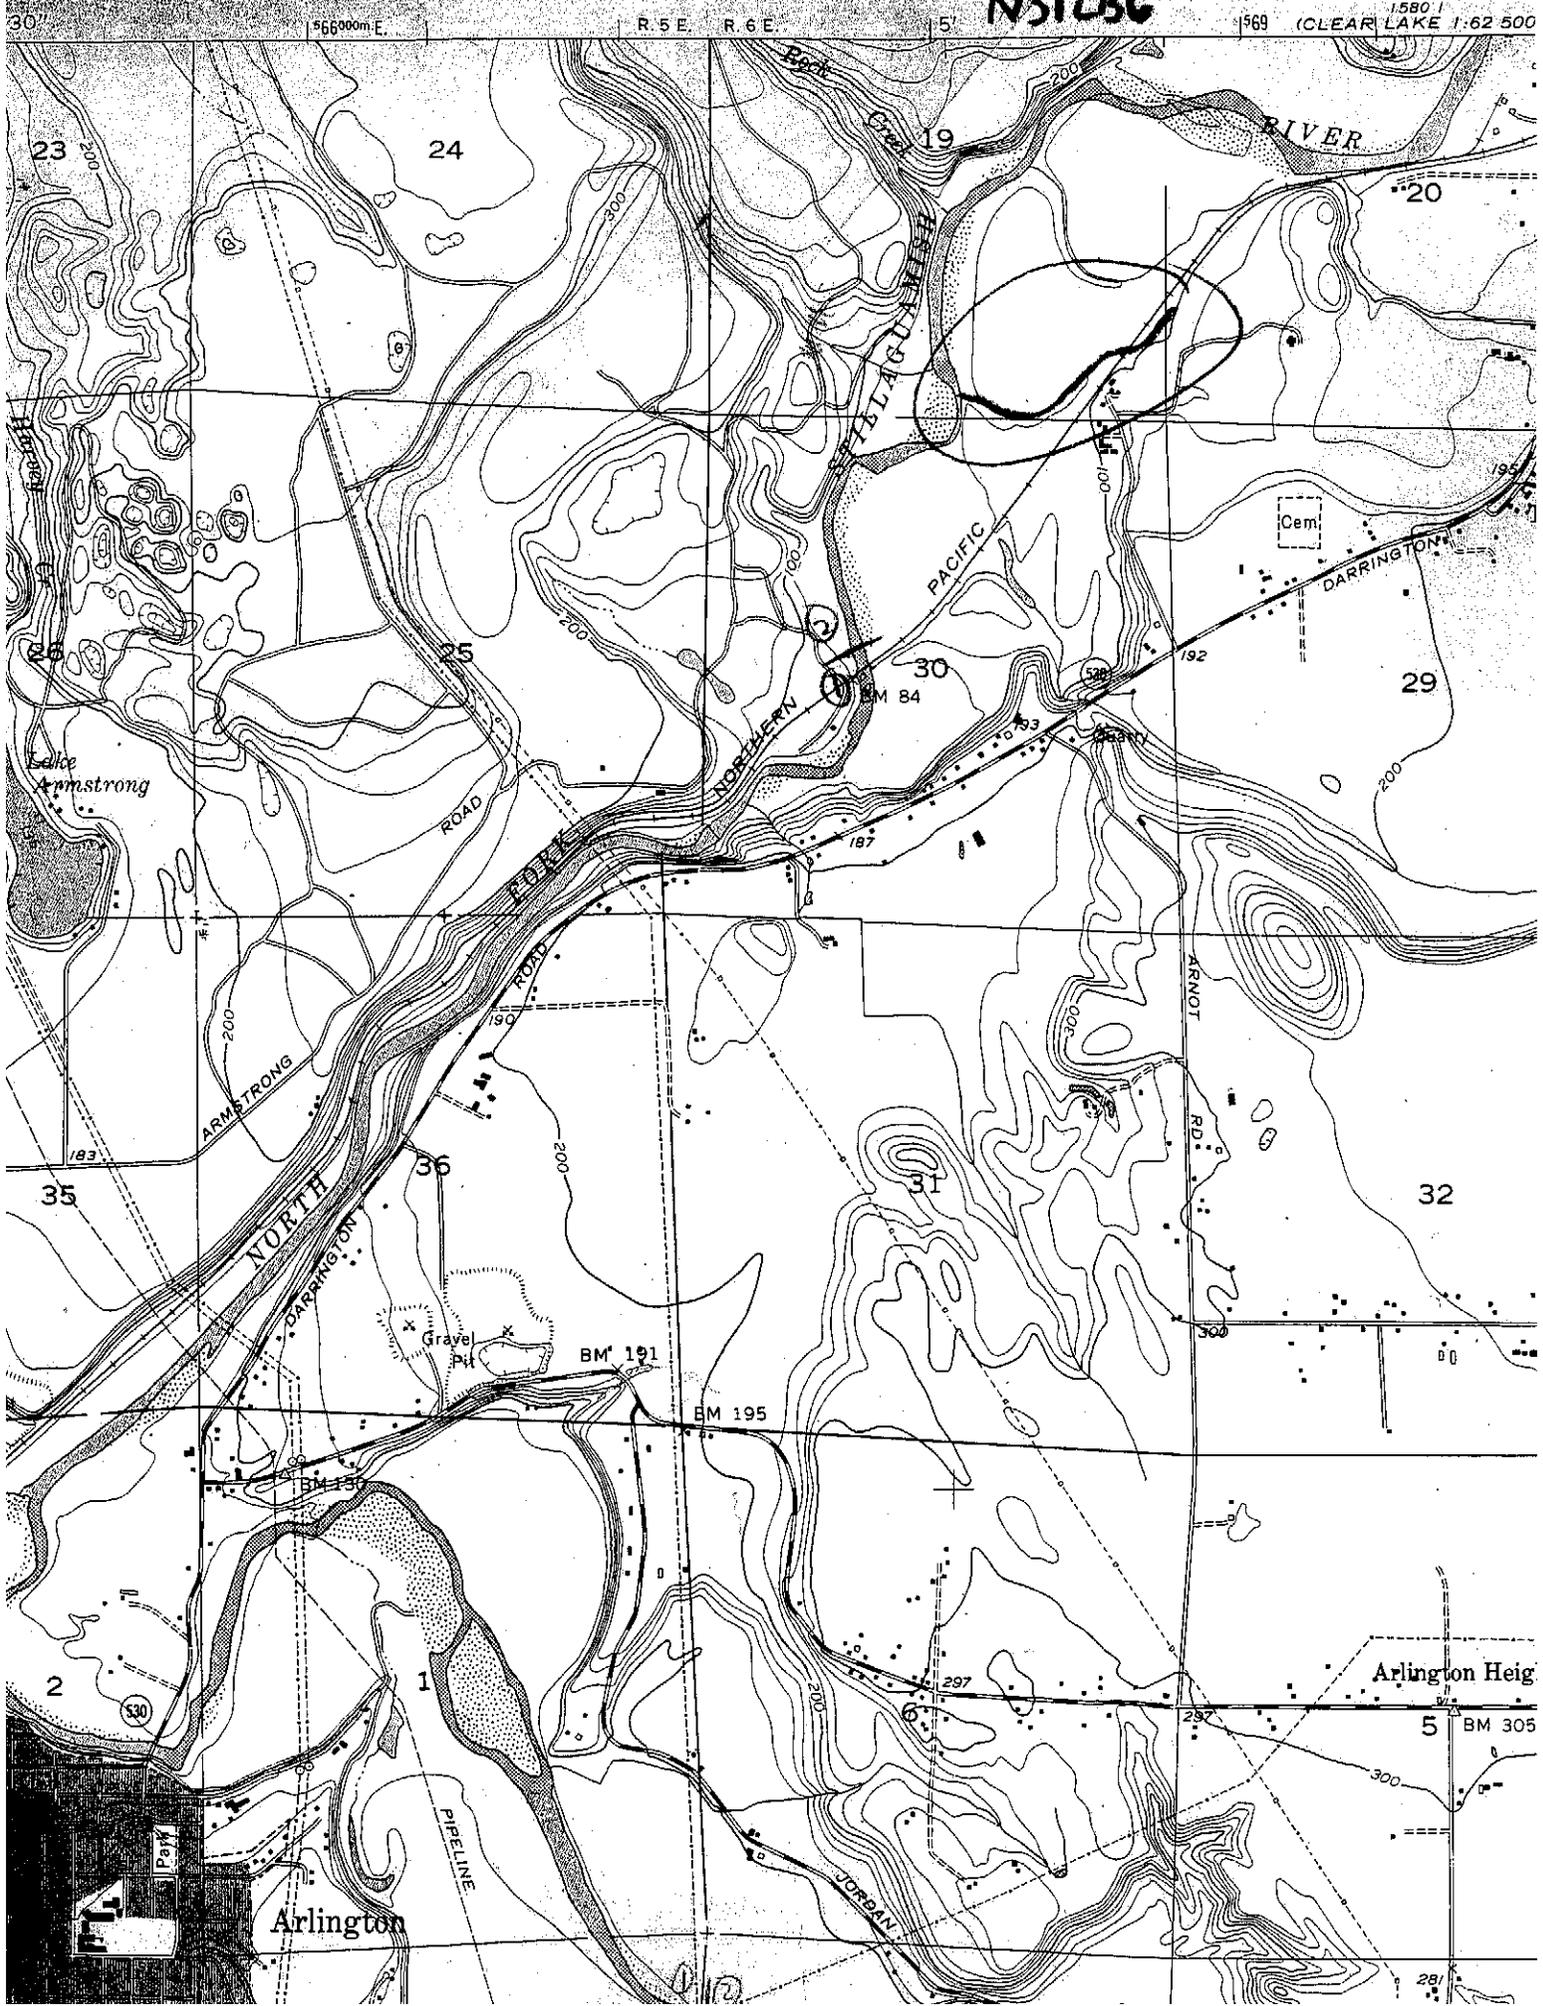
NSILB6

RUE PCC 0.34 DEEP 2M FILL  
SWAMP ON OTHER SIDE

RWT = 42° up  
WT 47.5° 46.5°

Flow - 0.3  
ACCESS - 1' DEEP OVER BANK

- 43m - W 1.2
- POOL/RIFP
- Small ACCESS
- Silt - BOTTOM
- Bank W/CLSD
- 48m W 3m
- mid - BOT.

216m ww 5m

- MUD - BOTT

243m ww 1.2m

- SHALLOW SIFT - BOTT

- JUN OBS

324m 4m ww

340m ww 6m

370m ww 23m

TO RR GR  
MEETS TORRENT WALL

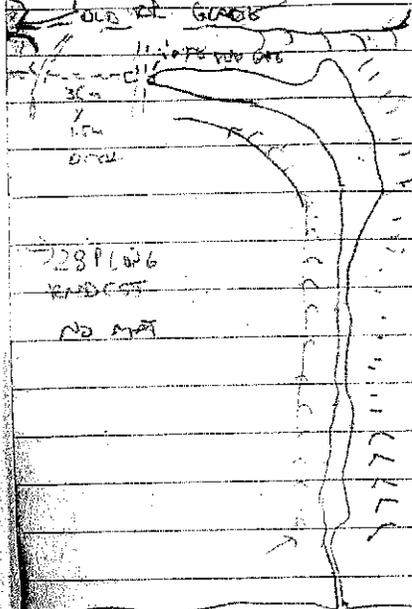
NE STUMP

O.O ENTRY
