Describe pond and other rearing habitat: The first 146 meters of the stream is in a pasture that has a small brushy strip along banks that are stomped by livestock in places. From 146 meters to 346 meters, the stream flows through a hardwood patch and it averages 0.7 meters in width. It is mud-bottomed, slow-moving and shallow, and there is skunk cabbage growing along and in the channel in places. Upstream of this section is a cattail marsh area where this stream originates from.

Site id. code: PI1RB7
 Site name:
 Scale: 1"=40M
 Observer(s): OLIS
 Legal location: NW 1/4 S25 T32 R4E

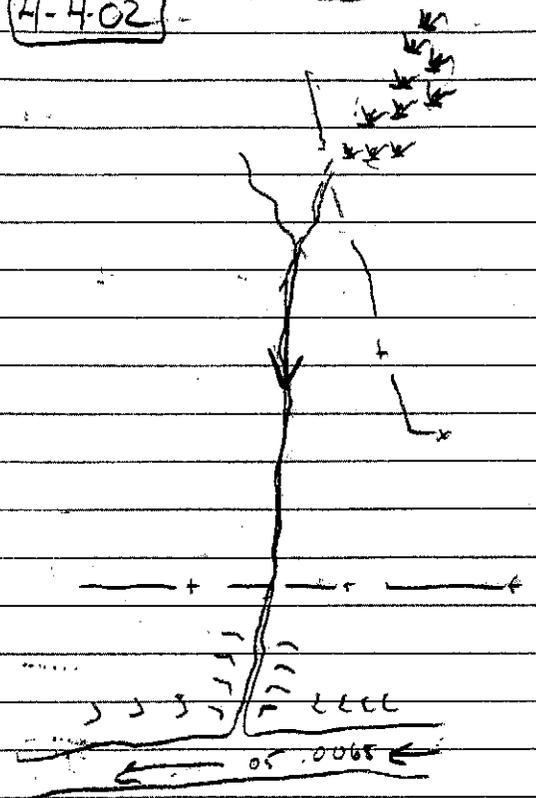
PII RB7

0.0 ENTRY

47m ww 0.5 m

83m - ww 2.5

146m - WW 1m

183m - WW 0.7m

328m WW 0.7m

346m - AREA OF

- @ BASE OF MARSH
- @ EDGE OF FIELD
- END OF SURVEY

- NO SPAWNING
- GOOD OVER-WEED
- REWEED - NO PEST SEEN
- PROB. DISCOVERED
- IN LATE SUMMER
- MARSH HAS CATTAILS,
- WATER P., SAGES - PEST

ENHANCEMENT OPPORTUNITIES: Tree planting and fencing along the banks on the lower end of the site.
