Site id. code: P12RB14  
 Site name:  
 Scale: 1" = 40m  
 Observer(s): OLS  
 Legal location: SW 1/4 S9 T32N R5E

P12RB14

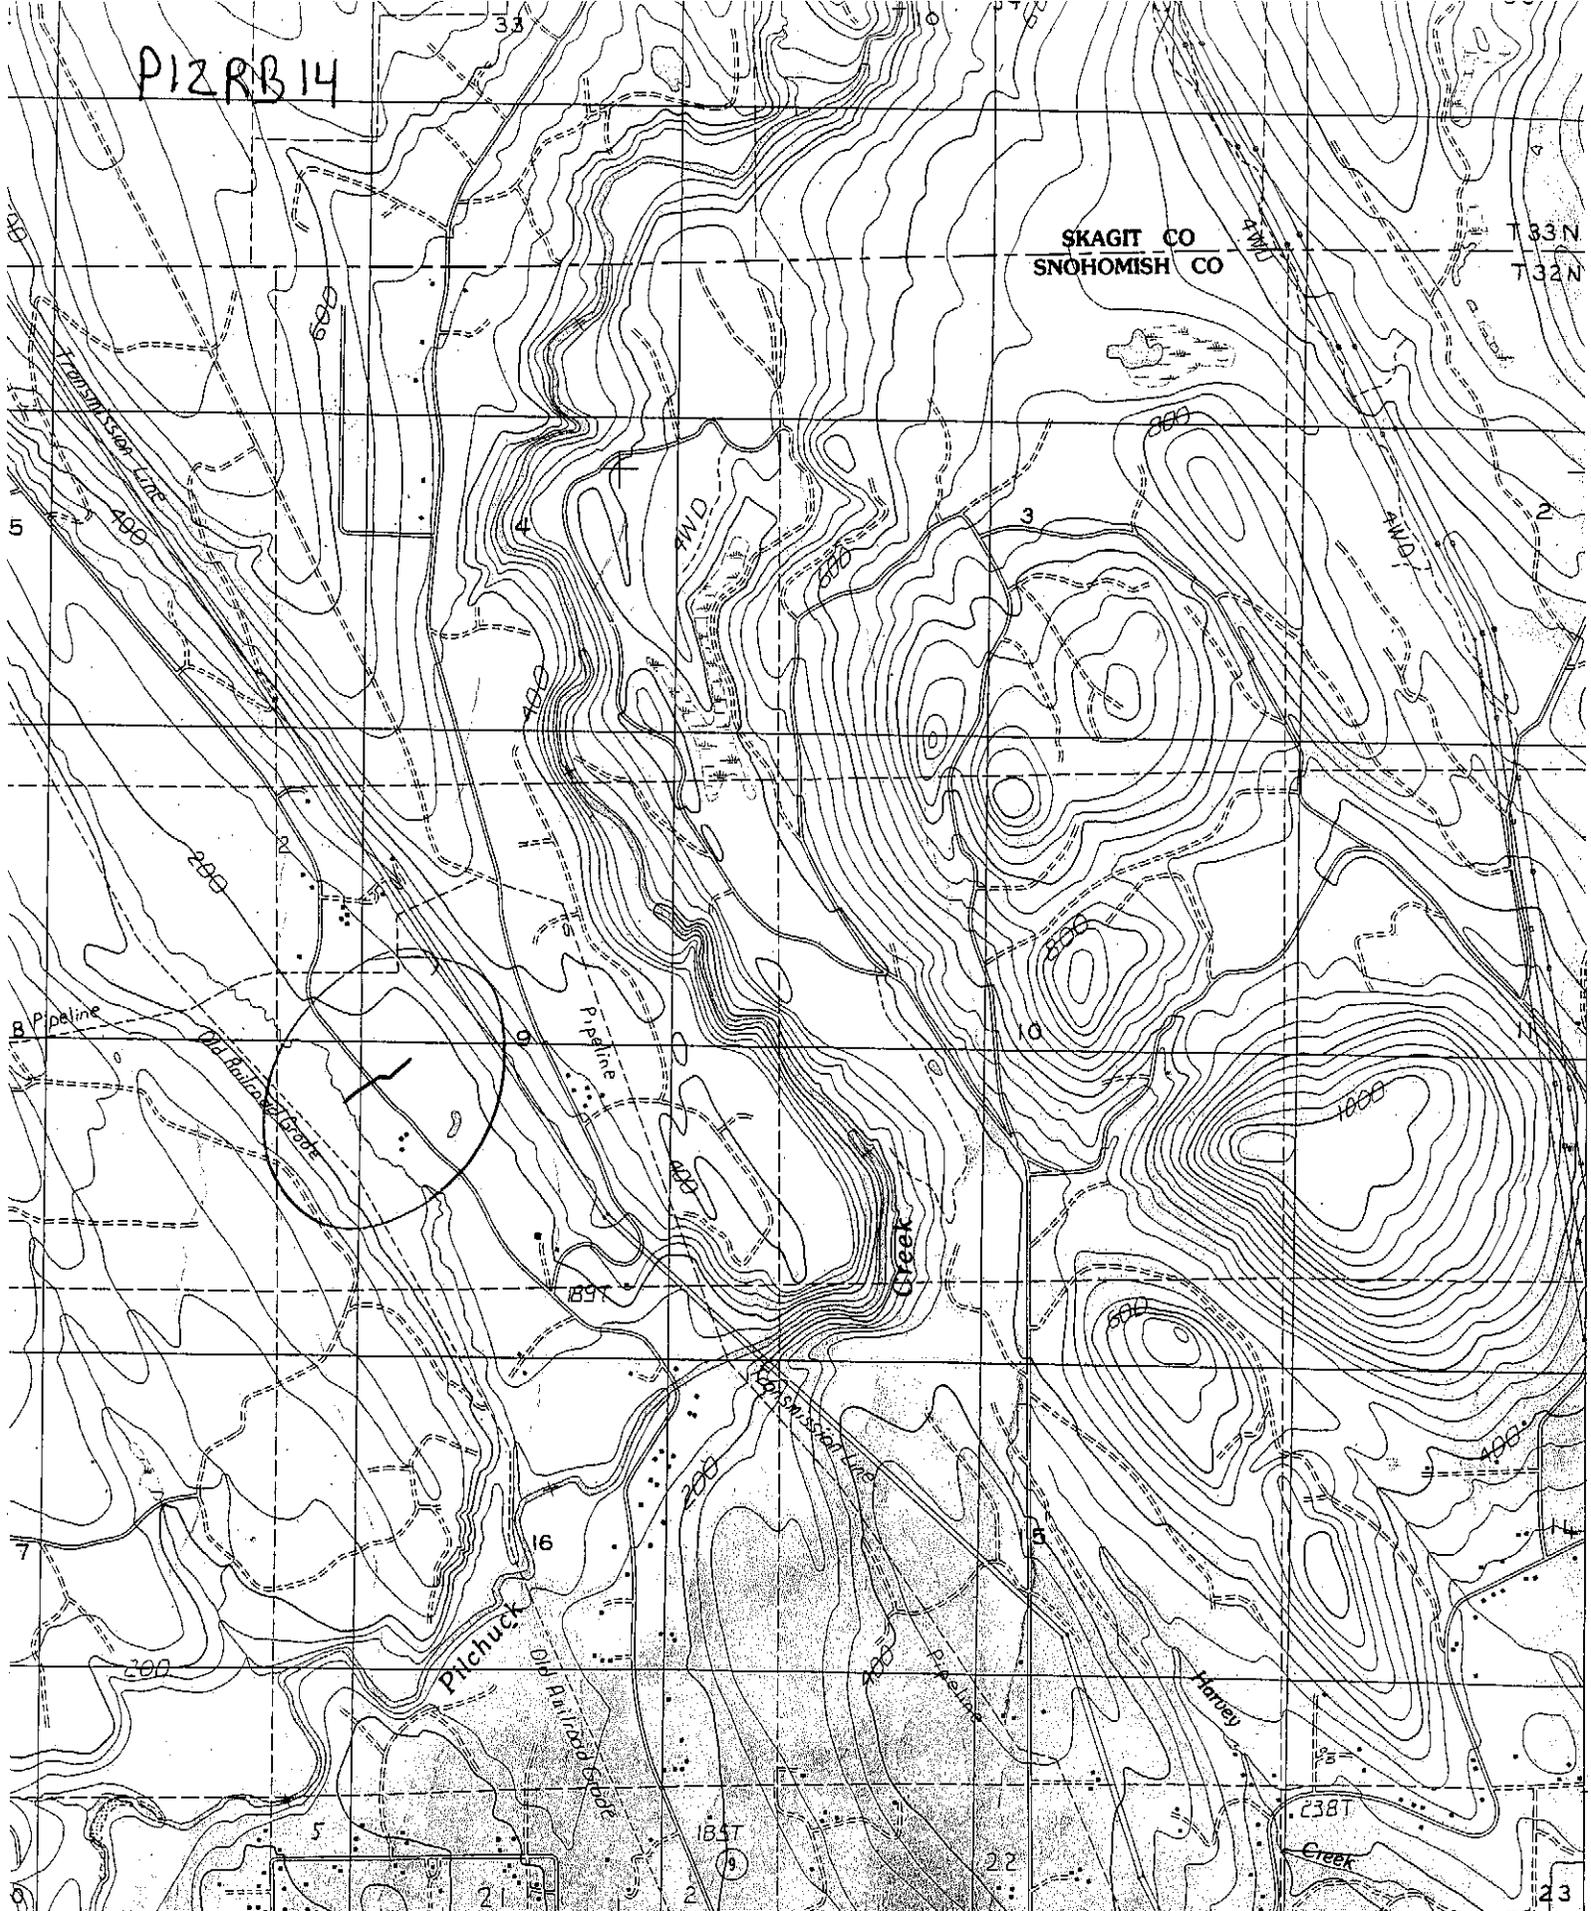
PIZRB14

RM 0.9

SW 1/4 S9 T32 R5E

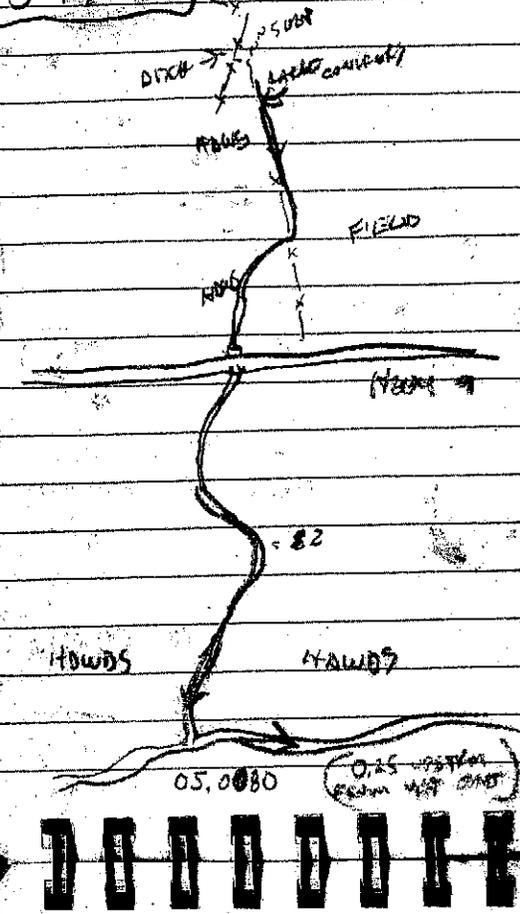
0.0 ENTRY

FLOW 0.3 CFS  
 WT - 45.5°  
 RWT - 44°  
 ACCESS - 6000  
 (EDDY POOL)

6.3m ww 1m  
 - GRAVEL / COBBLE  
 - MOSTLY RIFF 25% POOLED  
 - 5% SAND  
 - 4% SP.  
 - 2-4" GRAVEL

14.8m ww 1.2m  
 - SILT / MUD SUBSTR  
 - 50% POOLED

163m WEST. END OF  
CULV.

(4-25-CONTINUOUS)  
REZERO @ HWY 9

227m WALK 1m

- END OF SURVEY
