FISH INFORMATION

Site id. code: PIZ RB20
Site name:
Scale: 1" = 10m
Observer(s): B. Barkdull
Legal location: SW16 T32N R5E

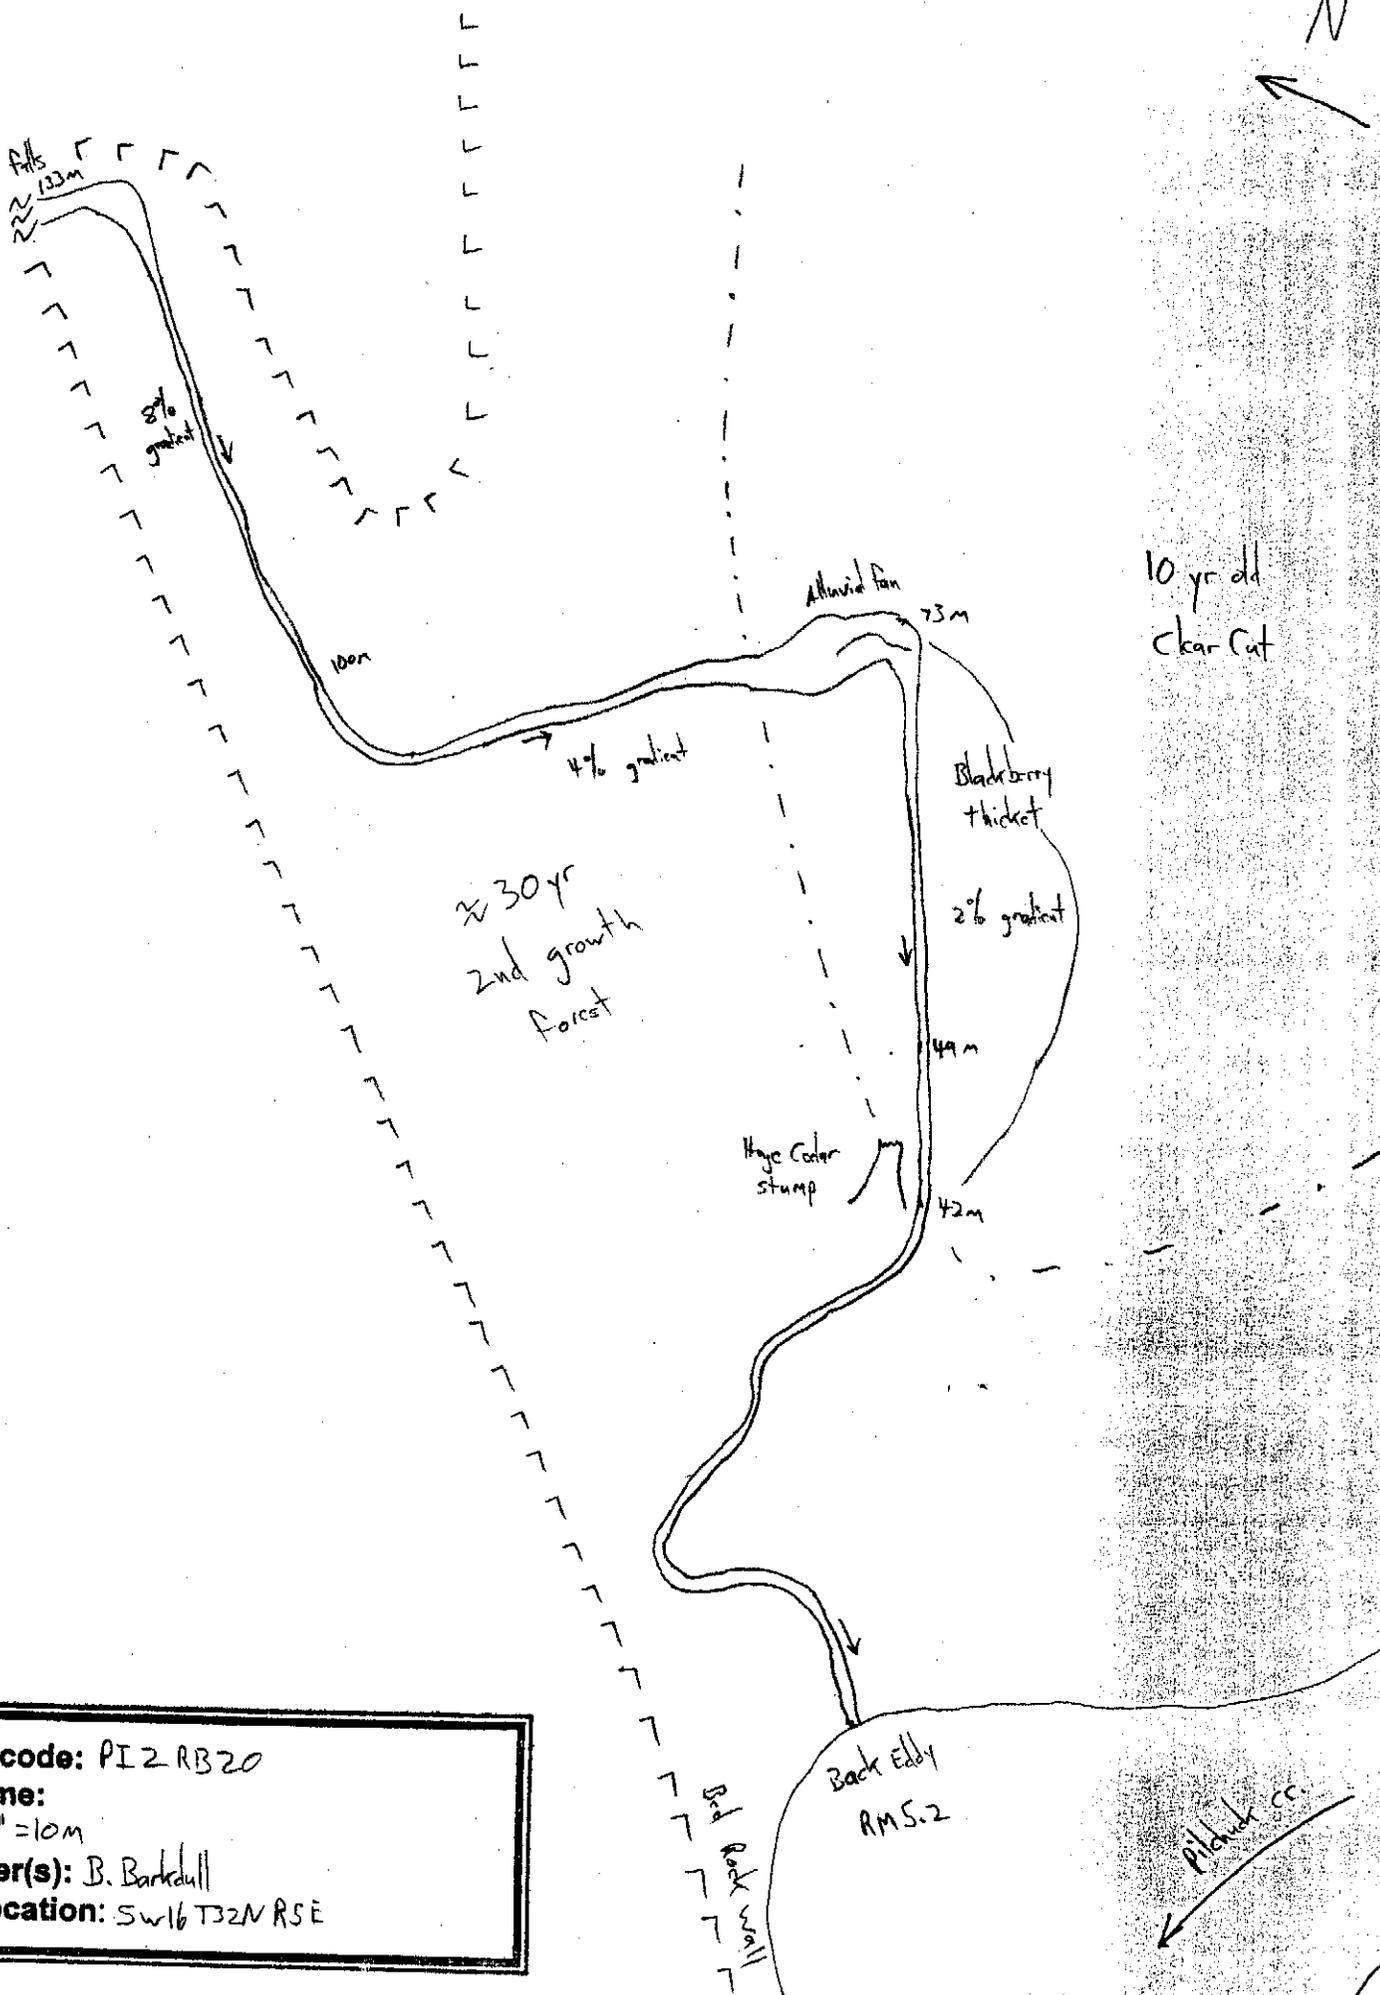
4/30/02 Verb to Pitlock on
 on R Bank above PTF Access 007A
 River 51°, stream 52° Cole post
 0.0 0.5 Big Eddy at mouth
 42 1.2 at Big Stamp many log
 mostly white, all good gravel
 in Pitlock 0.0
 49 All diametric range
 73 1.2 starting Bed into 2nd grade
 100 1.2 Entering gully gully steeper
 133 1.2 falls

All sporadic to 73m

73 to 100 50% time steep Big
above
