RIVER: SOL DUC

TRIB: Beaver Creek - 20.0324
AREA: S-R5
SITES: S-324L-07, S-324L-08
WRIA: 20.0324M, 20.0324O
NAMES: Unnamed

DATE: 6/00

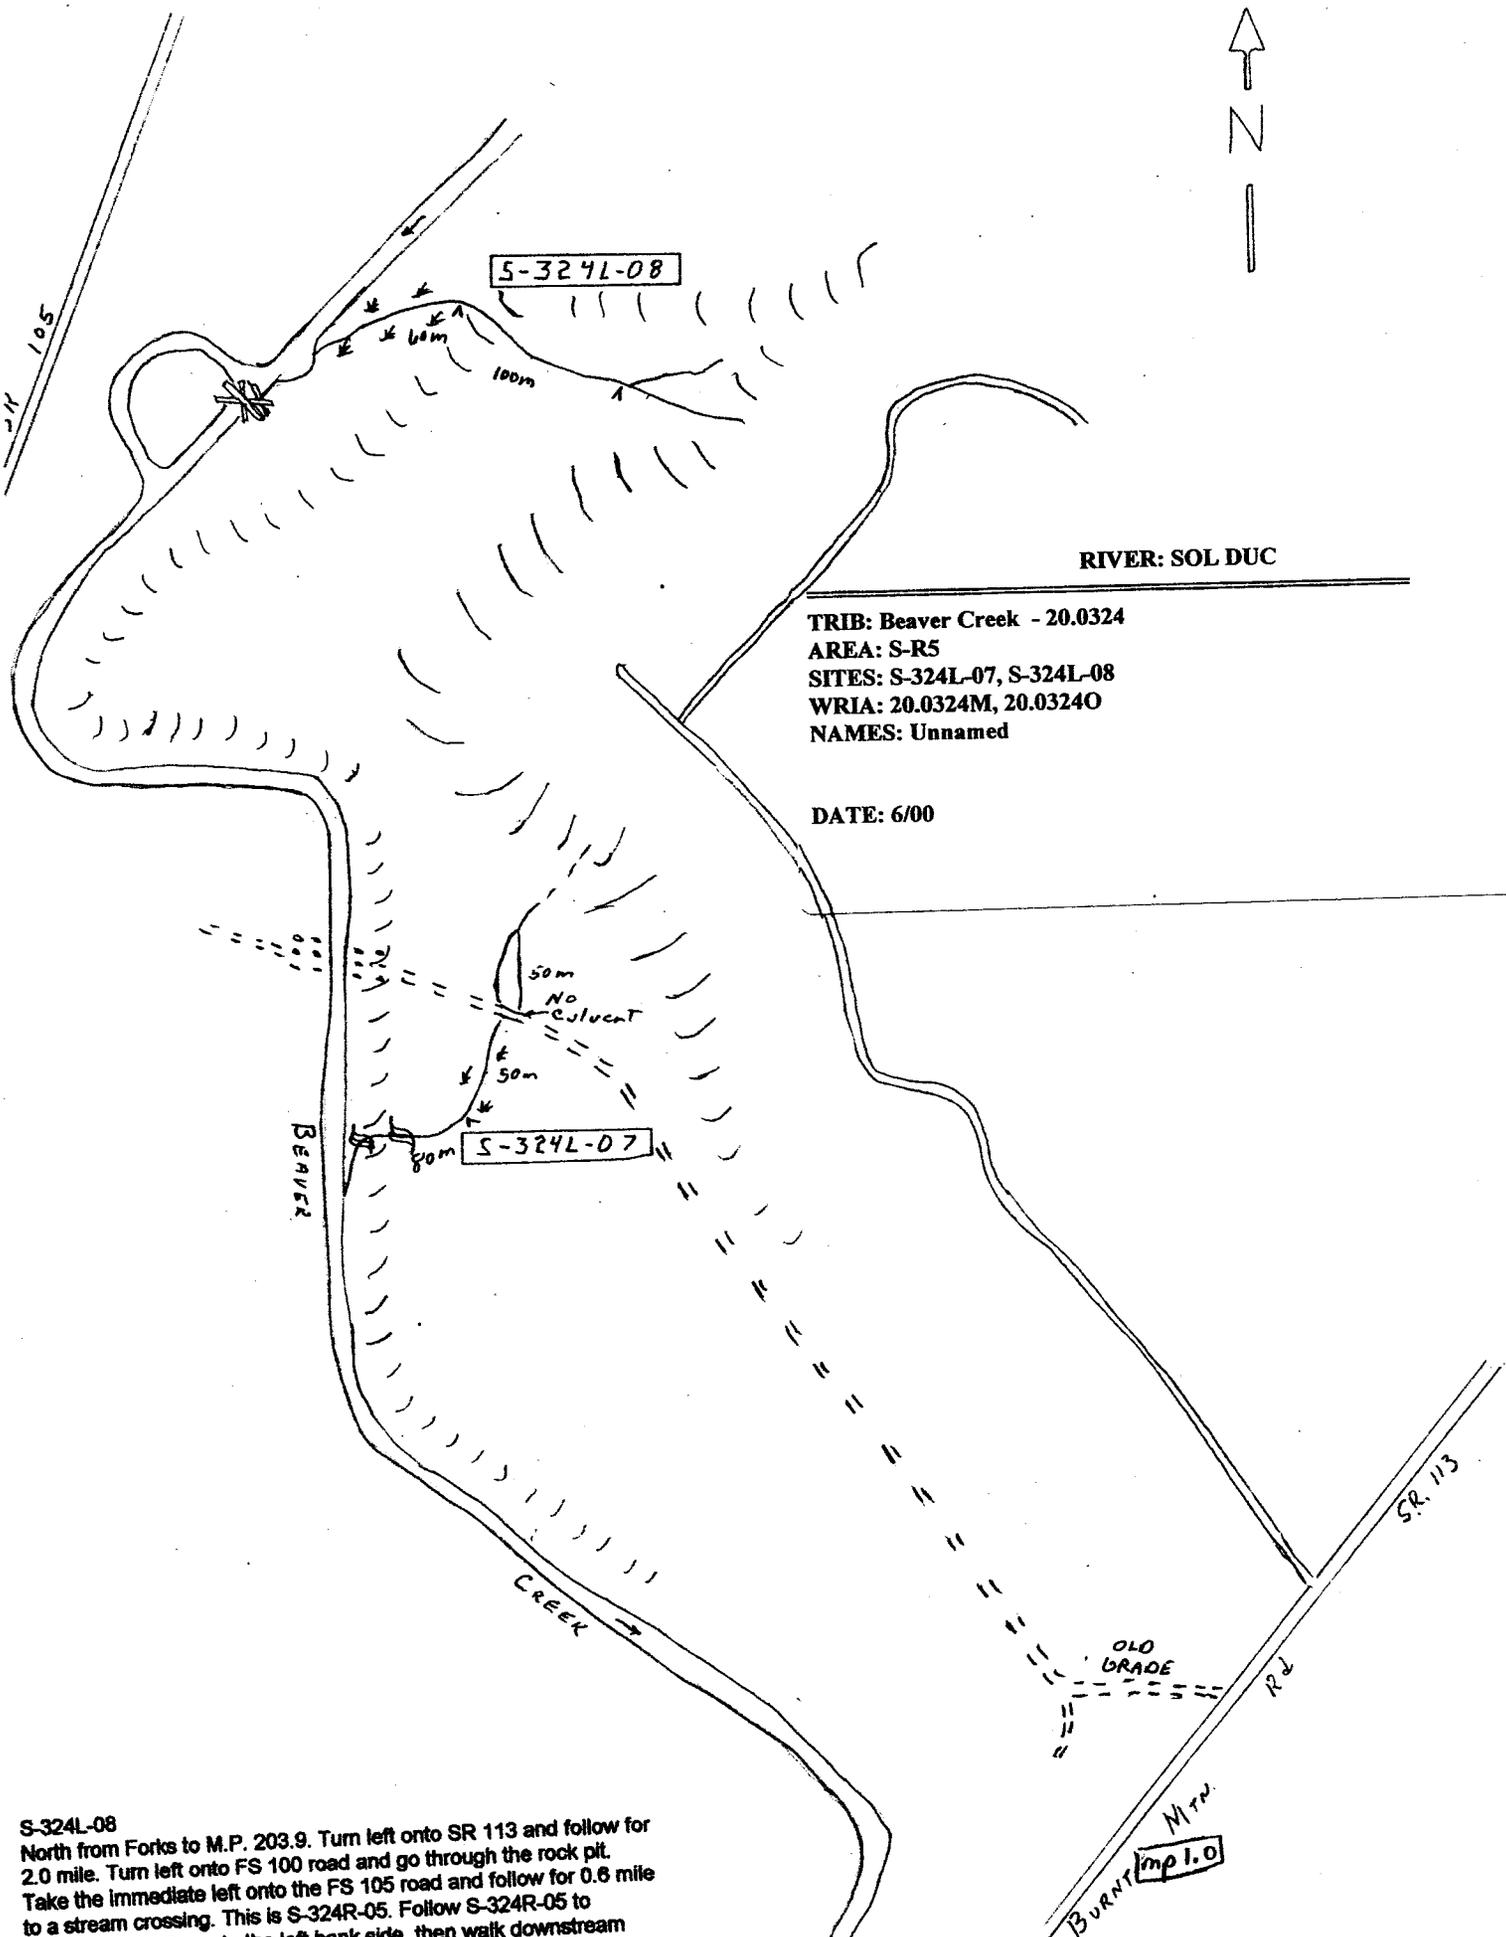
S-324L-08
North from Forks to M.P. 203.9. Turn left onto SR 113 and follow for 2.0 mile. Turn left onto FS 100 road and go through the rock pit. Take the immediate left onto the FS 105 road and follow for 0.6 mile to a stream crossing. This is S-324R-05. Follow S-324R-05 to Beaver Creek. Cross to the left bank side, then walk downstream about 50 meters. S-324L-08 is located just above a log jam.
