RIVER: SOL DUC

TRIB: Beaver Creek - 20.0324

SITE: S-324L-16, S-324L-17, S-324L-18, S-324L-19

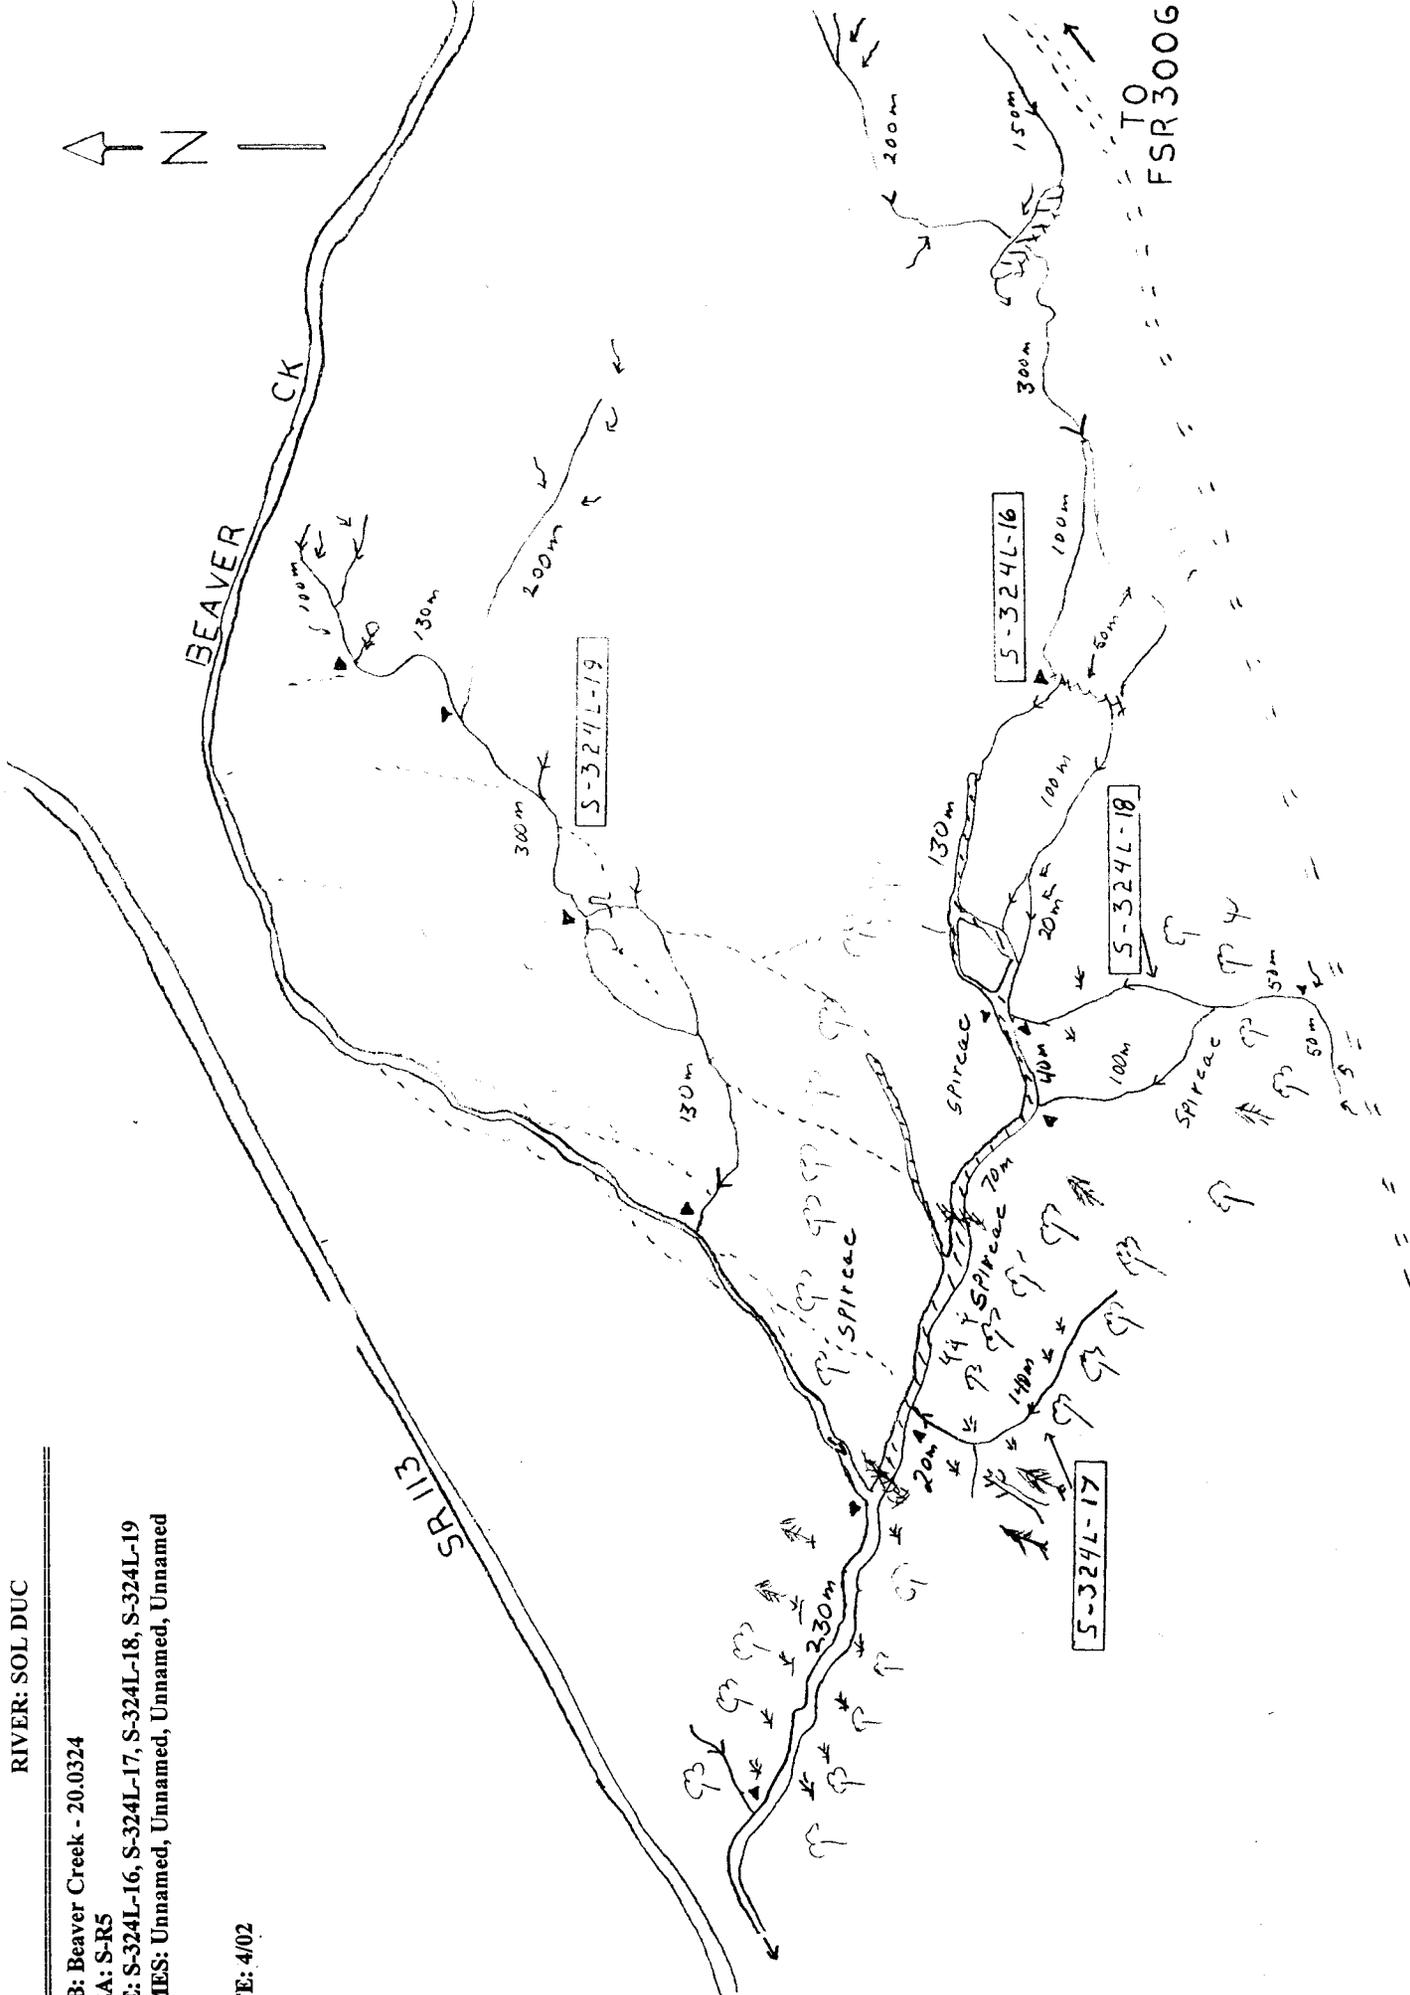
North from Forks to M.P. 203.9. Turn left onto SR 113 (Burnt Mountain Road). Follow for 4.8 miles to a wide spot off to the right side of the road, at the southerly end of the guardrail. Walk down and cross Beaver Creek. Follow a southerly bearing.
