STATE OF WASHINGTON  
DEPARTMENT OF FISH & WILDLIFE  
LANDS AND RESTORATION SERVICES PROGRAM  
Salmonid Screening, Habitat Enhancement &  
Restoration Division (SSHEAR)

OFF-CHANNEL SITE INVENTORY DATA

Site No.: S-R7-02

Site Name: Riverside Creek

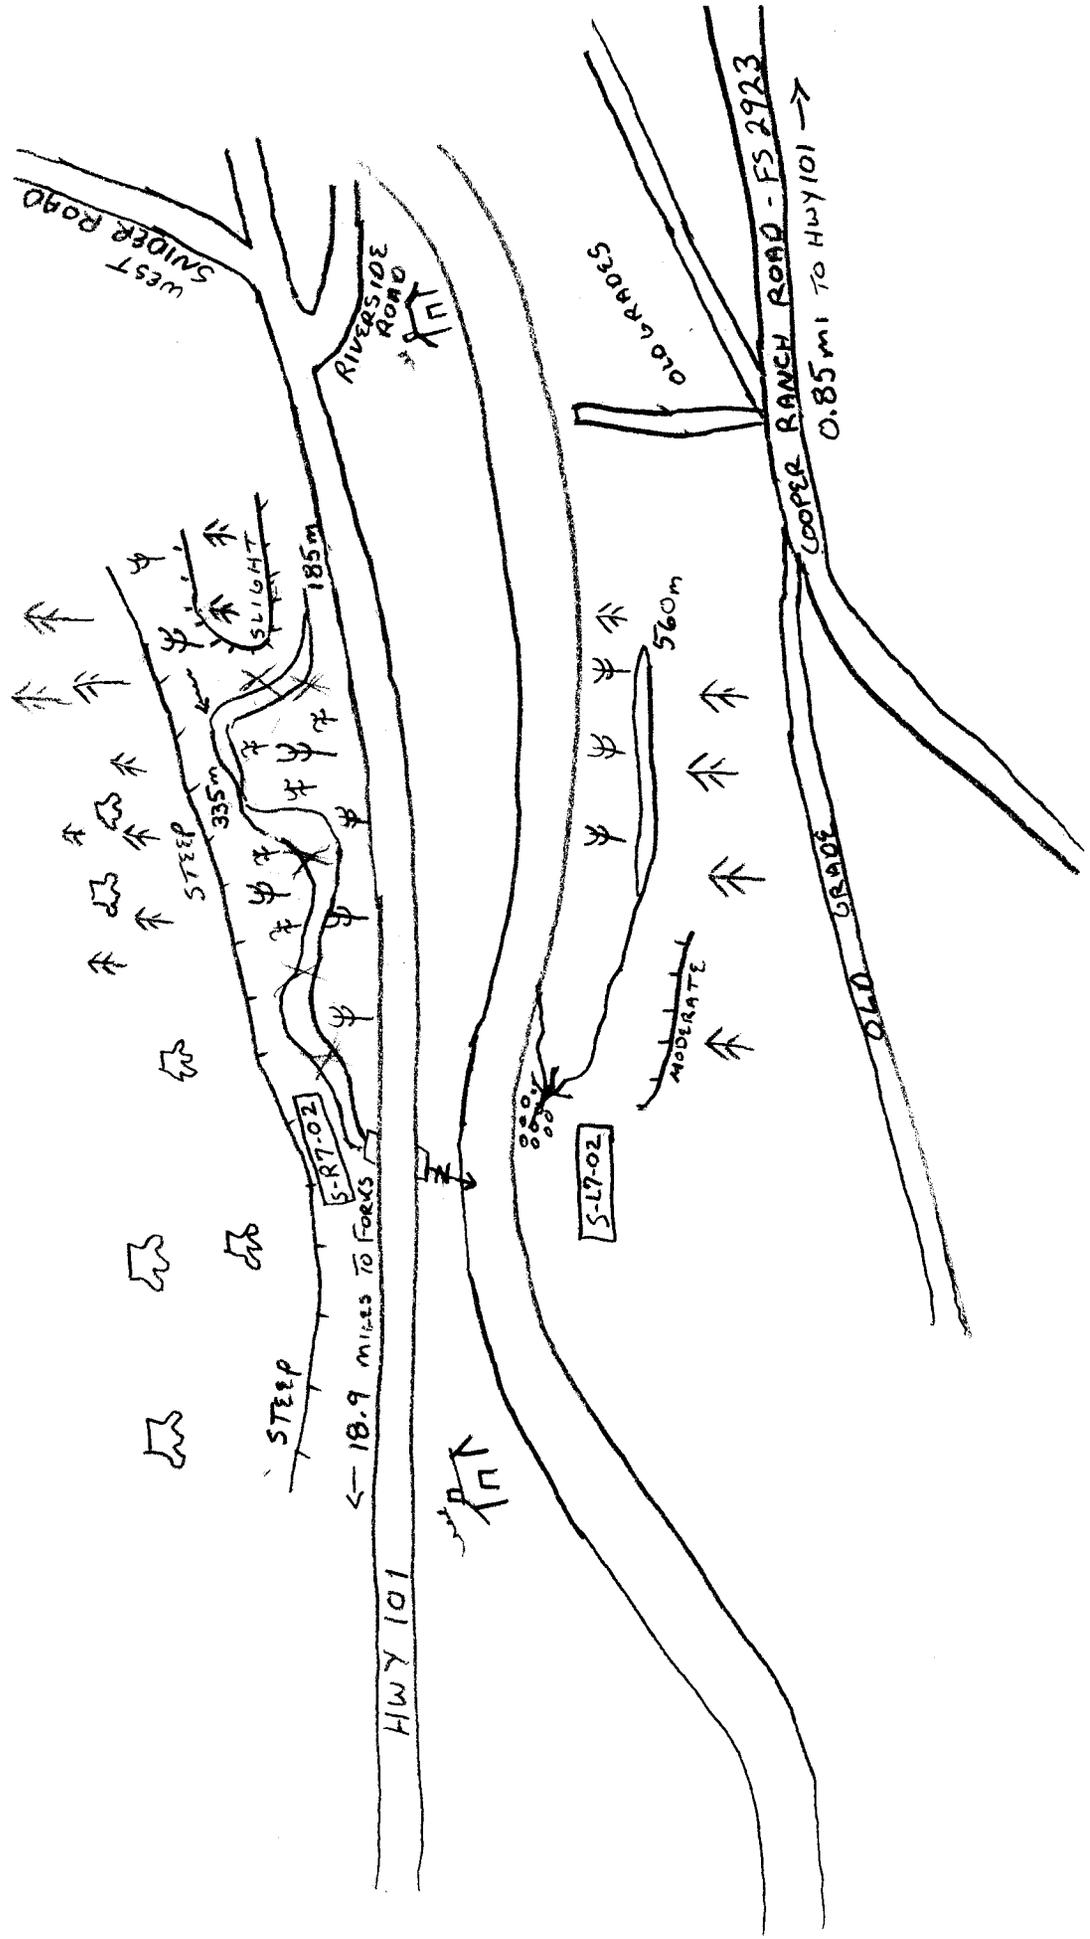
RIVER: SOL DUC

AREA: S-R7, S-L7

SITES: S-R7-02, S-L7-02

WRJA: 20.0336D, 20.0336E

NAMES: Riverside Cr, Forestland Sp

DATE: 1/97
