SITE INFORMATION

Site Identifier : SA10LB1 **Landowner Type :** Federal
Site Name : Skinny Sauk **Landowner Name :** USFS
WRIA : 03.1175A **Address :**
Region : NS **Address2 :**
Trib to : Sauk R **City :**
River Mile : 33.80 **State :**
River System : Sauk R **Zipcode :**
Legal Description : SW1/4S19T31NR11E **Phone :**
County : Snohomish
Habitat Type : man-made impoundment

Date : 8/22/96 **Observer :** Barkdull **Survey Type :** initial

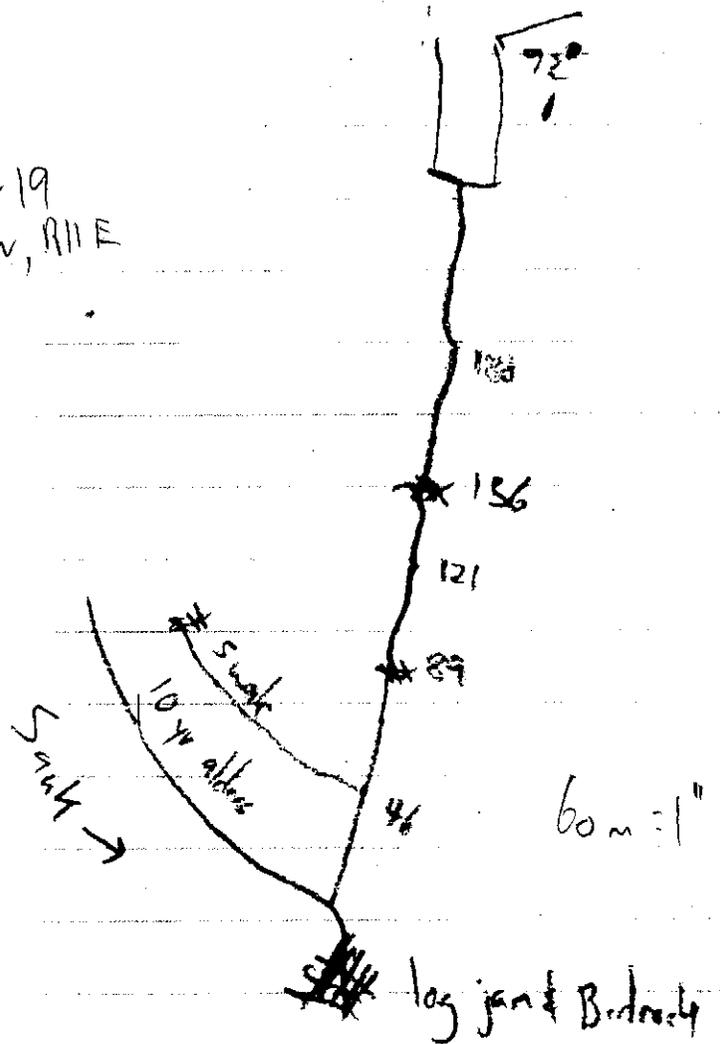
Sw 19
T31w, R11E

8/22/96 Skinny sank
 0.0 15m wide 1.5m deep
 92 12m 5m LB tub
 gradually tapering
 148 9m
 240 5m
 340 5m patches of spiny gravel
 End of channel
