**SITE INFORMATION**

**Site Identifier :** SA1LB2 **Landowner Type :**  
**Site Name :** **Landowner Name :**  
**WRIA :** 03.0673X **Address :**  
**Region :** NS **Address2 :**  
**Trib to :** Sauk R **City :**  
**River Mile :** 1.60 **State :**  
**River System :** Sauk R **Zipcode :**  
**Legal Description :** NW1/4S2T34NR9E **Phone :**  
**County :** Skagit  
**Habitat Type :** terrace tributary

**Date :** 02/25/1996 **Observer :** Barkdull **Survey Type :** initial

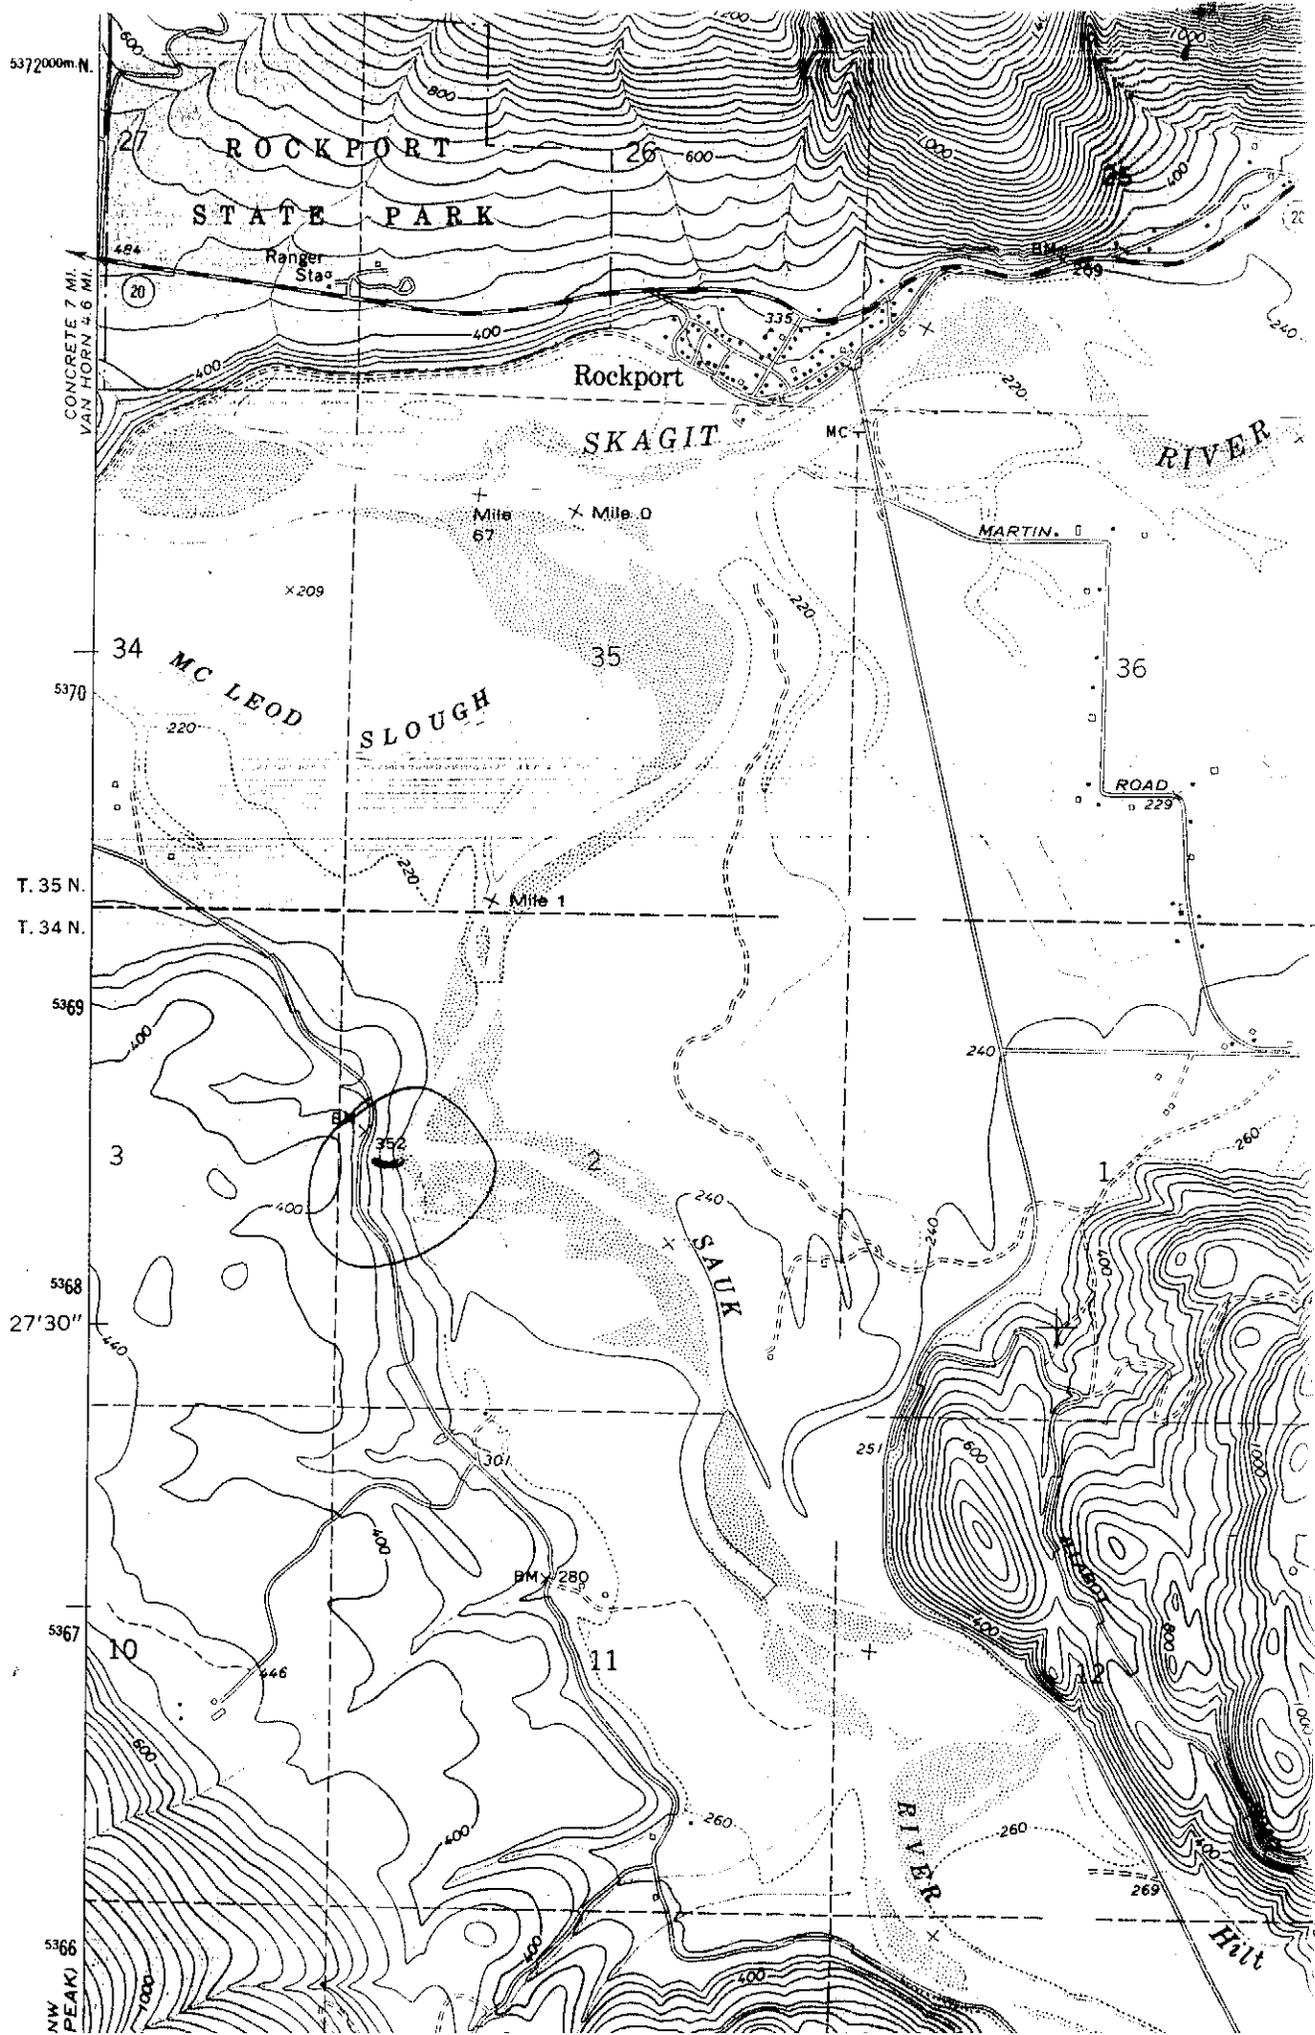
Site id. code: SA1LR2  
Site name:  
Section # = 25<sup>m</sup>  
Owner(s): R. B. Hill  
Legal location: NW 2 T34N R9E

clear cut

Concrete - Sauk valley road

Very steep hill

80 metres falls

Alluvial fan

74 m

Colluvium & debris

Rock wall

Am 1.6

Sauk River

2/25/96 stream Below Bracket Mark  
0.0 0.2 cascade at mouth 4%  
74. 0.8 riffly, mid bottom, good cover  
88. 1.0 gravel, possible rattierot  
spanning 42°, 10% grade
