SITE INFORMATION

Site Identifier : SA5RB1 **Landowner Type :** Private
Site Name : **Landowner Name :**
WRIA : 03.1076X **Address :**
Region : NS **Address2 :**
Trib to : Dutch Cr **City :**
River Mile : 0.70 **State :**
River System : Sauk R **Zipcode :**
Legal Description : SW1/4S4T32NR10E **Phone :**
County : Snohomish
Habitat Type : terrace tributary

Date : 2/1/1999 **Observer :** Barkdull **Survey Type :** initial

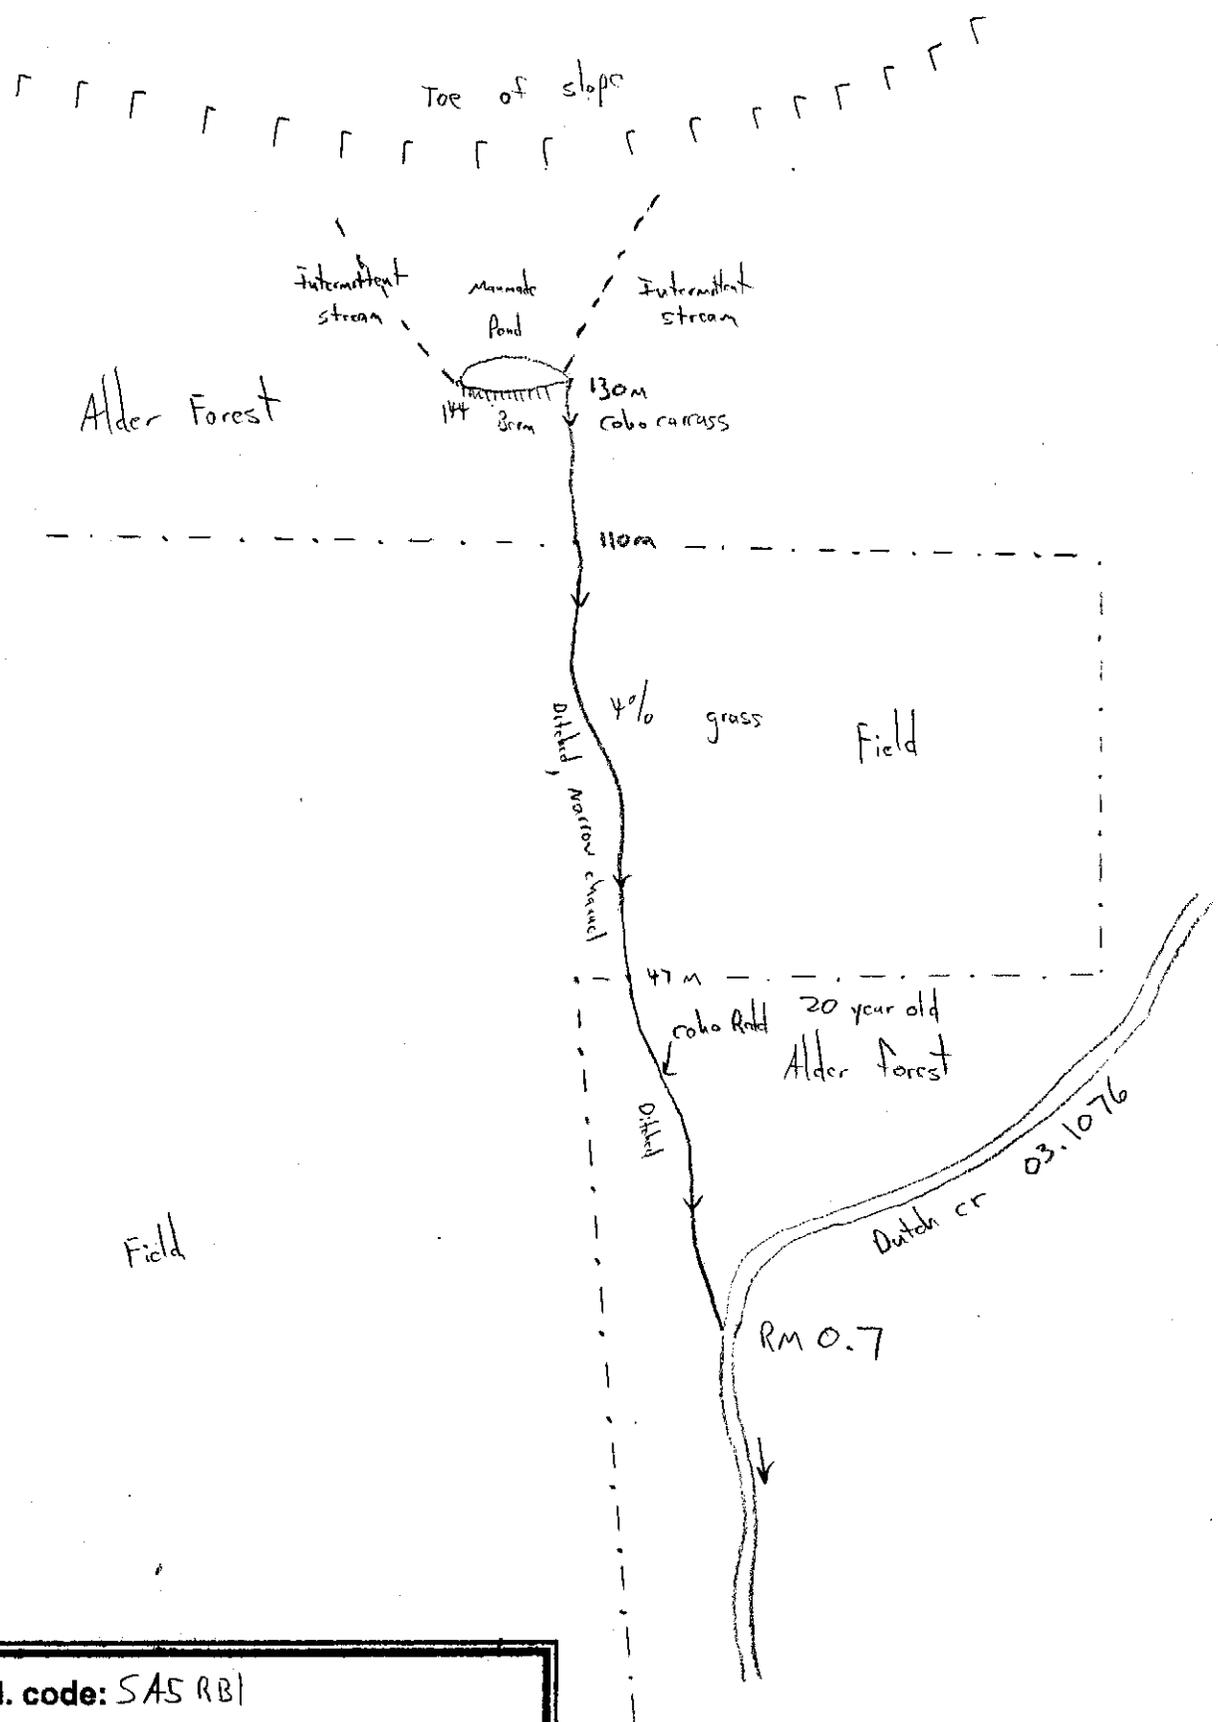
Site id. code: SAS RB1
Site name:
Scale: 1" = 25m
Observer(s): B. Barkdall
Legal location: SW 4, T32N, R10E

2/1/99 Trib to Dutch cr on Earth

2.0 0.1 of s 36°

47 0.4 edge of trees, 1 Red

10 0.3 edge of trees, very little
flow, 4% gradient

30 0.2 One carcass
drifted in both fads

Pool 14 x 4 wide

44 end of pool

whole site has been ditched

20% old alders on Bank

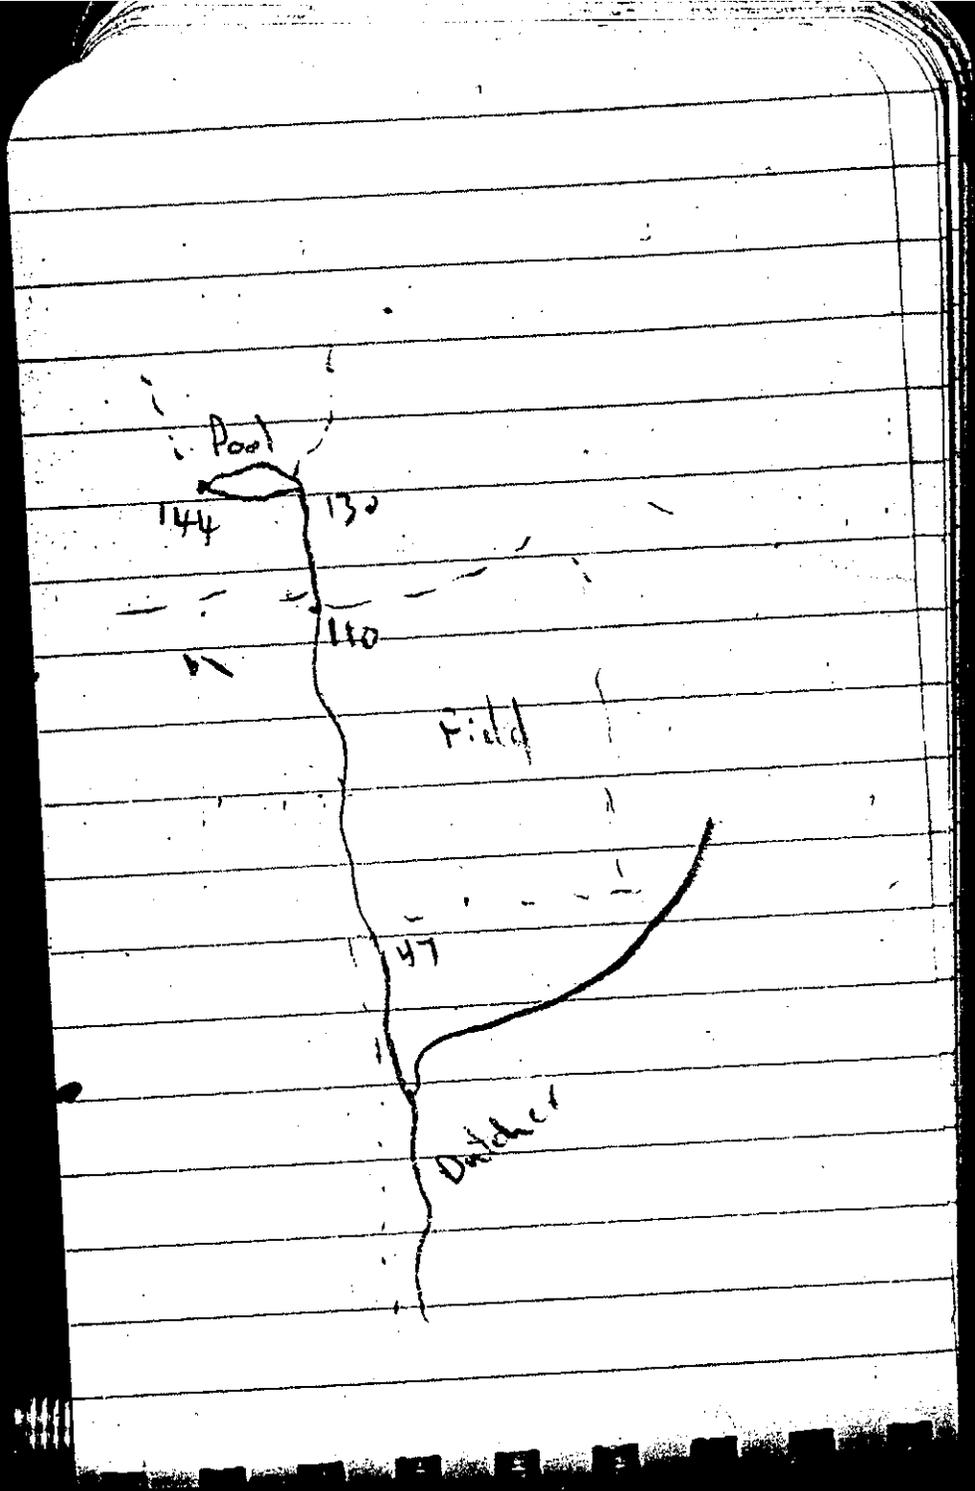
SAS RBI

SW 1/4 T32N, R10E

Rm 0.7

Pool
144 130
110

Field

47

Ditch
