**SITE INFORMATION**

**Site Identifier :** SA7RB5 **Landowner Type :**  
**Site Name :** **Landowner Name :**  
**WRIA :** 03.1095X **Address :**  
**Region :** NS **Address2 :**  
**Trib to :** 03.1095 **City :**  
**River Mile :** 0.10 **State :**  
**River System :** Sauk R **Zipcode :**  
**Legal Description :** NE1/4S25T32NR9E **Phone :**  
**County :** Snohomish  
**Habitat Type :** lower valley wall tributary

**Date :** 02/12/1996 **Observer :** Barkdull **Survey Type :** initial

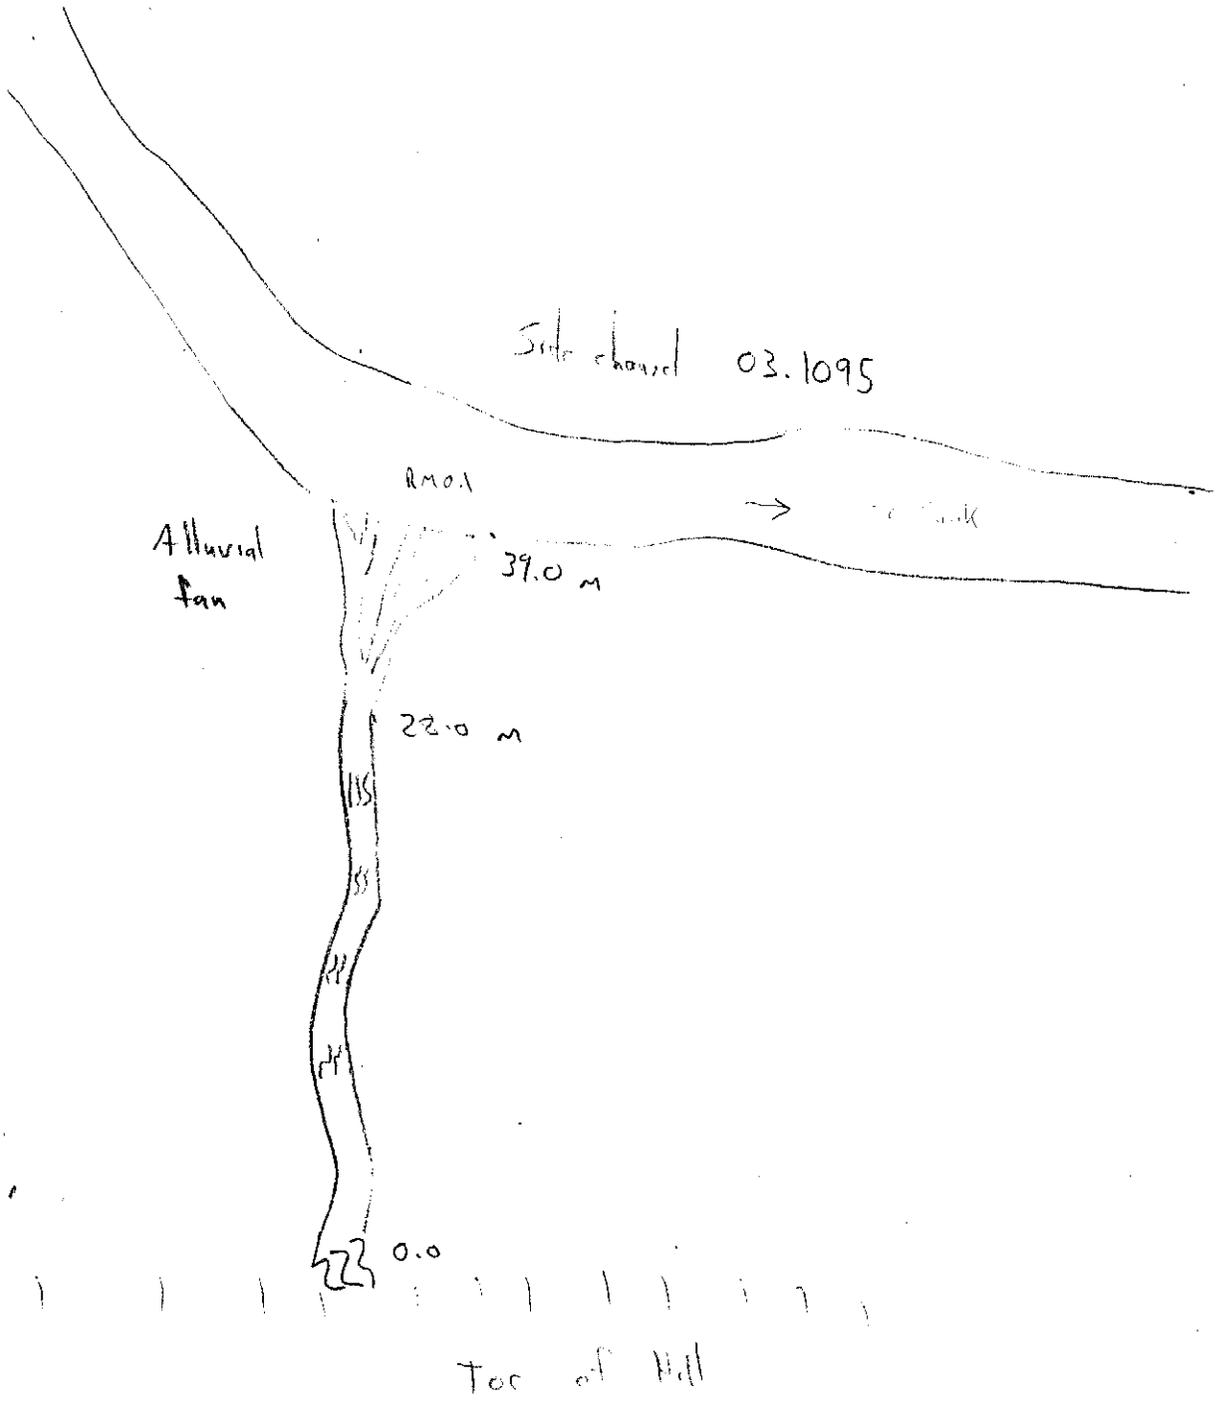
Site ID: SA7RB5  
 Date: 03.10.95  
 Scale: 1" = 10M  
 Observer(s): B. Barkdull  
 Legal location: NE25, T32N, R9E

2/12/96 Trib to 1095 (Sank r.) 41°  
0.0 Cascade 1 m wide bedrock  
28.0 1 m splitting channel, spawning below  
39.0 1 m main source of gravel for  
this fork of the creek  
41°
