**SITE INFORMATION**

<b>Site Identifier :</b>	SK3LB1	<b>Landowner Type :</b>	
<b>Site Name :</b>		<b>Landowner Name :</b>	
<b>WRIA :</b>	03.0281X	<b>Address :</b>	
<b>Region :</b>	NS	<b>Address2 :</b>	
<b>Trib to :</b>	Gilligan Cr	<b>City :</b>	
<b>River Mile :</b>	0.10	<b>State :</b>	
<b>River System :</b>	Skagit R	<b>Zipcode :</b>	
<b>Legal Description :</b>	NW1/4S35T35NR5E	<b>Phone :</b>	
<b>County :</b>	Skagit	<b>Coordinates</b>	
<b>Habitat Type :</b>	lower valley wall tributary	<b>East:</b>	1,603,566.10 <b>North:</b> 1,153,688.76

Site is a small steep surface stream which offers a short reach of mostly spawning habitat.

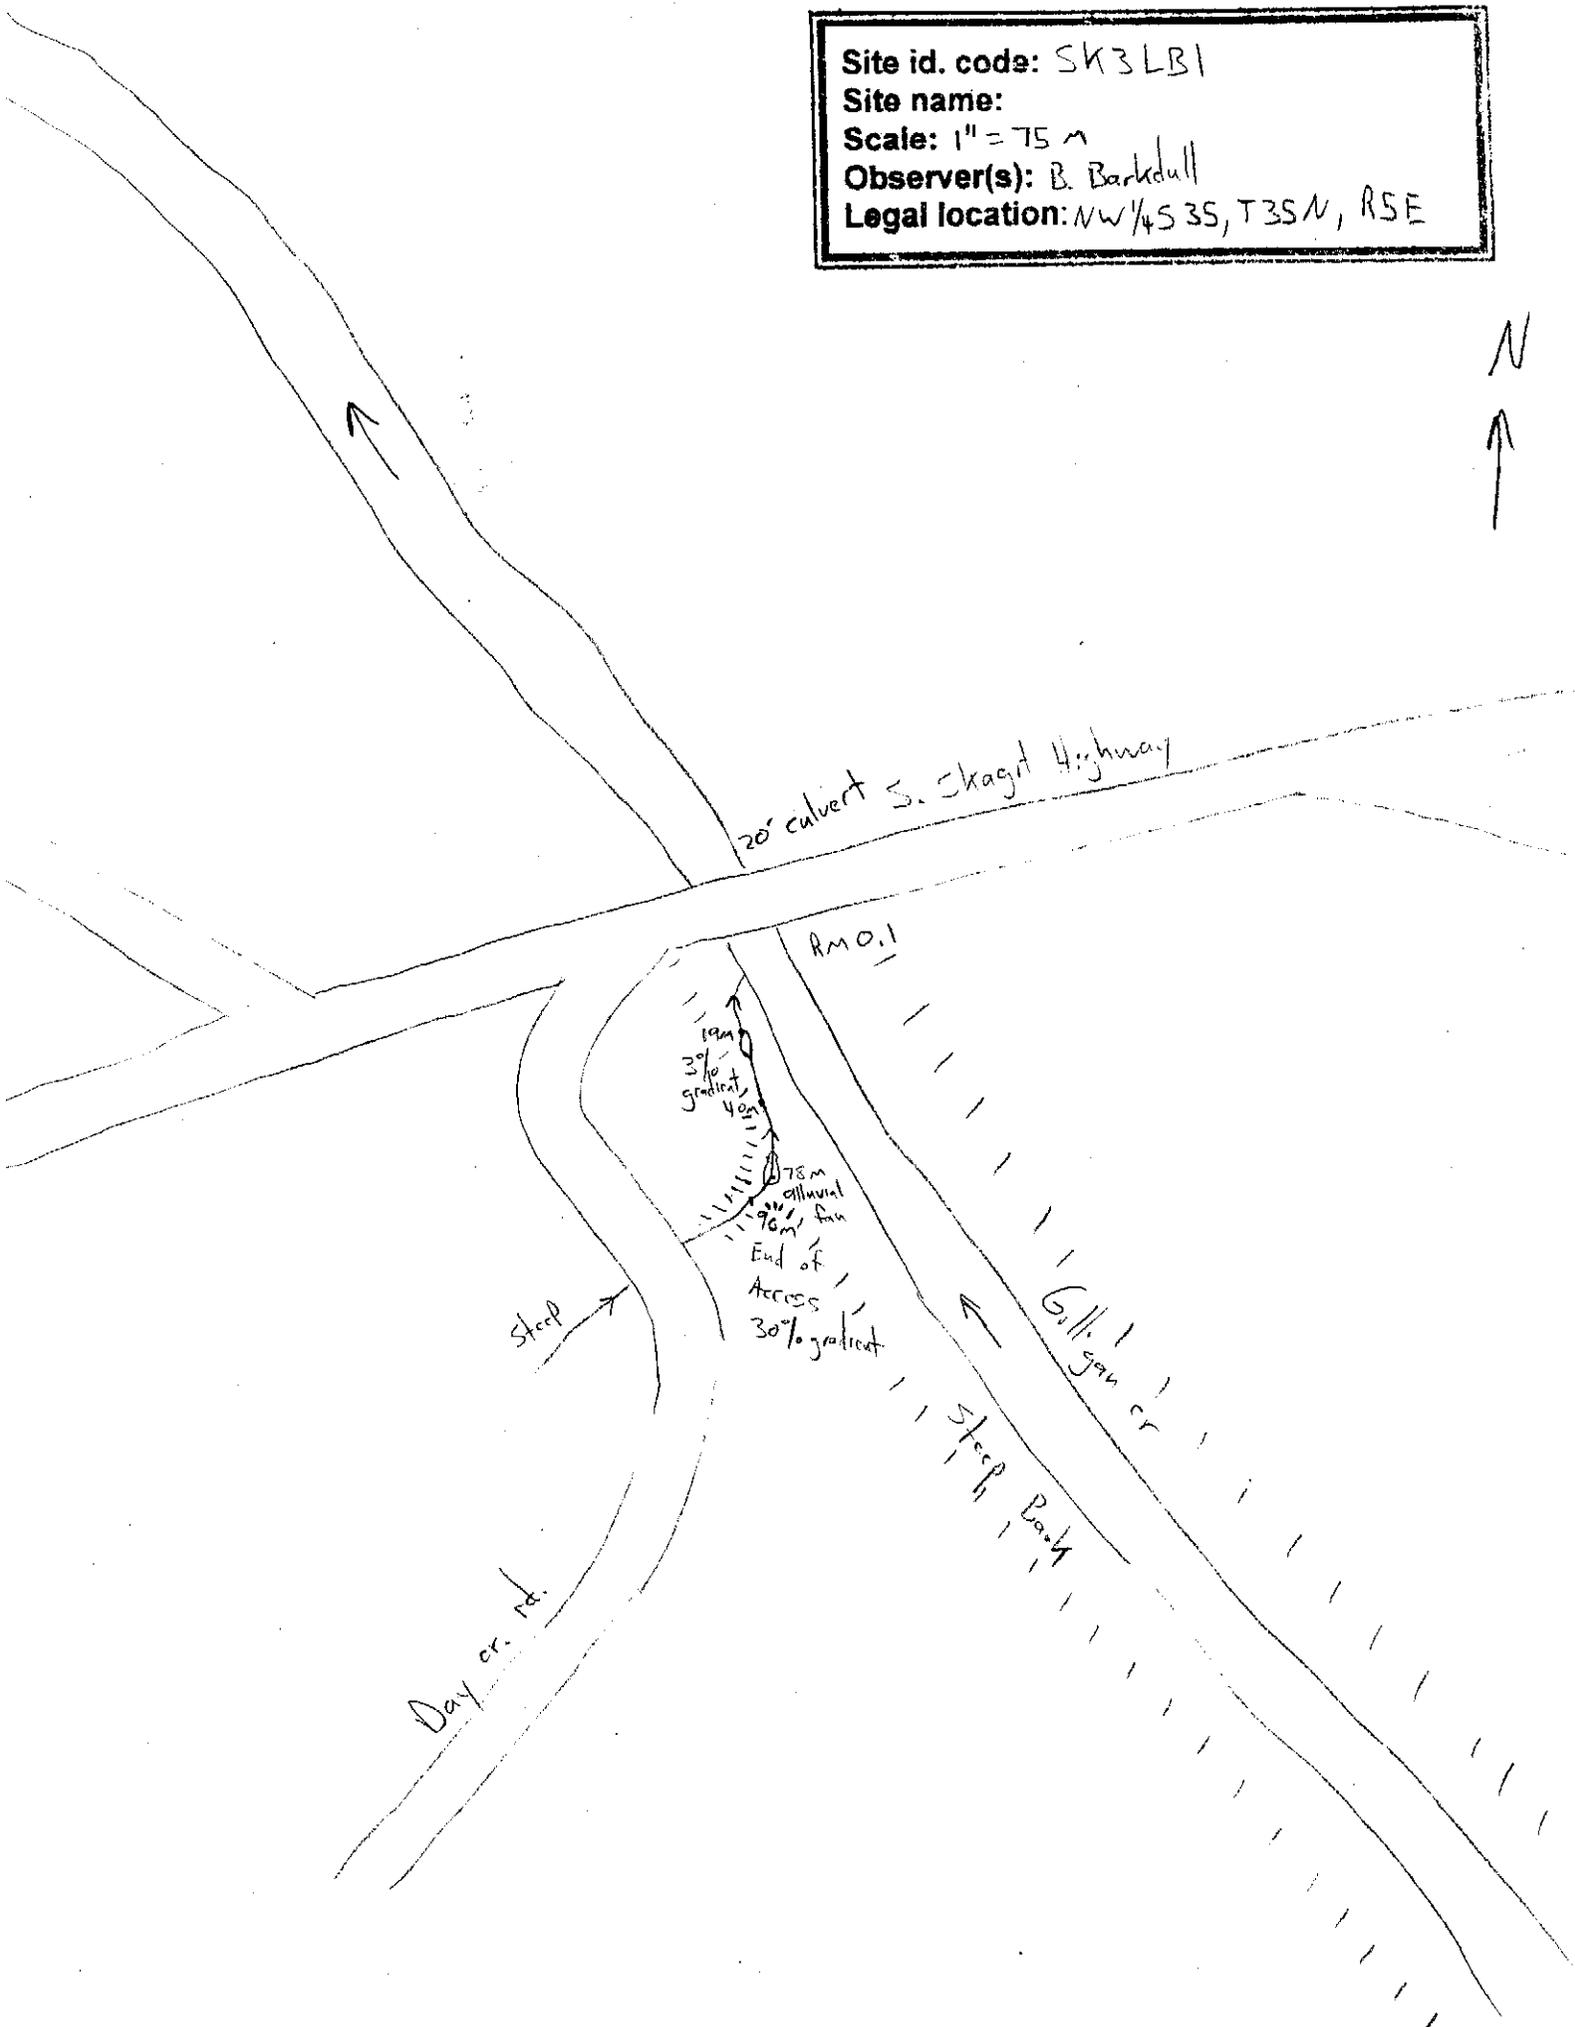
Site id. code: SK3LBI

20' culvert S. Skagit Highway

19m  
30% gradient  
40m

78 m alluvial fan  
96 m

End of Access  
30% gradient

Steep Bank

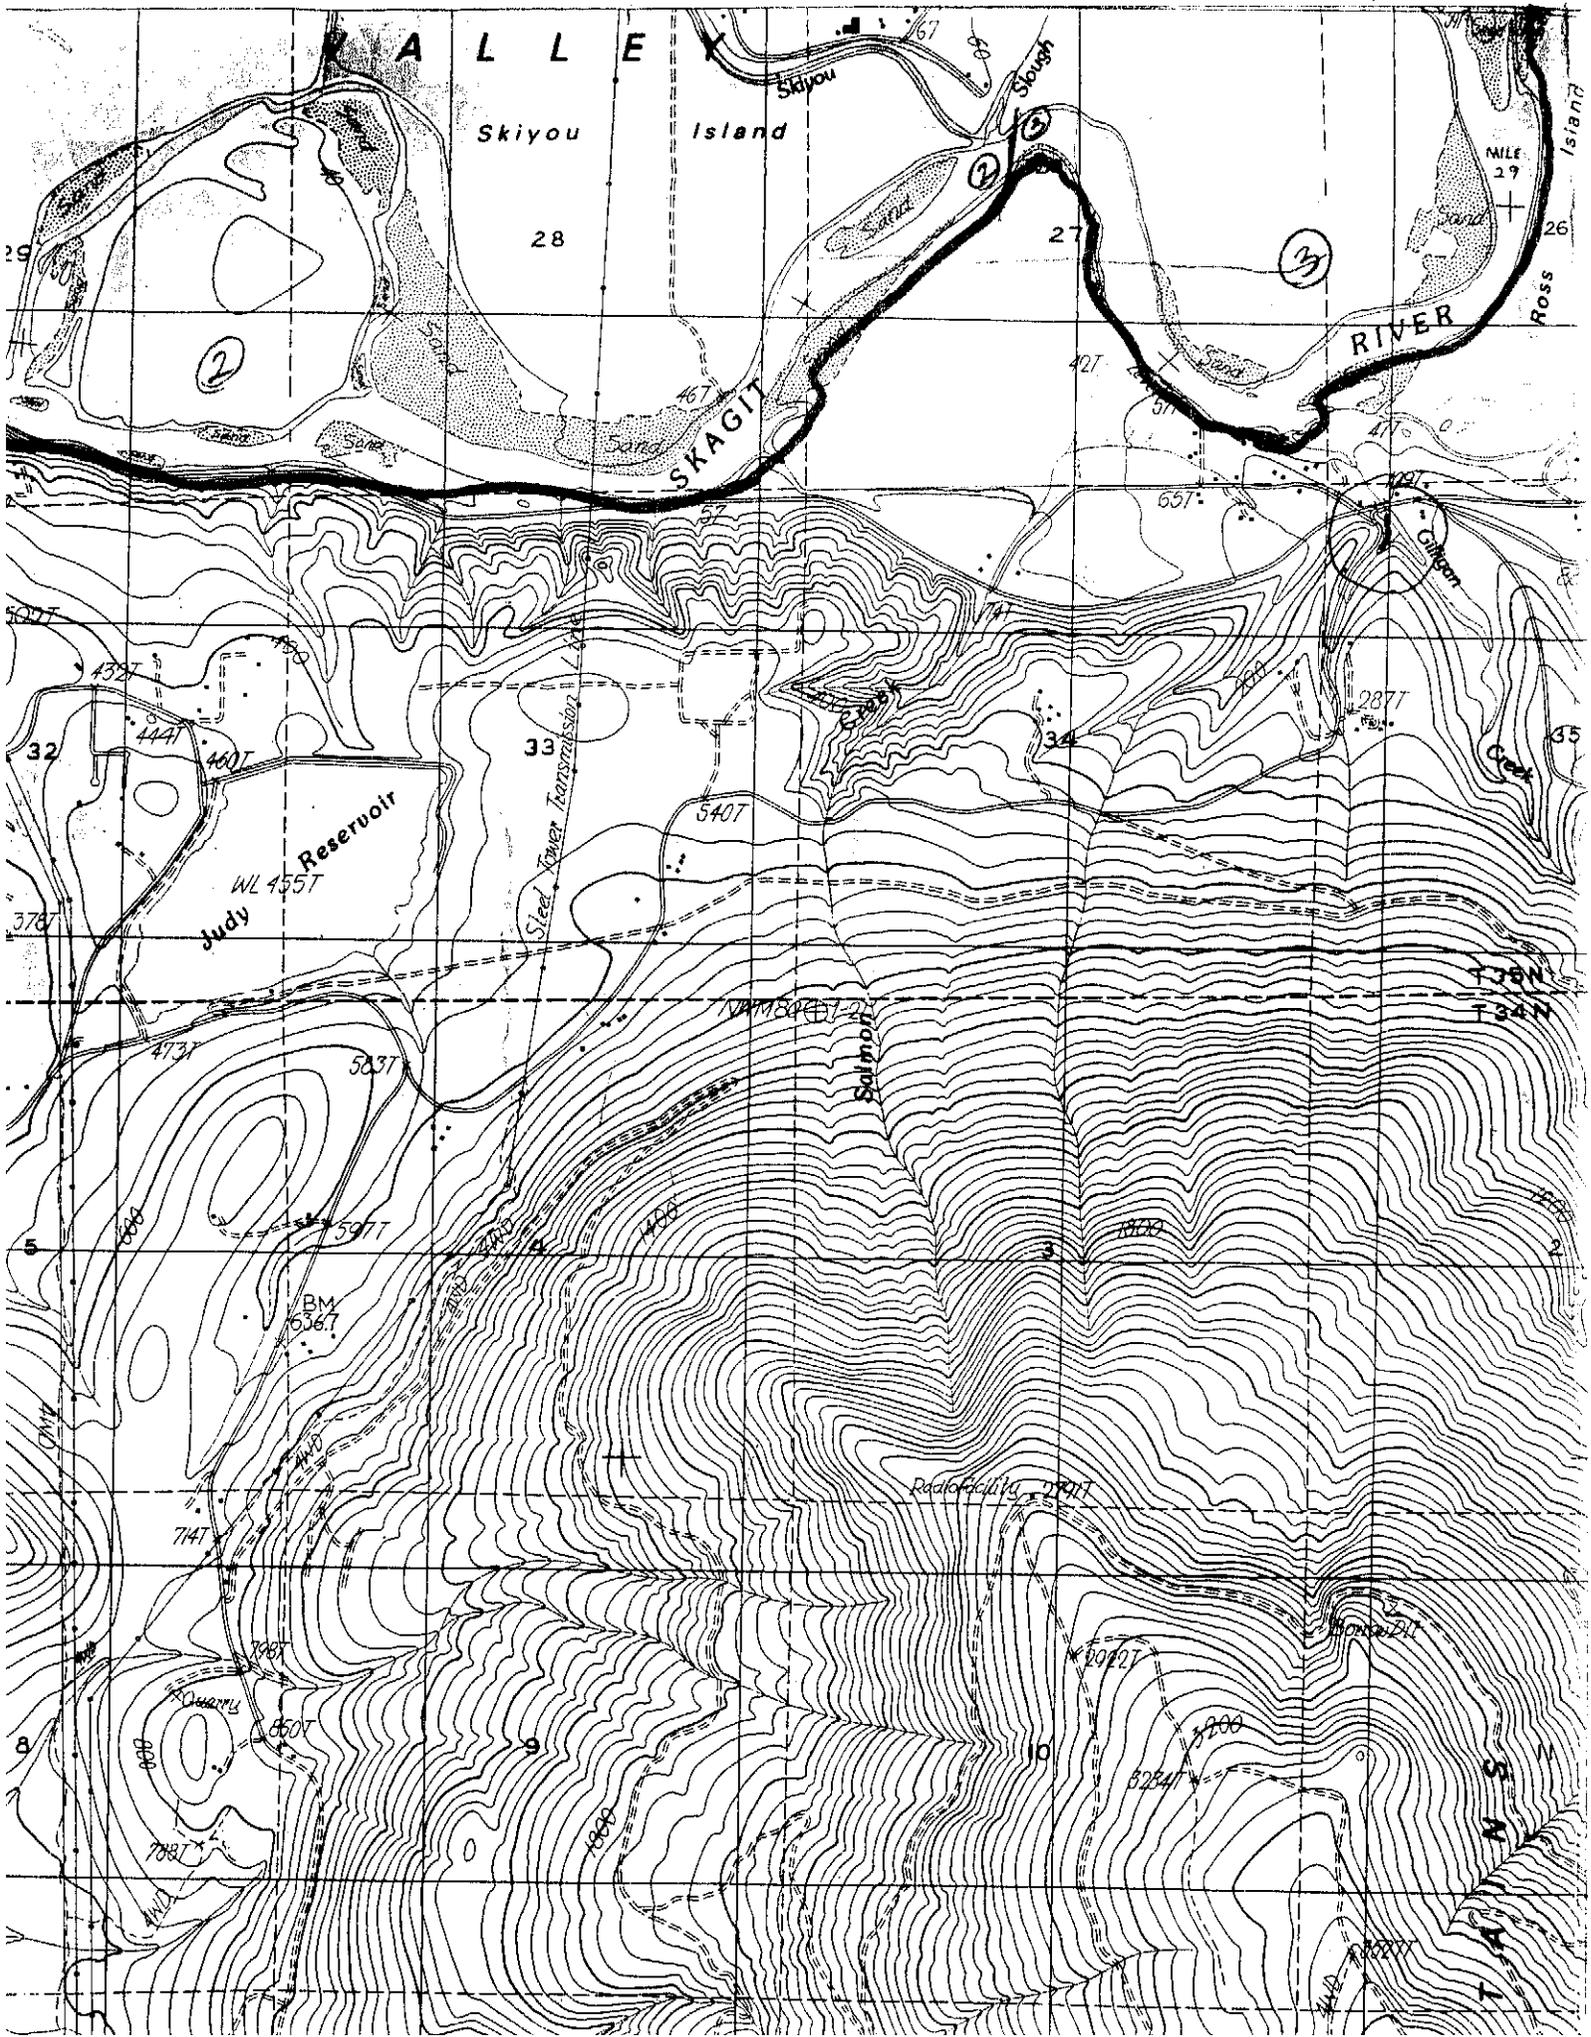
1/23/98 Gilligan cr. trib

0.0 1.0 Cascade, enters @ 20' culvert

19.0 1.5 3% gradient, window out

40.0 2.0 low gr. Nice gr.

78 1.5 at Alluvial fan 4% gr.

90 1.5 Pool of access, 30% gr.
