SITE INFORMATION

Site Identifier :	SK5LB2	Landowner Type :	
Site Name :		Landowner Name :	
WRIA :	03.0176X	Address :	
Region :	NS	Address2 :	
Trib to :	Skagit R	City :	
River Mile :	38.10	State :	
River System :	Skagit R	Zipcode :	
Legal Description :	NE1/4S22T35NR6E	Phone :	
County :	Skagit		
Habitat Type :	slough

Field Survey Information

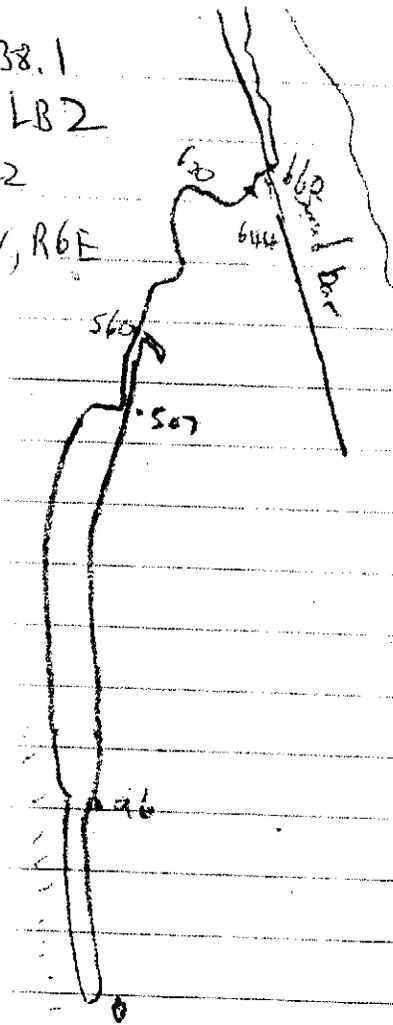
RM 38.1
 Sk5 LB2
 NB22
 T35N, R6E

- 0.0 sedges at end, defined swale.
- 96 12 ave, 1.5 deep
- 507 25 ave 1.0 deep
- 560 3 ave increas, mud bottom
- 620 2 ave inc, mud bottom
- 644 1 ave Beaver den
- 660 G.S at River

River 37, slough 42
