SITE INFORMATION

Site Identifier :	SK7LB3	Landowner Type :	
Site Name :		Landowner Name :	
WRIA :	03.0384X	Address :	
Region :	NS	Address2 :	
Trib to :	Savage Cr	City :	
River Mile :	1.30	State :	
River System :	Skagit R	Zipcode :	
Legal Description :	NW1/4S23T35NR7E	Phone :	
County :	Skagit	Coordinates	
Habitat Type :	lower valley wall tributary	East:	1,667,645.00
		North:	1,160,920.00

Field Survey Information

Date : 4/18/01 **Observer :** Barkdull **Survey Type :** initial

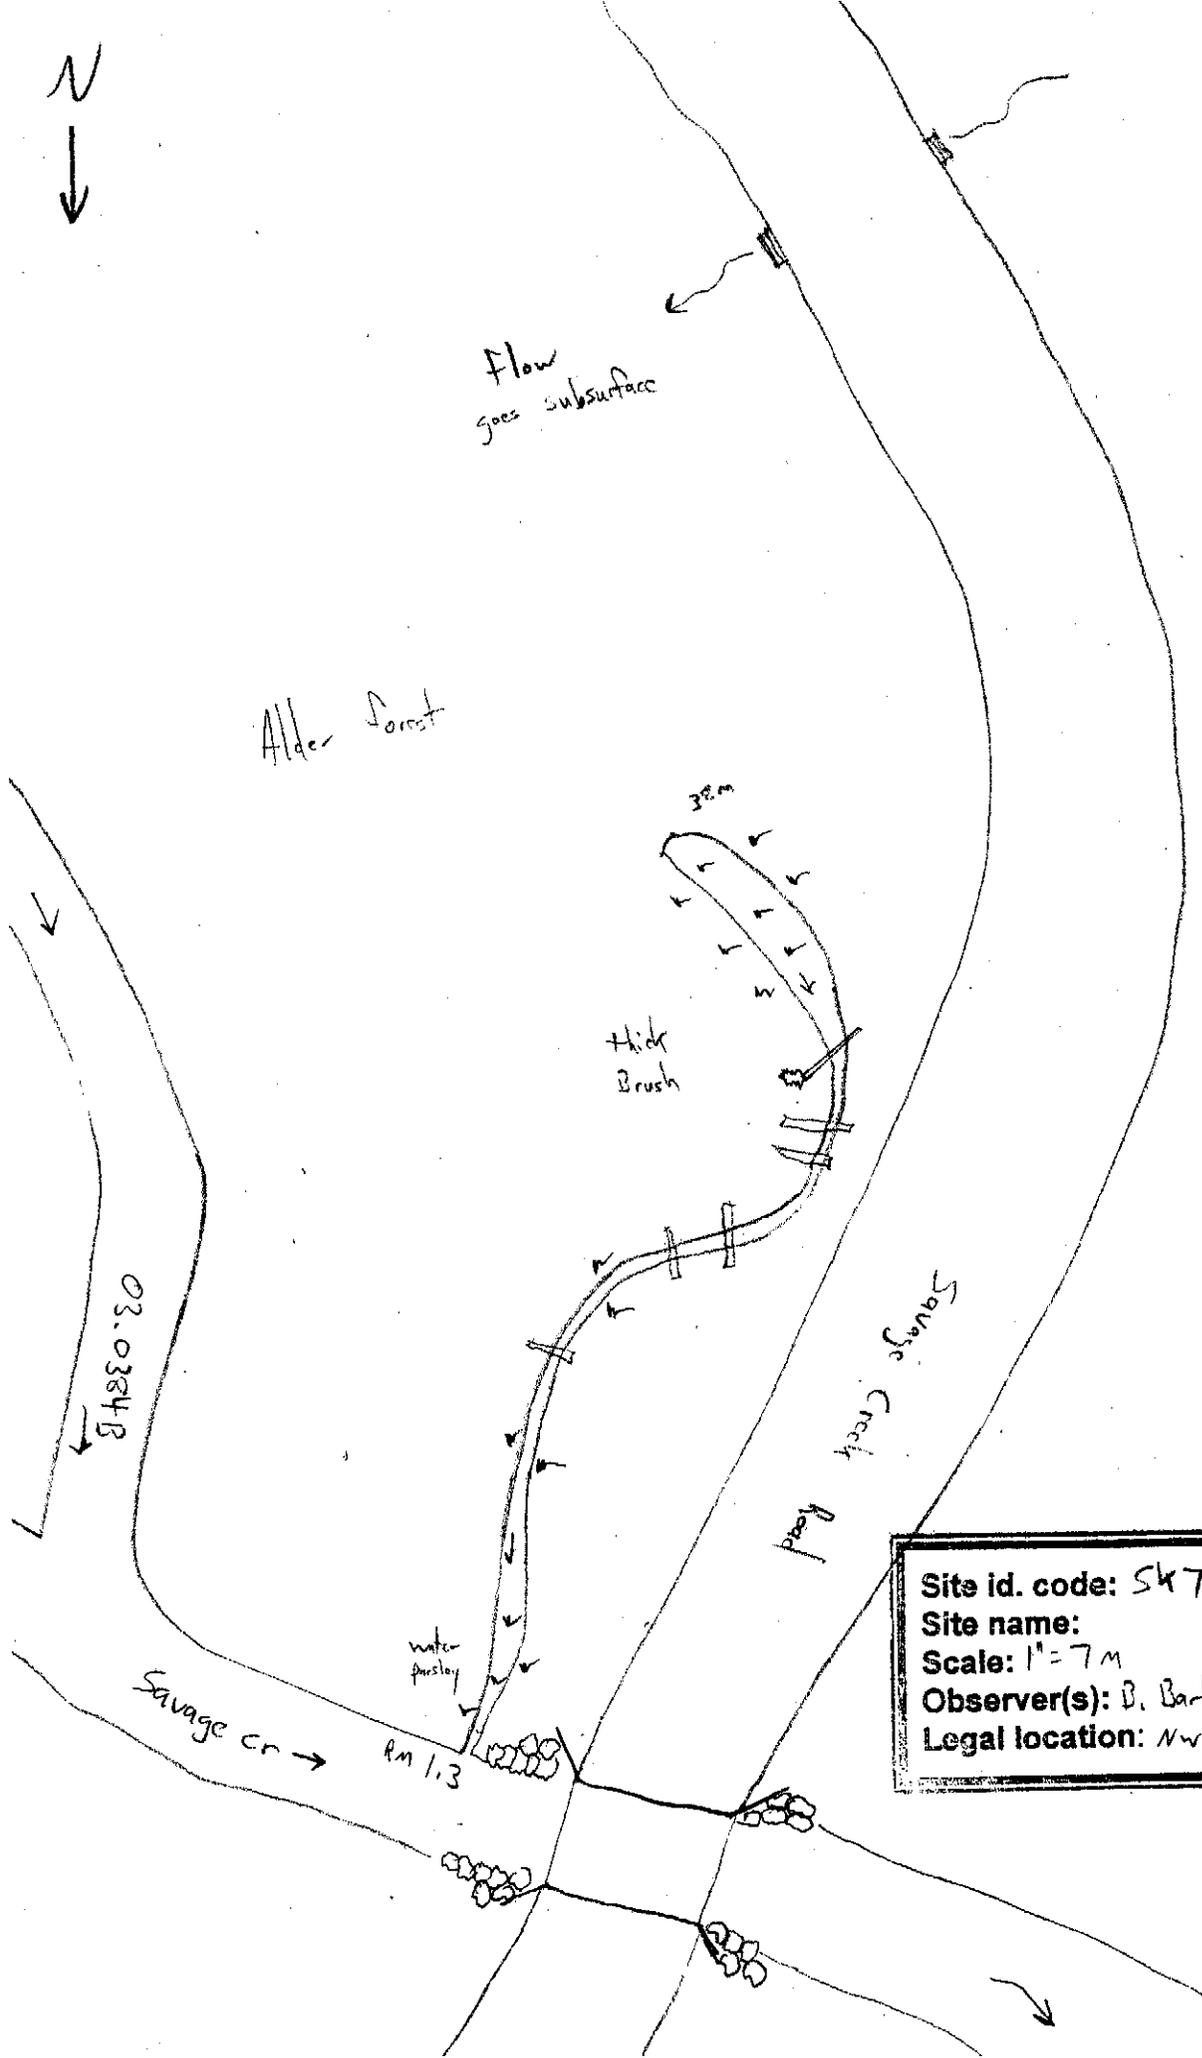
Site id. code: SK7LB3
Site name:
Scale: 1" = 7M
Observer(s): B. Barkdull
Legal location: NW23, T35N, R7E

Describe spawning habitat: Two patches of good quality spawning gravel are located near the outlet.

Describe pond and other rearing habitat: Stream averages 4% gradient with a mix of pools and riffles, with woody debris, water parsley and thick brush offering excellent cover.

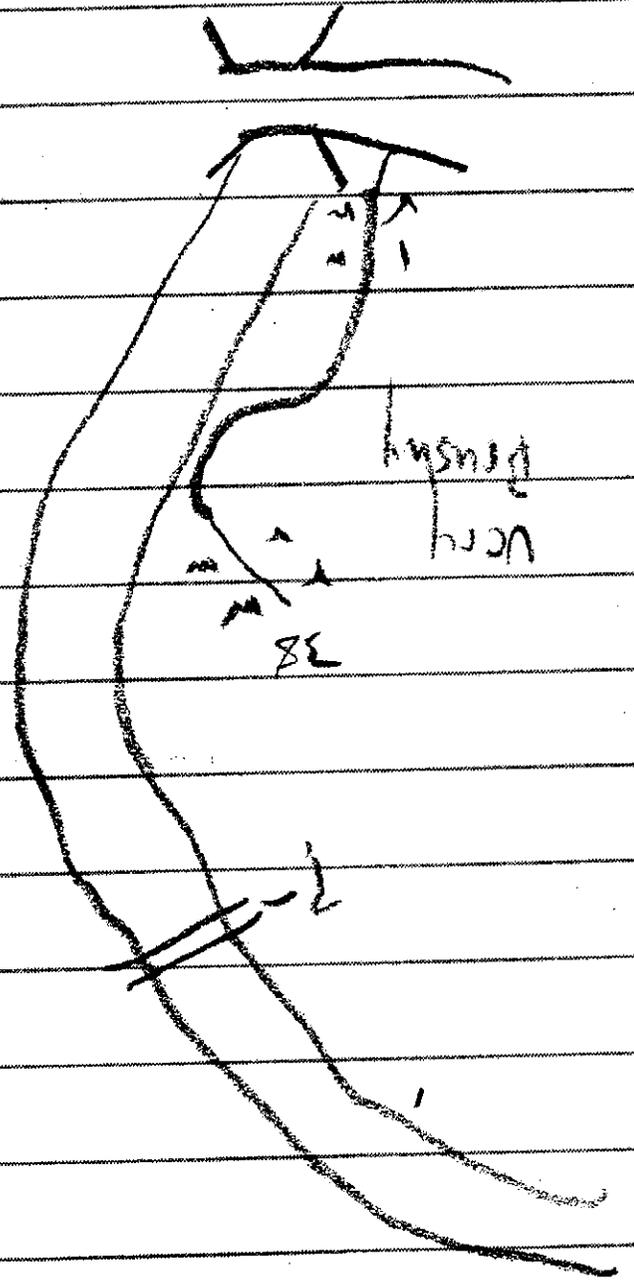
sk7LB3

413101 truck to salvage cr

2.0 water celery at math

Colo Fry Present

2 apparent leads?

38 1.5 ave 10 m sp ground
spring fed, 1/2% gradient
