SITE INFORMATION

Site Identifier :	SK7LB4	Landowner Type :	
Site Name :		Landowner Name :	
WRIA :	03.0384BX	Address :	
Region :	NS	Address2 :	
Trib to :	03.0384B	City :	
River Mile :	0.60	State :	
River System :	Skagit R	Zipcode :	
Legal Description :	SW1/4S23T35NR7E	Phone :	
County :	Skagit	Coordinates	
Habitat Type :	lower valley wall tributary	East:	1,669,306.00
		North:	1,160,117.00

Field Survey Information

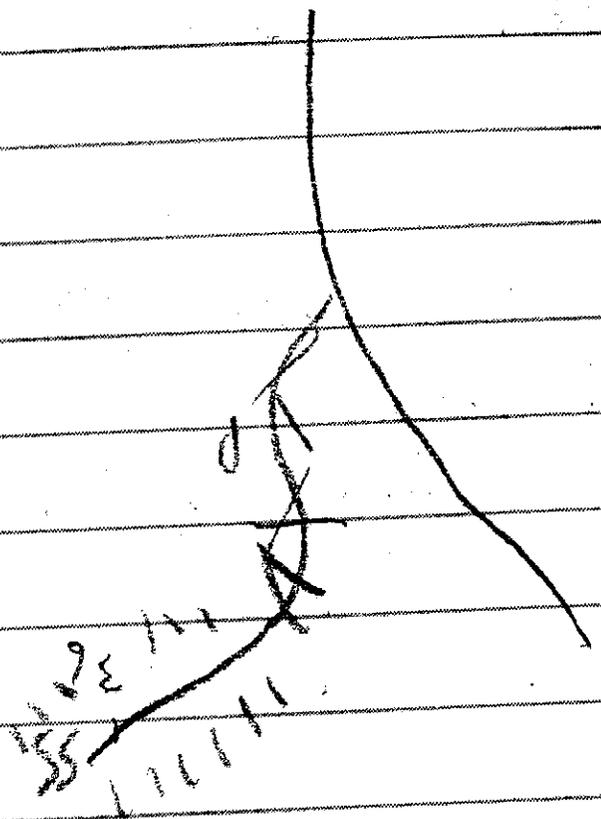
5/29/01 trib to Savage manhole

36 1.5 extremely brushy

patches of good grass

one road observed Scorpion?

50% of stream covered in

slash. End of line gradient

0.5 cfs
