FISH INFORMATION

Site id. code: SS12RB8
Site name:
Scale: 1" = 60m
Observer(s): B. Bardsall
Legal location: SW17, T30N, R10E

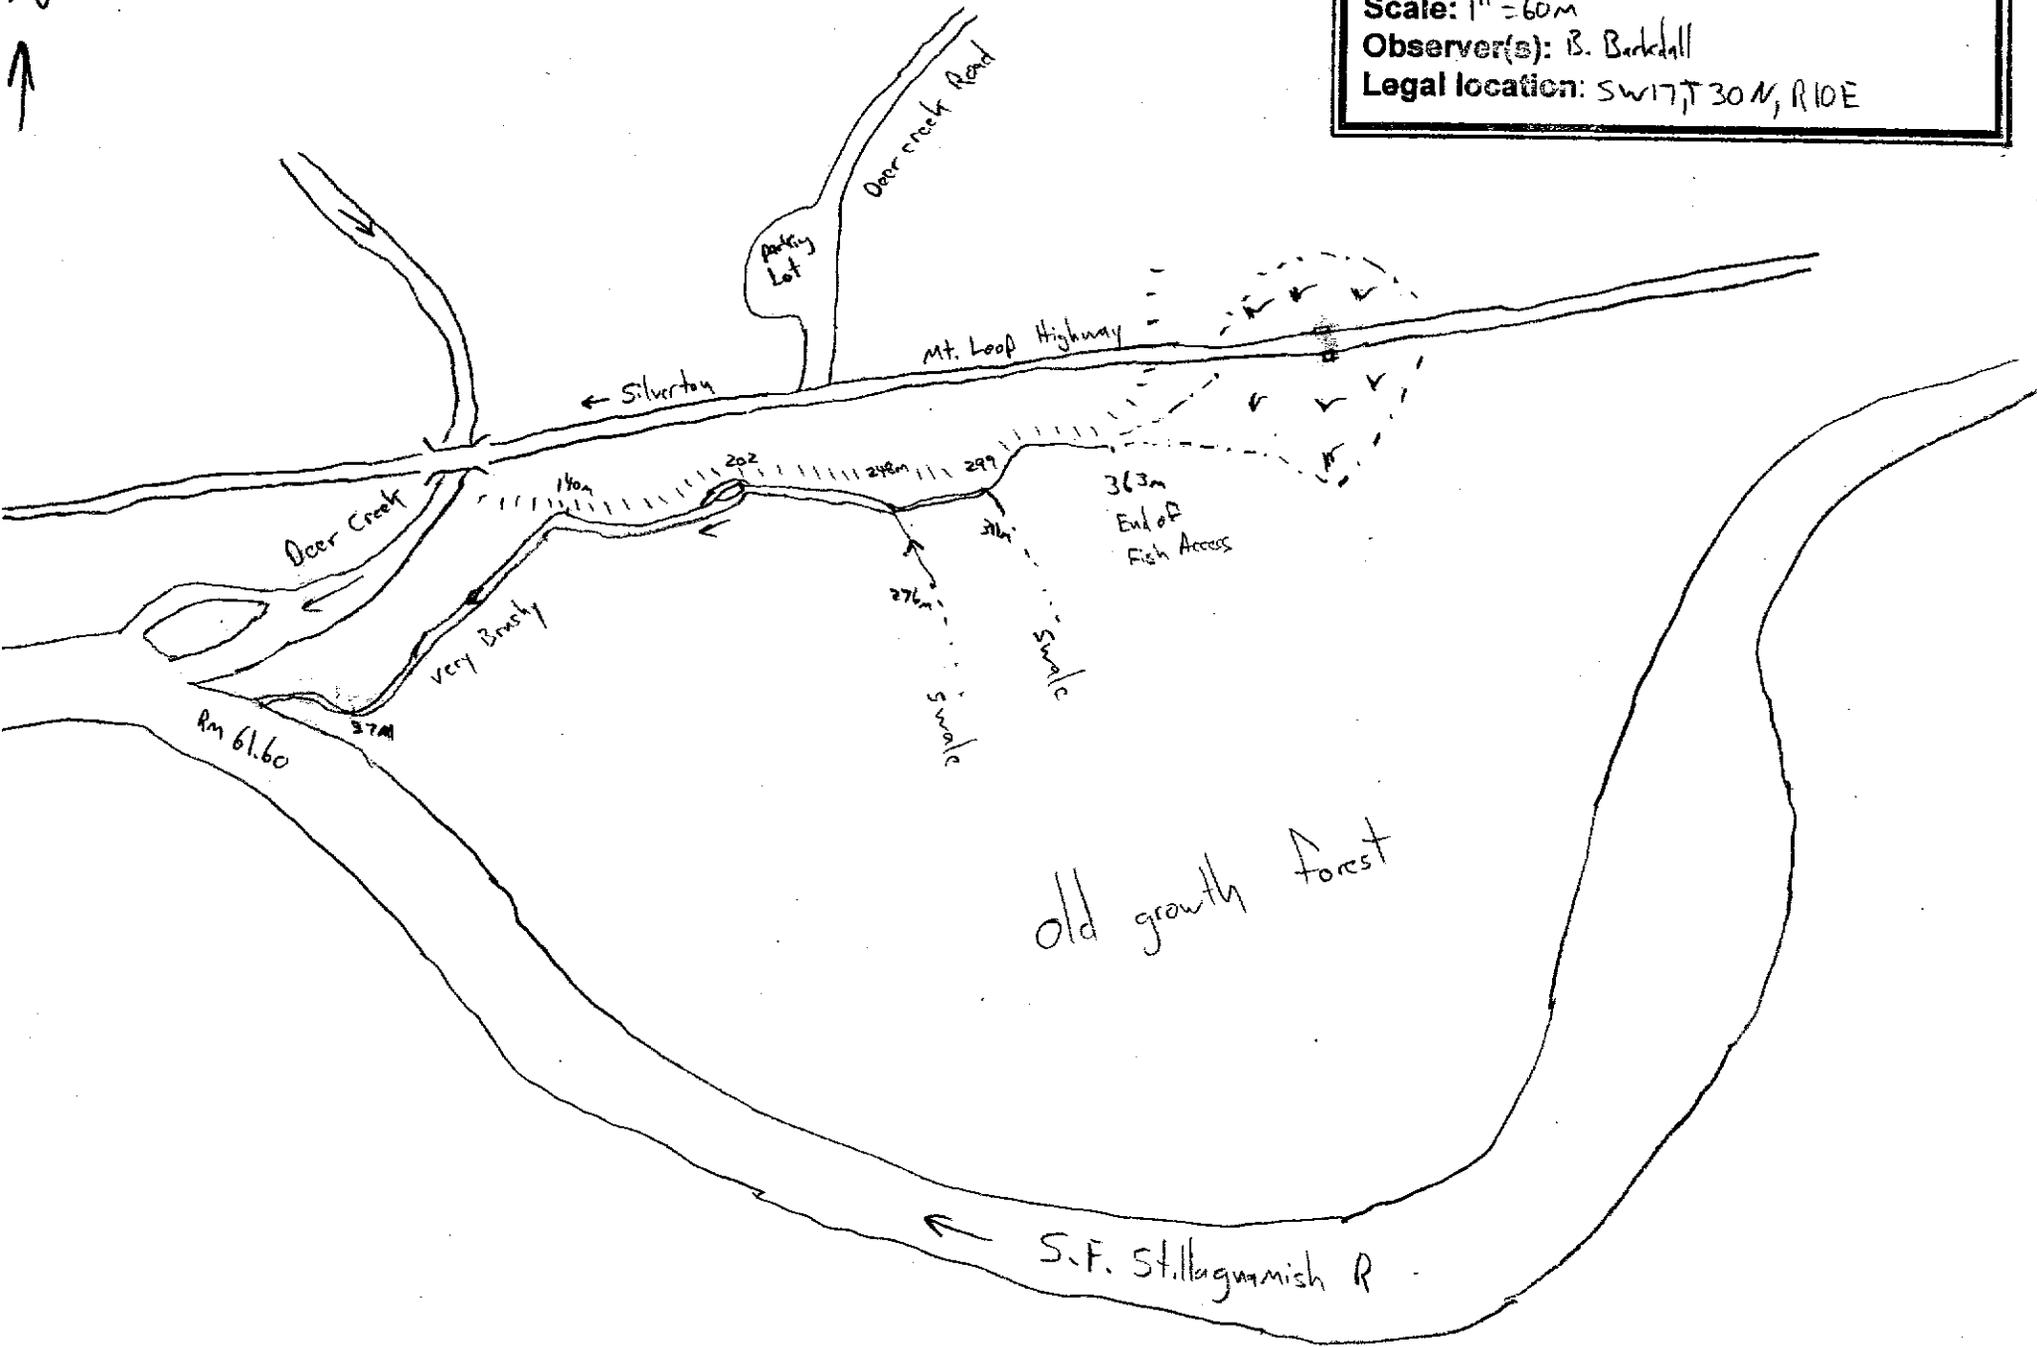
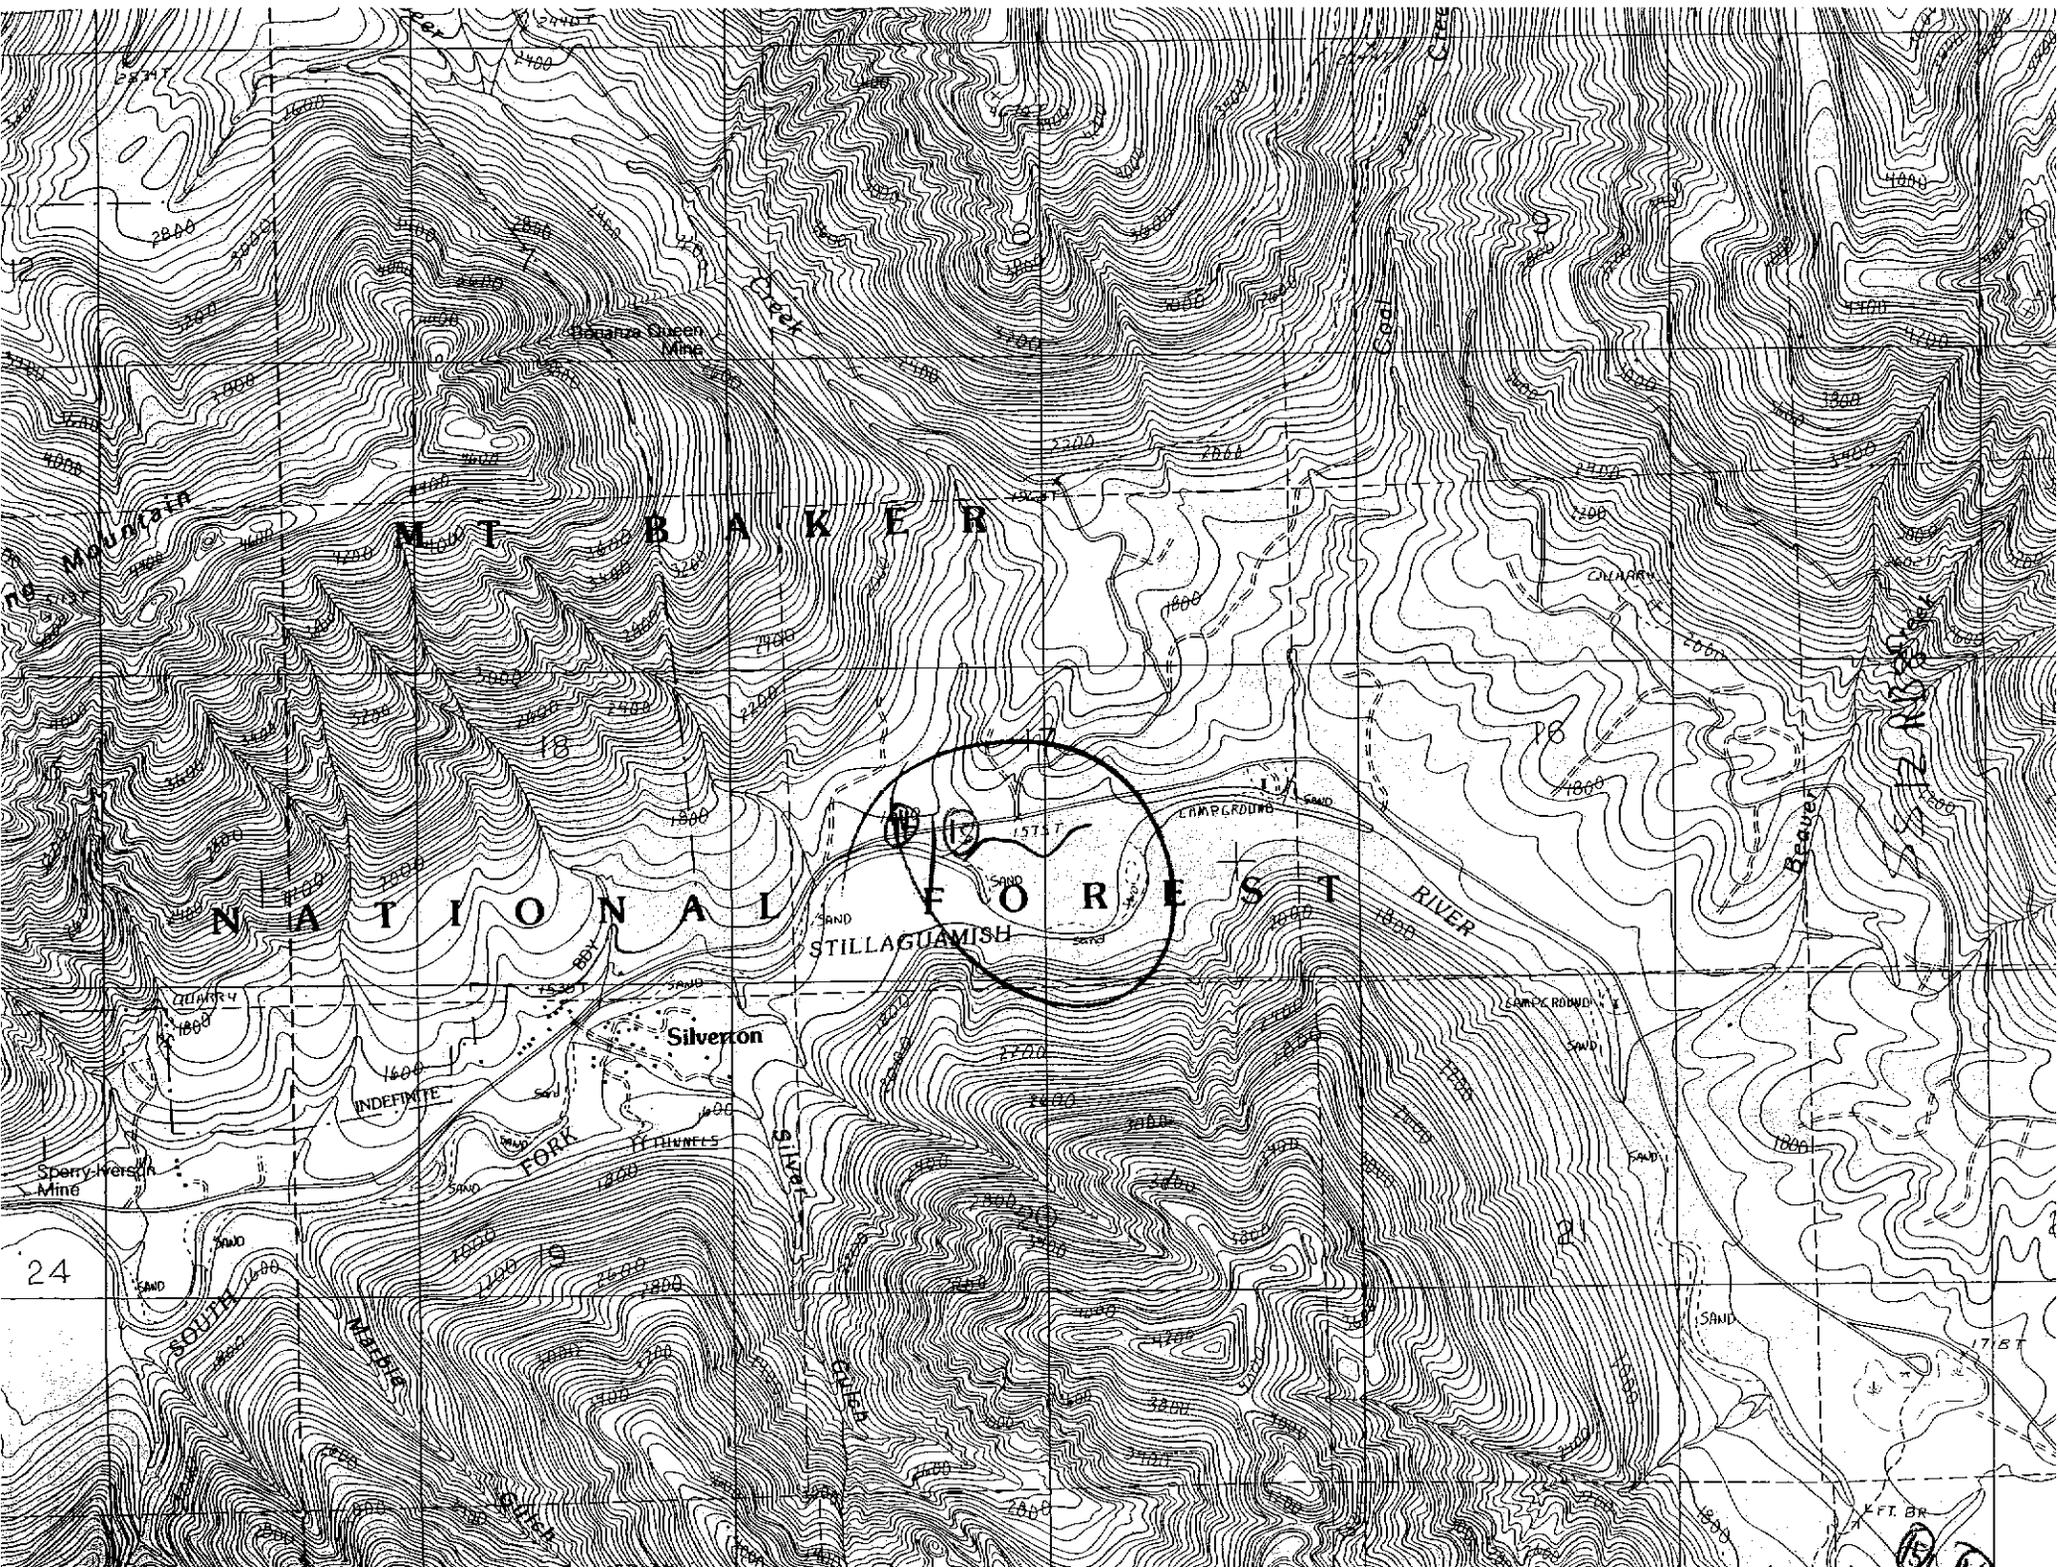
Describe spawning habitat: A small amount of spawning gravel is present near 200 meters on a riffle, most of the substrate is cobble sized.

Describe pond and other rearing habitat: The site is dominated by large pools with thick brush on the banks and an old growth overstory. Flow decreases the further upstream you go, terminating in a scrub-shrub wetland near the head end. Site was nearly dry when observed in August.

Describe: Fish have easy access to the site when flows are moderate, access is difficult during low flows due to a cascade at the mouth.

Describe: No Juveniles were observed on the day of the survey, two adults were observed near the mouth but no redds were observed.

12/16/02 site Just above
Deer cr l cfs, watered by Surinam
2 adults at mouth 40° , 40°
0
37 3.0 cable bottom, in dd coal ch
93 3.0 ss, sc, fl + pool
140 2.0 Pool, turves
202 4.0 mostly pool, at Road e
248 3.0 channel splits, cont toward
River on LB ch
276 1.5 pool
276 Restart Mainstem
2909 2.5 RD turb
311 1.0 Restart at Mauston
363 2.0 channel no longer defined
385 2.0 no layer def
Habitat
