Site id. code: SS13 RB13

Observer(s): B. Barkdull

Legal location: NW35, T30N, R10E

RM 66.70

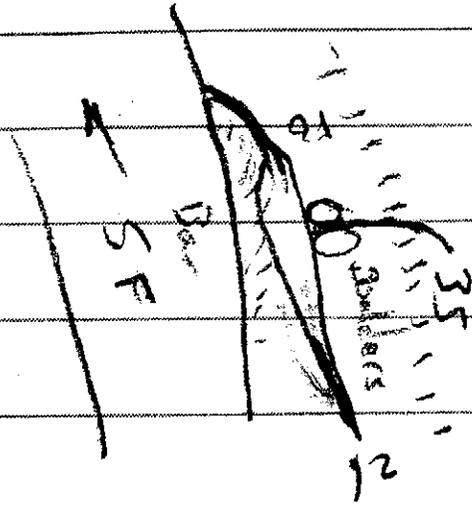
SS13 RB13

Describe pond and other rearing habitat: The site is mostly made up of a pool up to one meter in depth. A short riffly channel leads up to a pool. The pool is fed by a short inlet spring popping out of the base of the hill. The site has water parsley throughout.

Describe: Site was completely full of coho fry on the day of the survey. There appeared to be an old redd at the outlet of the pool.
