Site id. code: SS4RB2
Site name: FOX LAKE
Scale: 1"=40M
Observer(s): OLIS
Legal location: NE 1/4 S11 T30N R6E

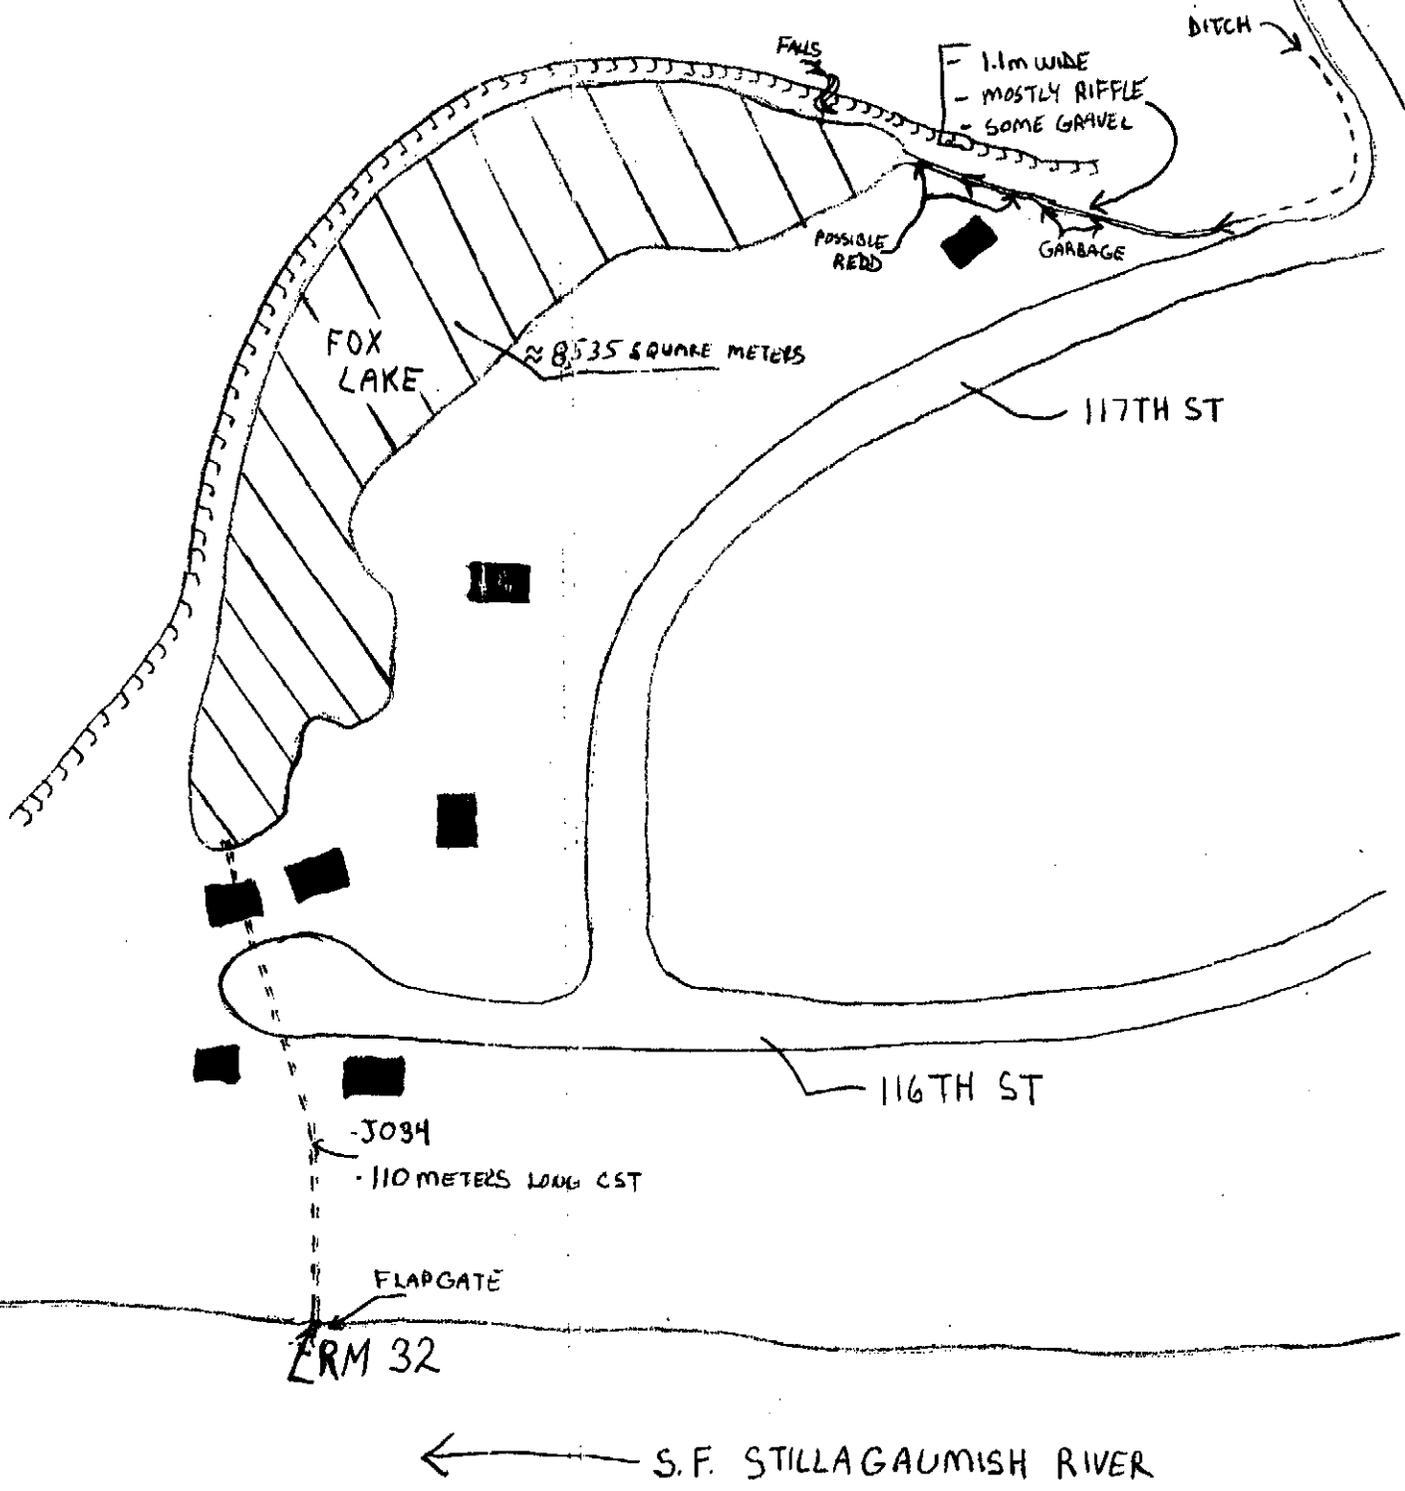
Describe pond and other rearing habitat: The pond is approximately 210 meters long by 40 meters in width. The right bank of the pond is bordered by a steep terrace wall that is vegetated with hardwoods and brush. The left bank is bordered mostly by houses and lawns. It has a muddy substrate with some woody structure present. The pond is fed by an intermittent stream/ditch that has a small amount of spawning habitat.

Describe: There is a very long culvert with a flapgate on the downstream end that connects this small pond to the river.

Describe: There were two areas in the inlet that looked like possible old redds but no carcasses were found. The culvert that connects this site to the river impedes fish passage.

ENHANCEMENT OPPORTUNITIES: The structure at the entry area (JO34) is a fish barrier. The flapgate hinders fish passage but also keeps the river from backwatering into the pond during high flows. A structure that is more fish friendly and protects the pond from backwatering would enhance this site.
