**SITE INFORMATION**

**Site Identifier :** SU3LB10 **Landowner Type :**  
**Site Name :** **Landowner Name :**  
**WRIA :** 03.0170X **Address :**  
**Region :** NS **Address2 :**  
**Trib to :** Suiattle R **City :**  
**River Mile :** 8.20 **State :**  
**River System :** Suiattle R **Zipcode :**  
**Legal Description :** NE1/4S24T33NR10E **Phone :**  
**County :** Skagit  
**Habitat Type :**

Site id. code: SU3LB10

Legal location: NE ¼ S24 T33 N R10E

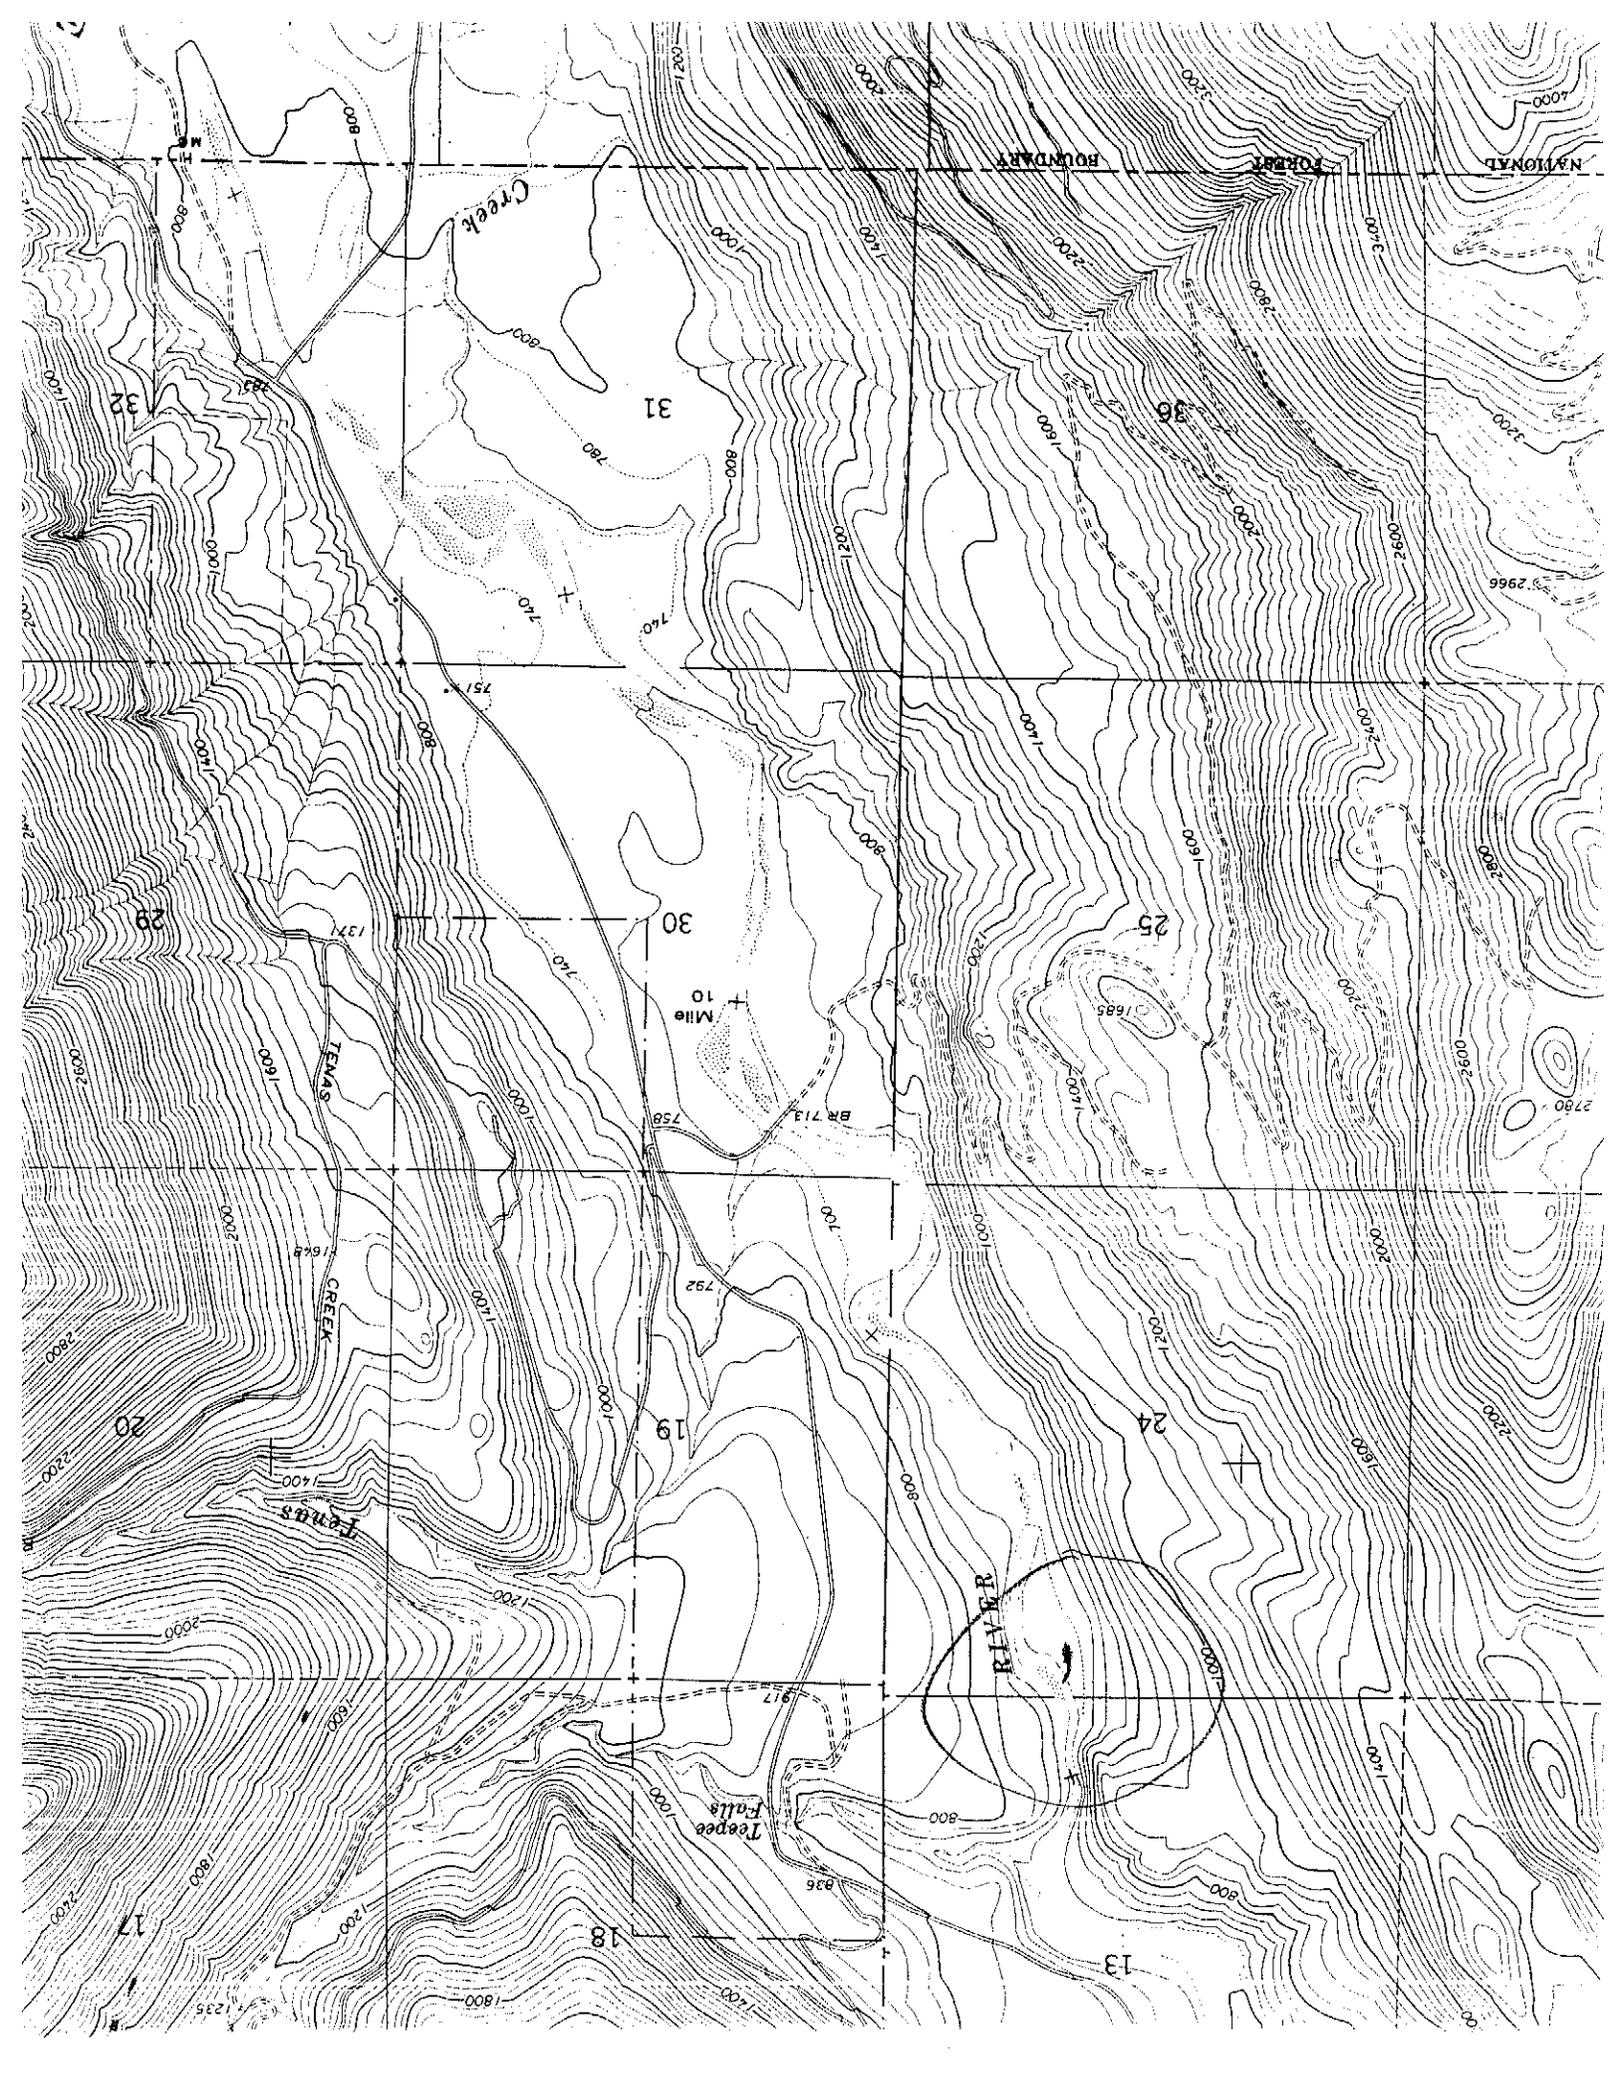
SU3LB10

0.0 ENTRY

- FLOW - QICFS
- REC WTR TEMP - 43
- STRM. TEMP - 48
- ACCESS IS GOOD - HOLDING POOL @ ENTRY

52m WW 1m RIFF

- SUBSTR. HARD CLAY
- GOOD COVER ON BANKS

121m WW 5m - POOL

- VERY SHALLOW
- IN CLEAR CUT HEADING TWD TERR. WALL

- SKUNK CABBAGE AND OTHER WETL. PLANTS

121m... SUBSTRATE IS  
MORE ORGANIC

148m WW 1M

- SLOW MOVING SHALLOW
- END OF WTR
- WET SITE CONT.
- ALONG WALL BASE
- PROBABLE MUCH MORE WATER DURING RAINY PERIODS.

WTR TEMP 48°

- NO SPAWNING HAB.
- DRIES UP IN SUMMER
- MODER. FLOOD POTENTIAL

- WAS NOT HIT TO  
HARD NOV. 95 FLOOD.
