#### FISH INFORMATION

#### ENHANCEMENT OPPORTUNITIES

Site id. code: S43LB2  
 Site name:  
 Scale: 1" = 50m  
 Observer(s): B. Barkdull  
 Local location: NW 31 T33N R11E

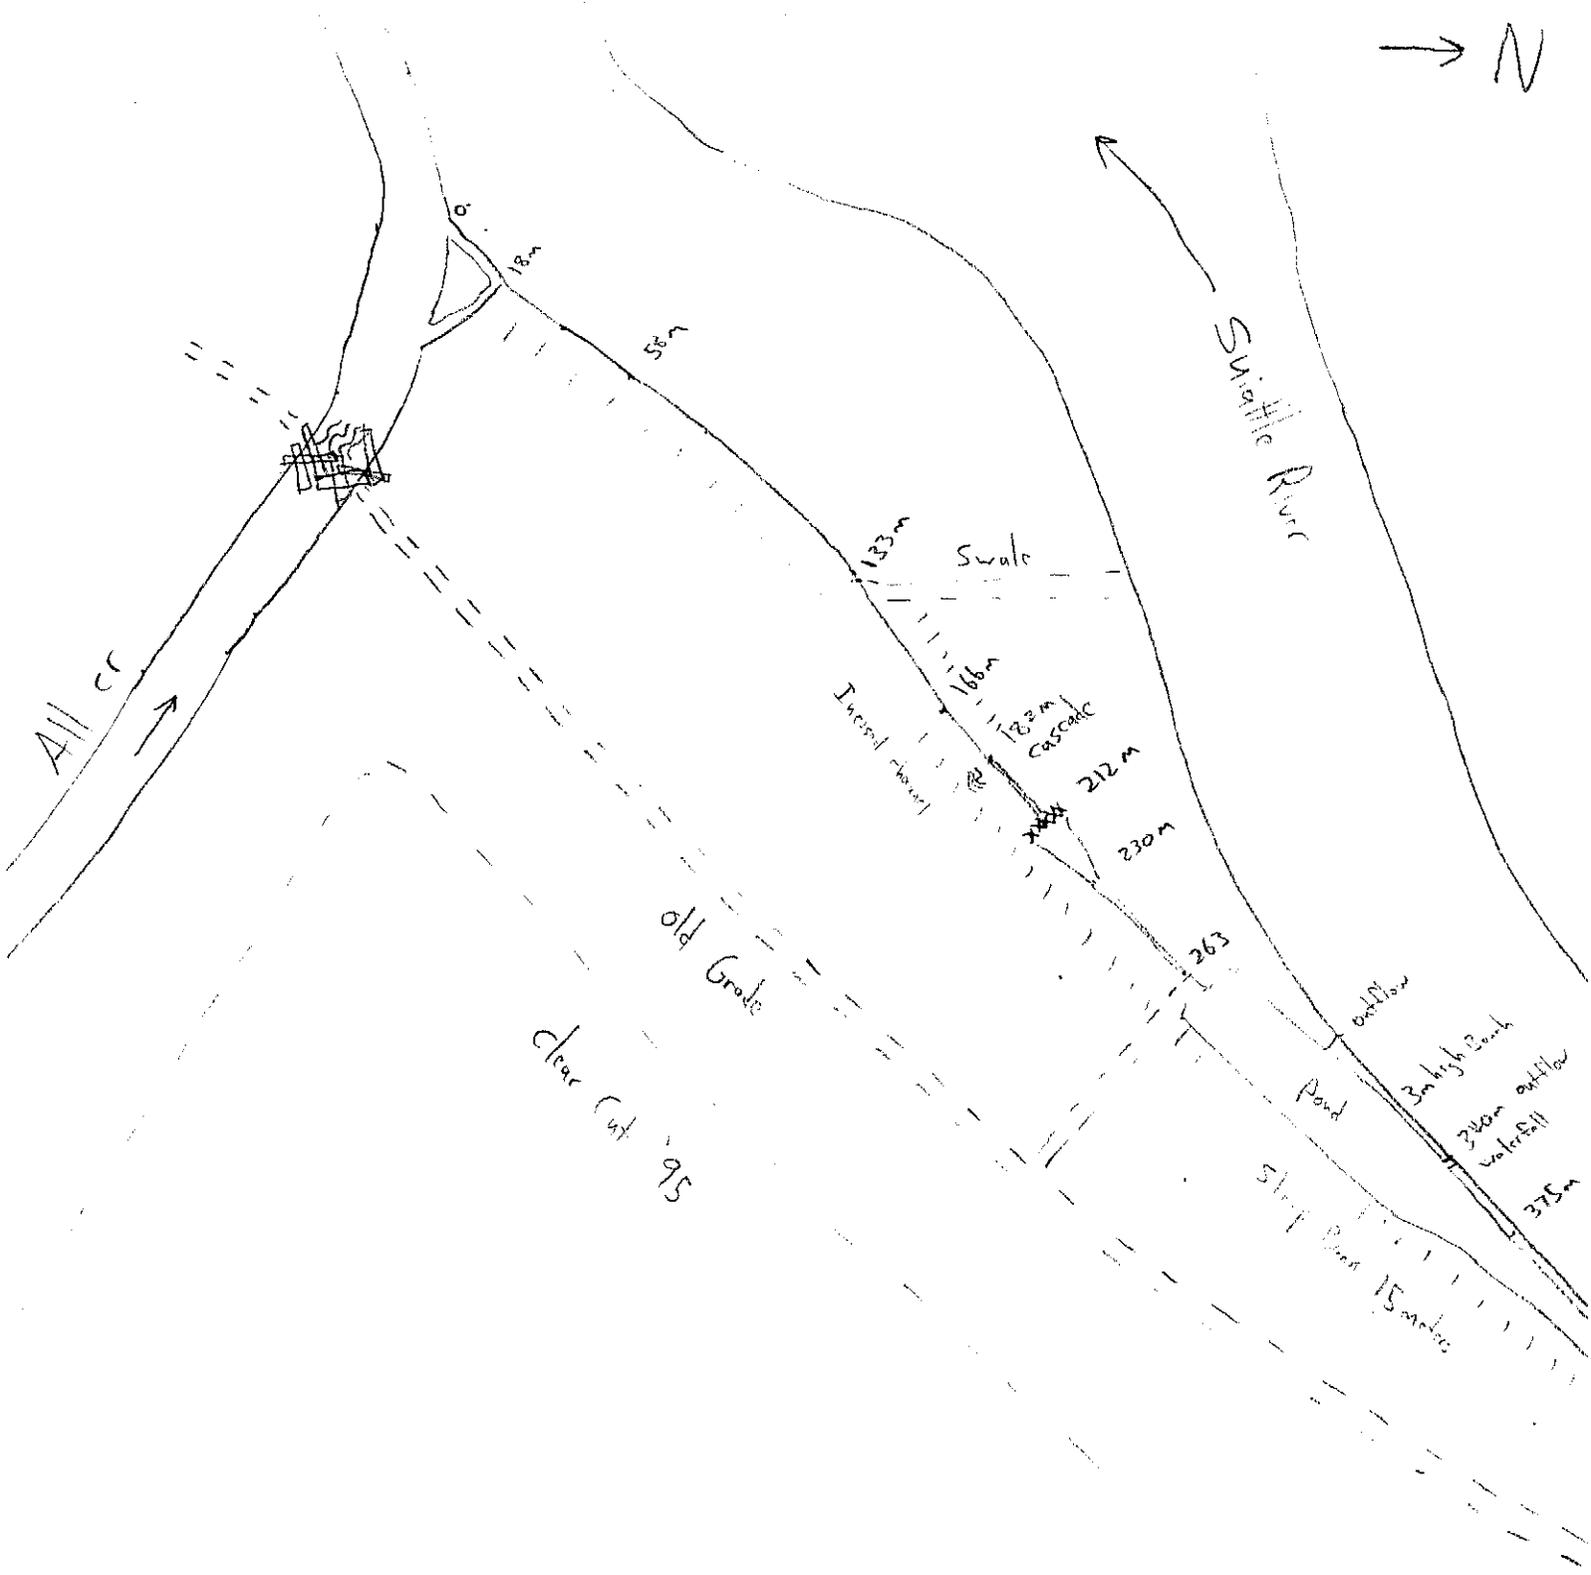
Describe pond and other rearing habitat: The outlet is mixed pool and riffles with good cover and woody debris, one small beaver dam creates a small pond.

Describe: Juvenile were observed in large numbers up to the beaver dam at 212 meters, a few were up to the large pond. Redds were observed in the patch gravel.

ADDITIONAL COMMENTS: A two meter drop over a distance of four meters seems to block access into the pond. By carefully placing weirs by hand passage could be improved. Dropping the pond level slightly would help to insure that all of the flow goes into the outlet helping passage. Currently part of the flow goes over the edge of the bench and directly into the river. This could be a small hand labor project.
