SITE INFORMATION

Site Identifier : SU3LB4	Landowner Type :
Site Name :	Landowner Name :
WRIA : 03.0786X	Address :
Region : NS	Address2 :
Trib to : All Cr	City :
River Mile : 0.20	State :
River System : Suiattle R	Zipcode :
Legal Description : NW1/4S31T33NR11E	Phone :
County : Skagit	
Habitat Type :

A small, short, low gradient wall-based system with good cover, and good fish use.

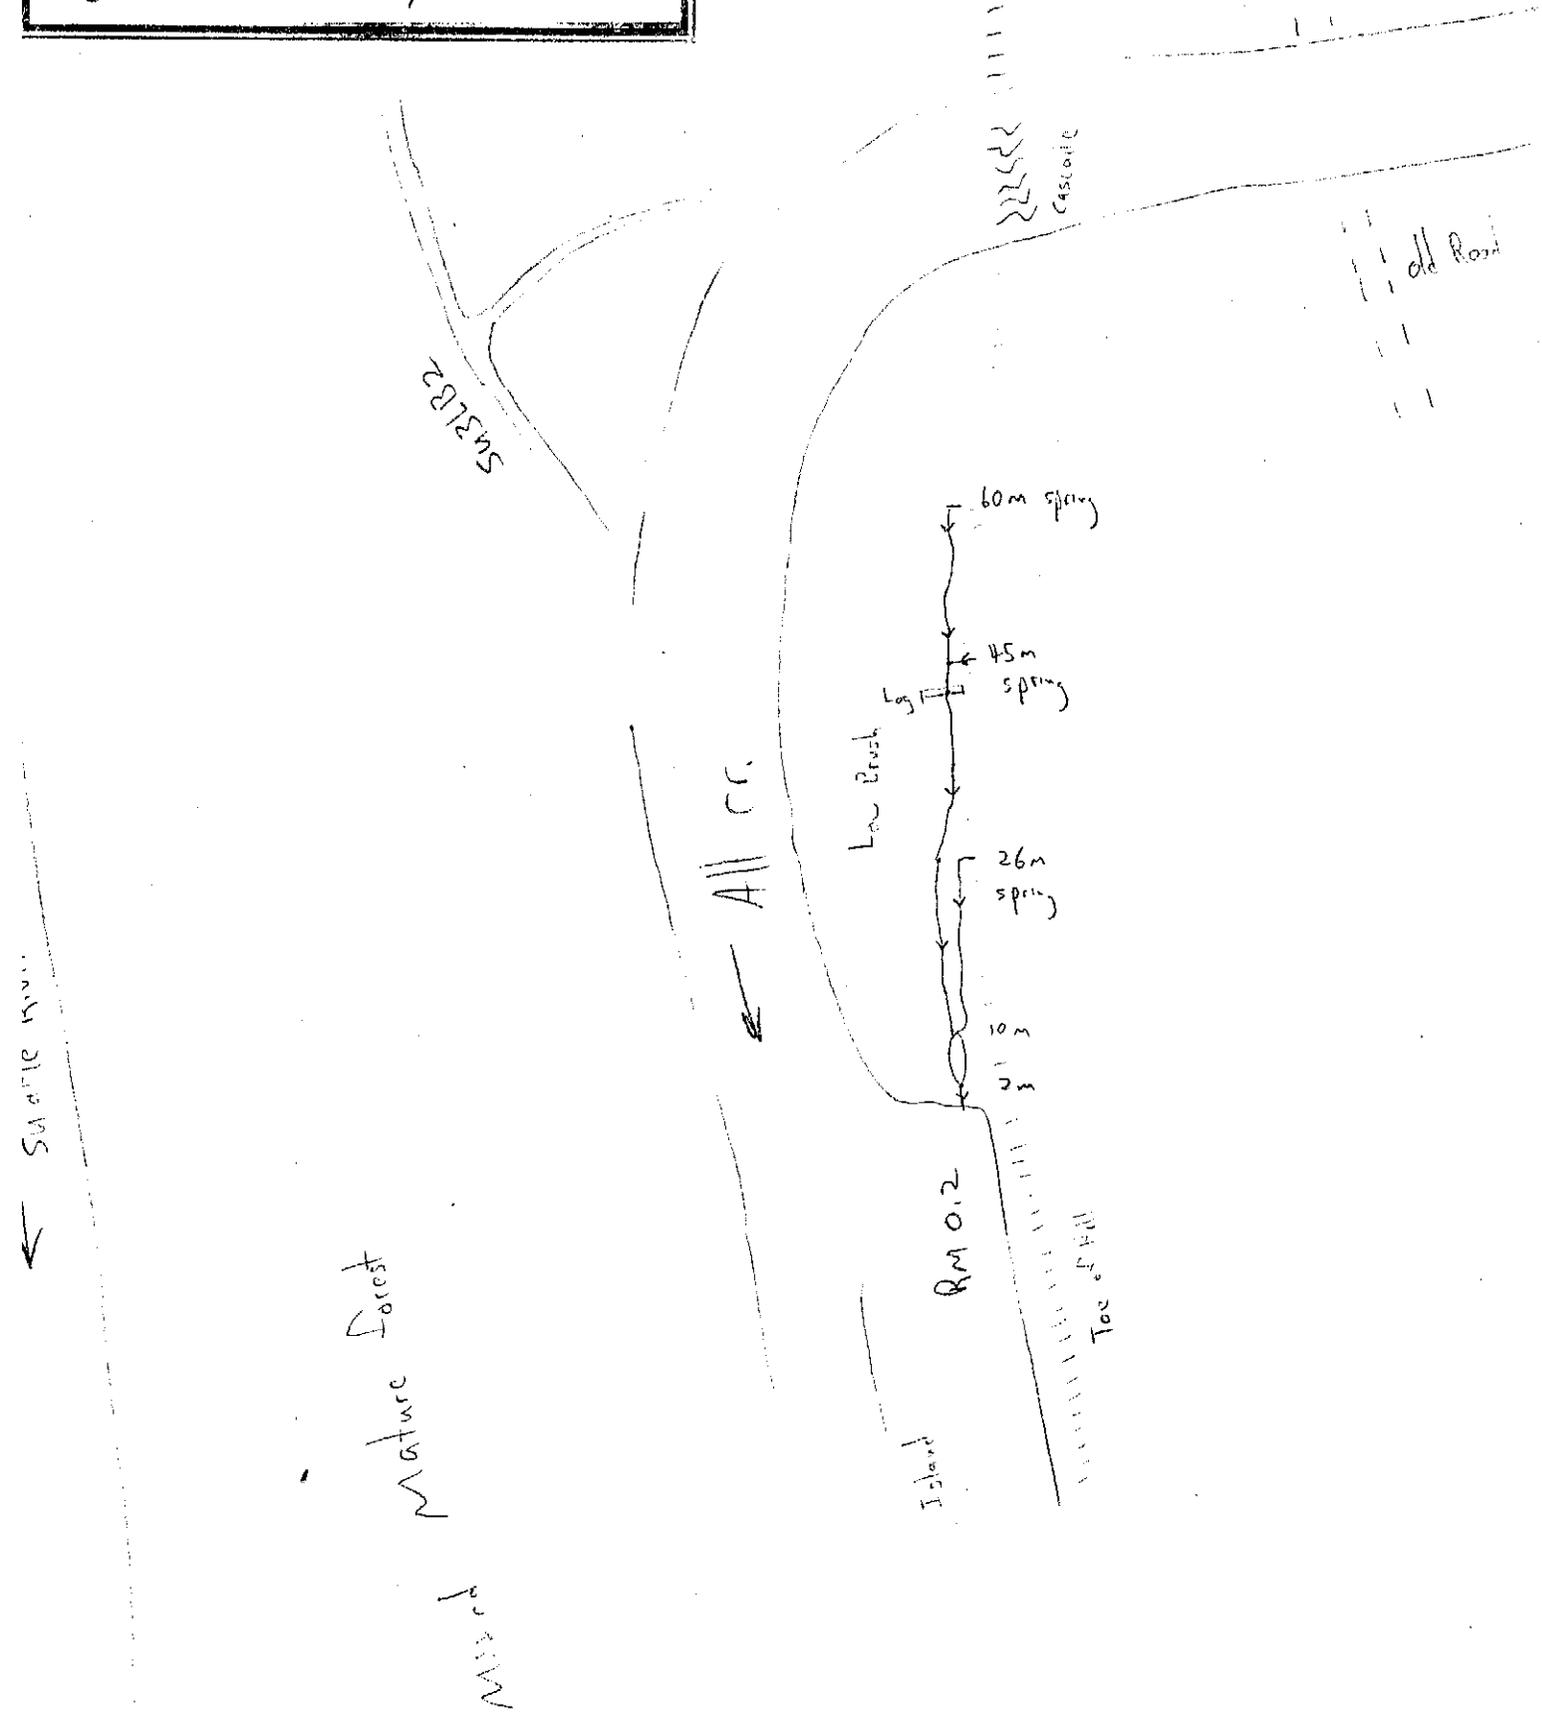
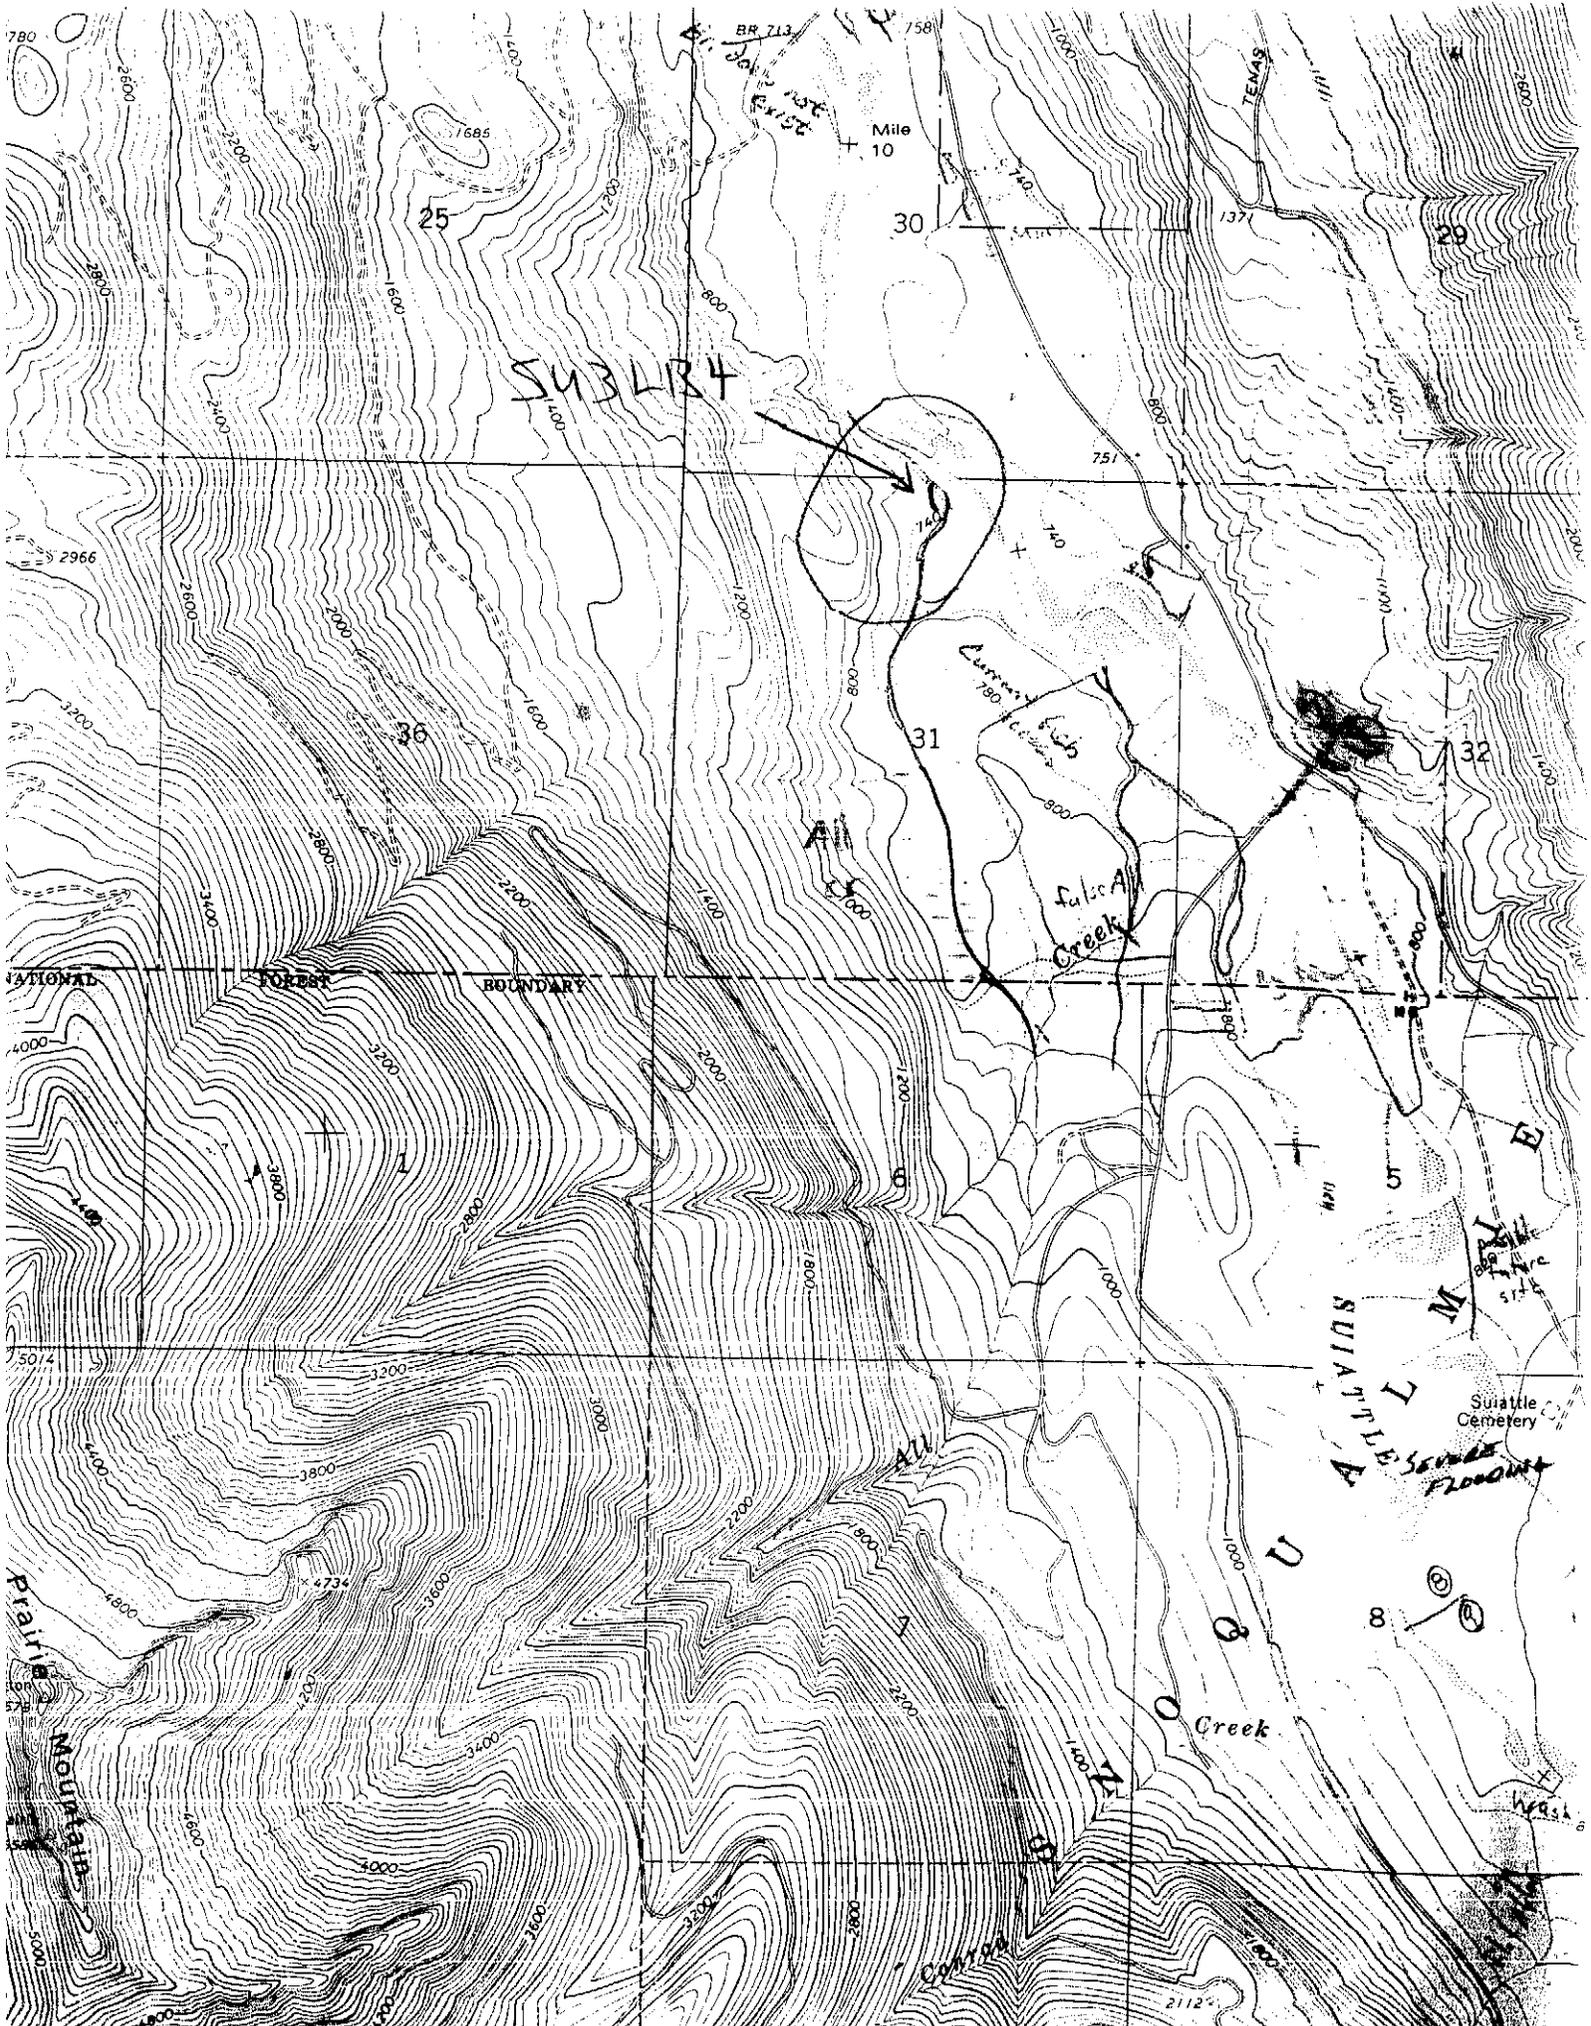
Site id. code: SU3284

Scale: 1" = 20 m.

RM 0.2
NW 1/4

11/4/96 All or springs
0.0 1m Oil CB
2.0 ~~2.0~~ silty Bottom 3
26.0 1m spray a little. More also
2.0m with safe (2/100)
43.0 1m patch good, 1 Bull
patch good to 3
45.0 spring water
60.0 0.5m end
not fluky at all, good water
Cattthroat have been
observed spawning here
Juveniles observed

All or 40°
upper end 44
lower end 44
