**SITE INFORMATION**

**Site Identifier :** SU3RB5 **Landowner Type :**  
**Site Name :** **Landowner Name :**  
**WRIA :** 03.0710X **Address :**  
**Region :** NS **Address2 :**  
**Trib to :** Suiattle R **City :**  
**River Mile :** 8.40 **State :**  
**River System :** Suiattle R **Zipcode :**  
**Legal Description :** NE1/4S24T33NR10E **Phone :**  
**County :** Skagit  
**Habitat Type :**

**Field Survey Information**

**Date :** 12/18/1995 **Observer :** Olis **Survey Type :** initial

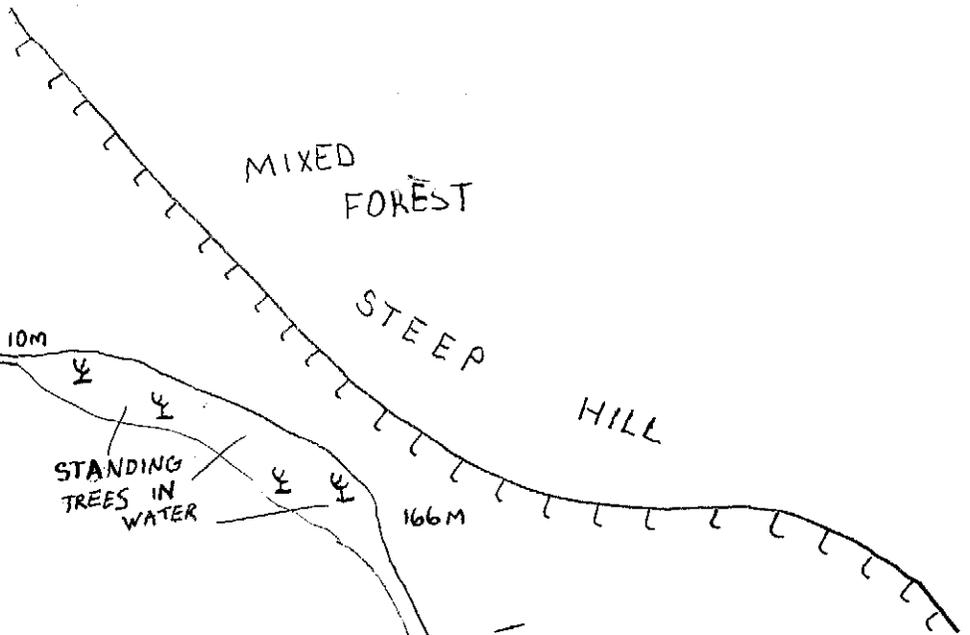
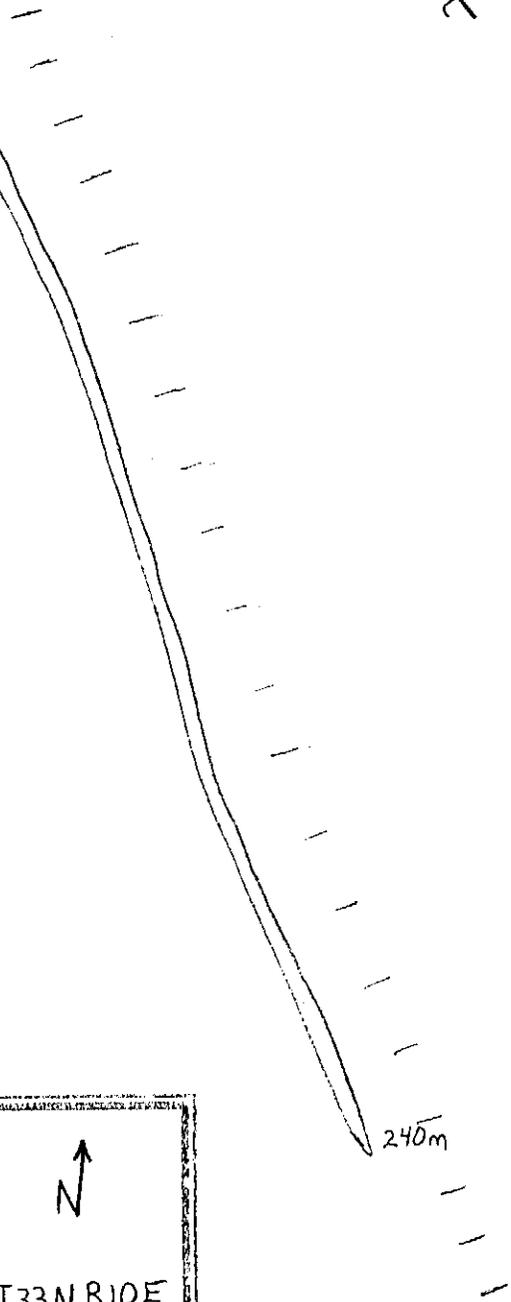
Site id. code: SU3RB5  
Site name:  
Scale: 1" = 25m  
Observer(s): MICHAEL OLIS  
Legal location: NE 1/4 SEC 24 T33N R10E

SUIATTLE

STANDING TREES IN WATER

MIXED FOREST

240m

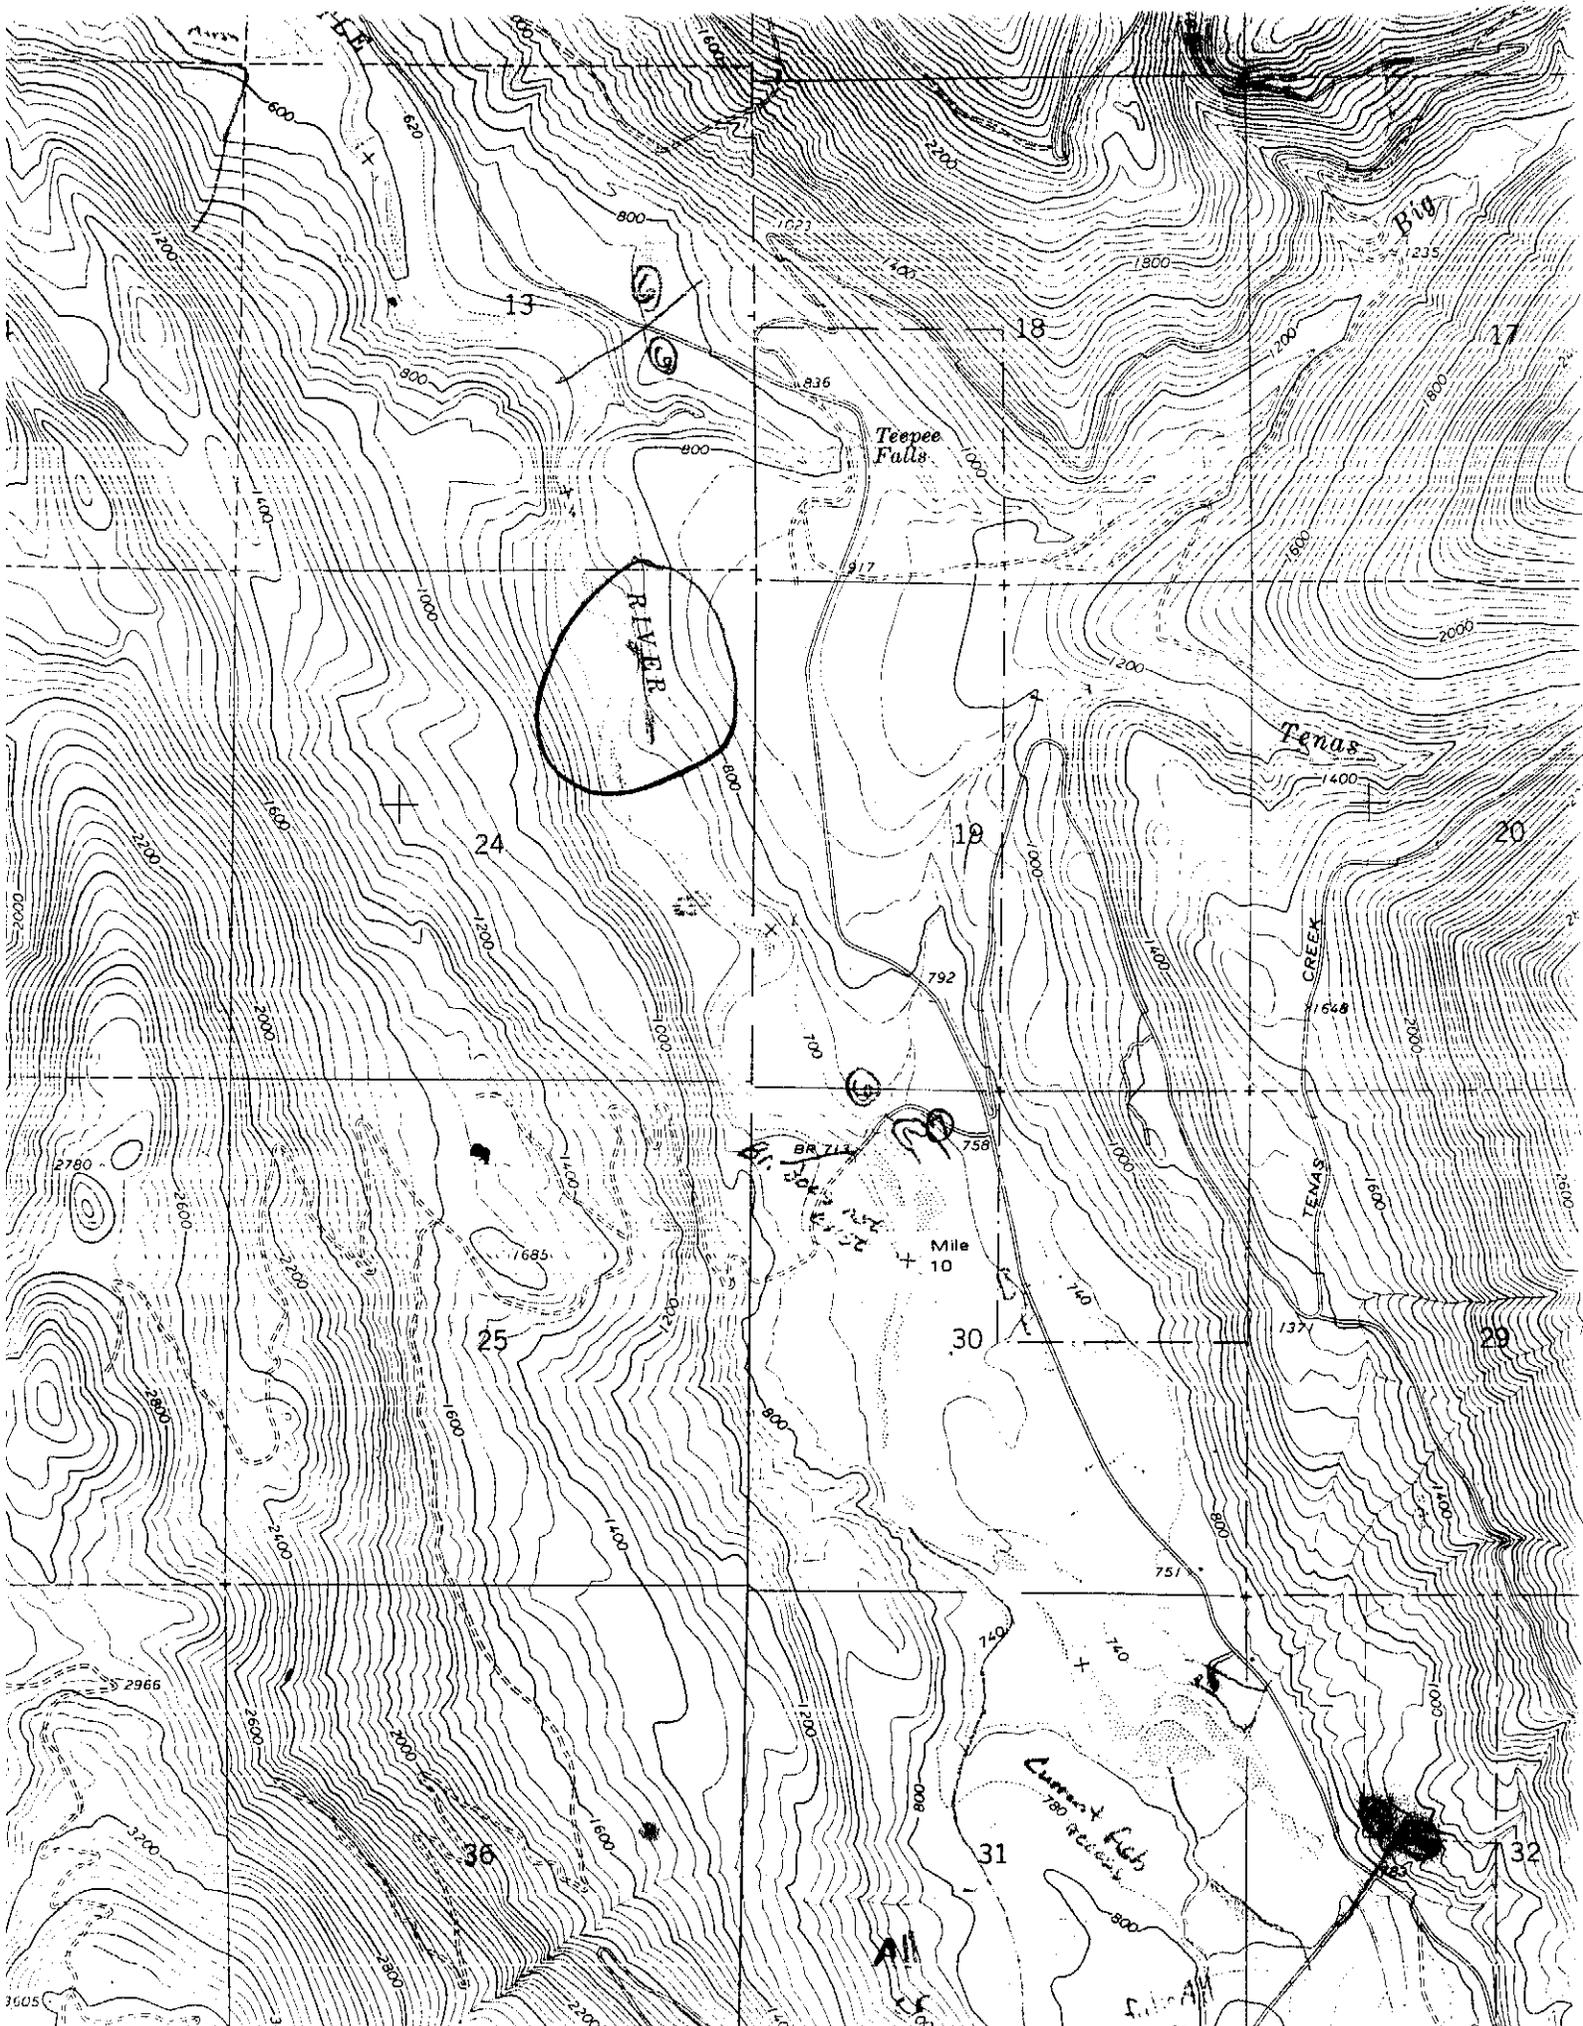
SU3RB5

O.O ENTRY

- NO ADULT ACCESS
- JUV. HAVE FAIR ACCESS
- ACCESS IS LITTERED WITH SILT & DEBRIS
- MOST OF RIVER FLOW IS ON OPPOSITE BANK
- 10m WW .5m RIFF
- SUBSTRATE IS SILTY AND COVERED W/ LEAVES
- THICK W/ BERRY BUSHES

60m WW 10m POOL

- NO APPARENT CHANNEL
- SHALLOW, W/ TREES  
STANDING IN WATER
- THIS AREA MAY  
POSSIBLY DRY OUT  
IN SUMMER

166m WW 2m POOL

- SOME SKUNK CABBAGE  
IN STANDING WATER

240m WW 2m POOL

- END OF FISH ACCESS
- THERE ARE SOME  
ISOLATED POOLS OF  
STANDING WTR AHEAD

- SEEMS TO BE  
- SURFACE & GROUND  
WATER FED
- HAS THE APPEARANCE  
OF BEING <sup>mostly</sup> DRIED  
UP DURING SUMMER
- NO FISH SEEN
- WTR TEMP 44
- SEEMED NOT TO  
BE BOTHERED BY  
RECENT FLOOD EXCEPT  
@ ENTRY AREA

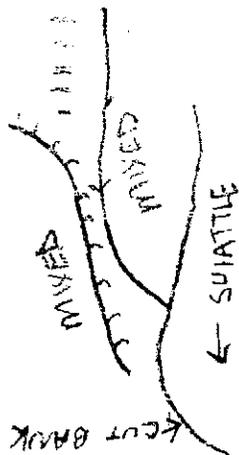
Short stream at toe of a steep hill that most likely becomes isolated from river and partially dried up during summer months.
