SITE INFORMATION

Site Identifier : SU6LB4 **Landowner Type :** Federal
Site Name : **Landowner Name :** USFS
WRIA : 03.0710X **Address :**
Region : NS **Address2 :**
Trib to : Suiattle R **City :**
River Mile : 20.90 **State :**
River System : Suiattle R **Zipcode :**
Legal Description : NW1/4S20T32NR12E **Phone :**
County : Snohomish
Habitat Type : overflow channel

This site consists of two intermittent connected channels that flow across a floody river terrace.

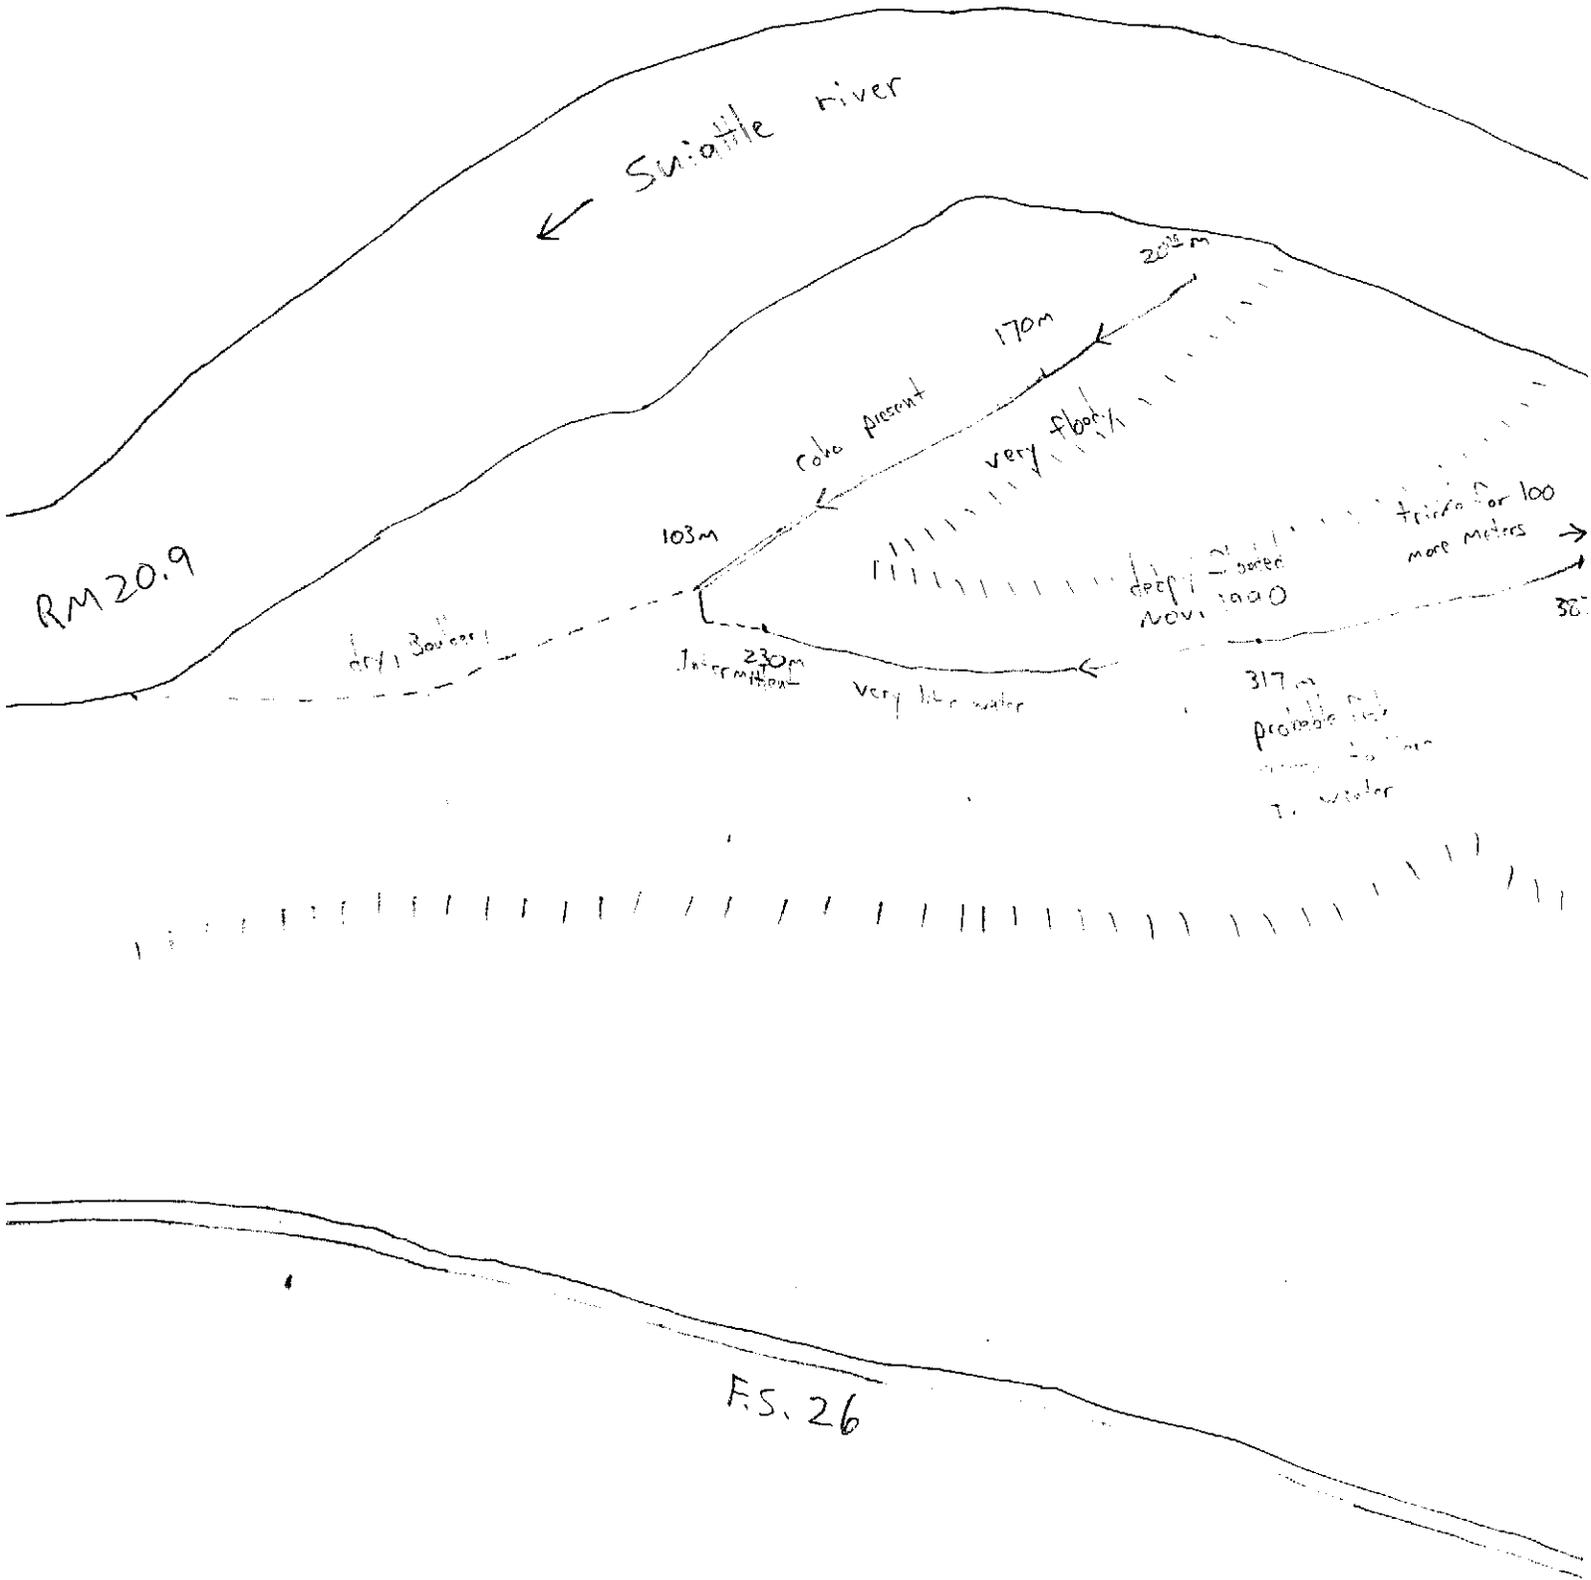
SU₆ LB4

Scale 1" = 33 meters

NW20, T32N, R12E

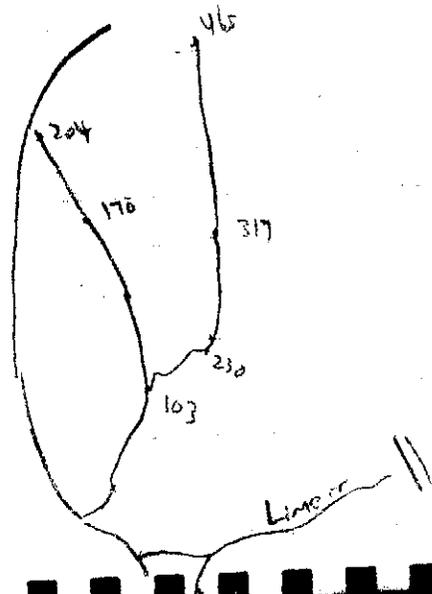
S46 LB4

7/25/95 ch. out above lime cre
0.0 dry ch 8'
103 dry CW 6' ave. at base, water
170^{RO} WW 4', ch 8 rock present
204 WW 1' ch 8 very little water
not active side ch. at present
204 LB.
230 CW 10' some puddles w/ fish
317 CW 3' water
387 WW 6' ch 8 water Building Foot
438 WW 8' ch 12 ch increasing in size
465 WW 2' ch 12 end of water

flood prone site, very little sp.
gravel
