**SITE INFORMATION**

**Site Identifier :** SU7LB4 **Landowner Type :** Federal  
**Site Name :** Yew Channel **Landowner Name :** USFS  
**WRIA :** 03.0710X **Address :**  
**Region :** NS **Address2 :**  
**Trib to :** Suiattle R **City :**  
**River Mile :** 25.00 **State :**  
**River System :** Suiattle R **Zipcode :**  
**Legal Description :** NE1\4S23T32NR12E **Phone :**  
**County :** Snohomish  
**Habitat Type :**

This is a very short, narrow channel along a bedrock toe. The bench is very flood prone and in danger of becoming the main river channel. A large log jam at the upstream end is protecting the bench.

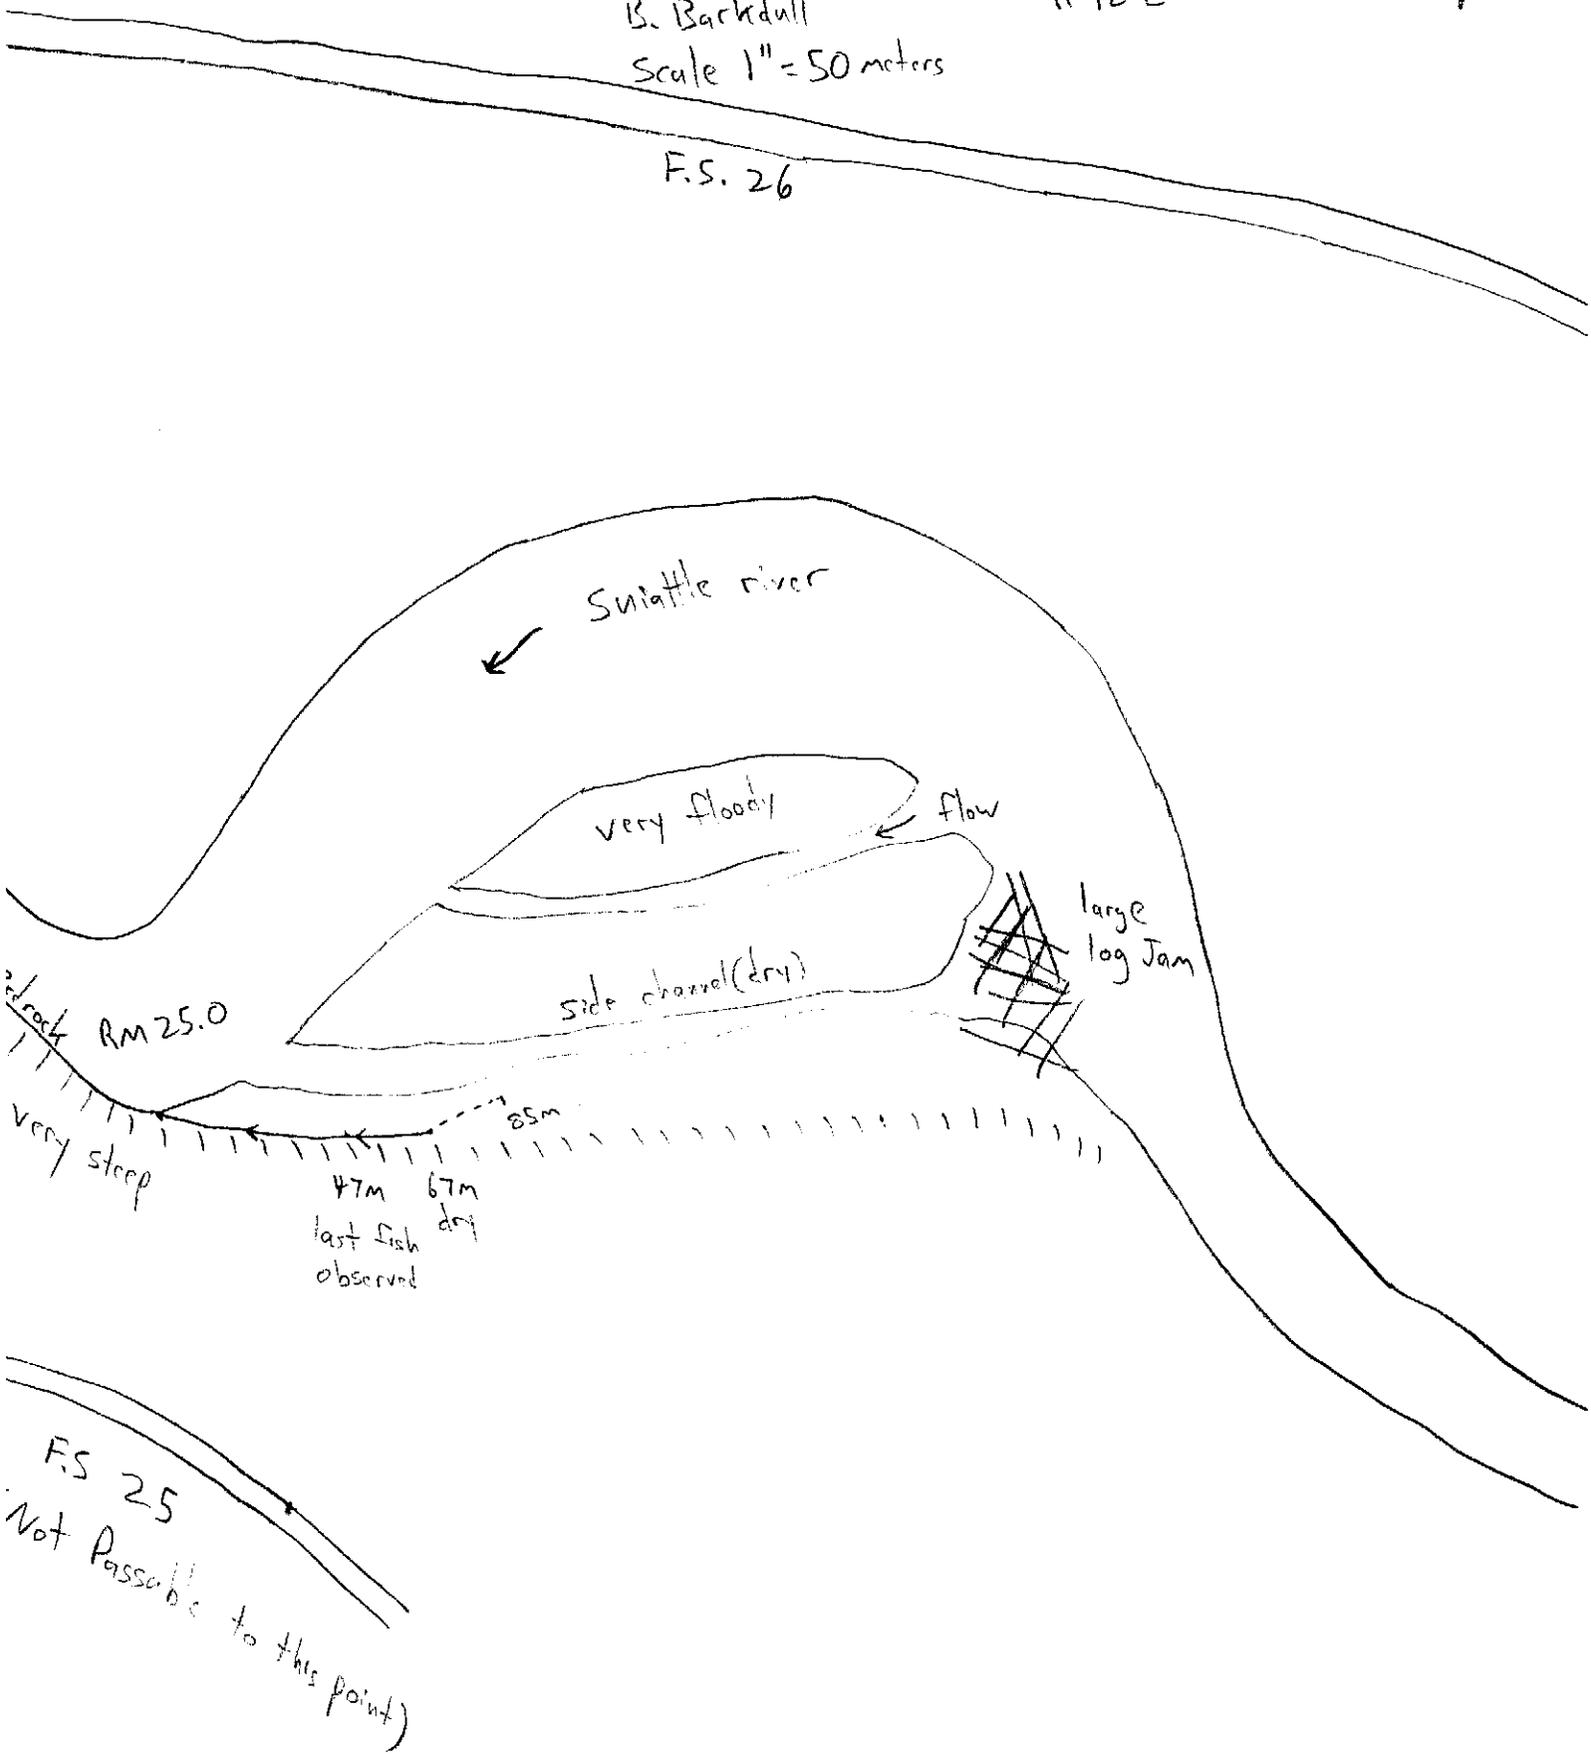
New channel

SW 7 LB4

8/2/95

Scale 1" = 50 meters

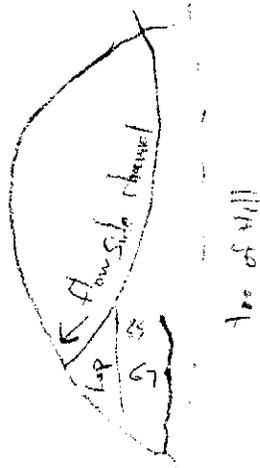
Yew channel

8/19/95 You ch. zone LB - 200 ft  
0.0 ww 1' Behind LB, deep cut  
47.0 ww 1.5' ch 3' vertical cut  
67. ww 1.0 ch 3' end of flow  
85 ch 3.0 end of channel
