# Olympic Wildlife Area Fish Retrofit

Habitat Program  
Salmonid Screening, Habitat Enhancement  
and Restoration (SSHEAR) Division

March 2000

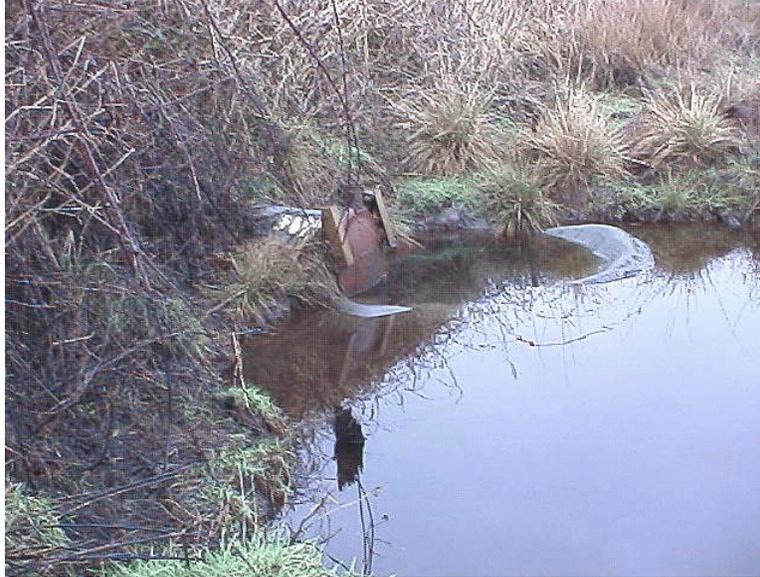
**Olympic Wildlife Area / Elk River Unit / Site 980235**

**Photo 1.** Breaching the dike at the Elk River Unit created excellent estuary habitat, but the solid plate steel tide gates create a near total fish passage barrier to additional rearing habitat.

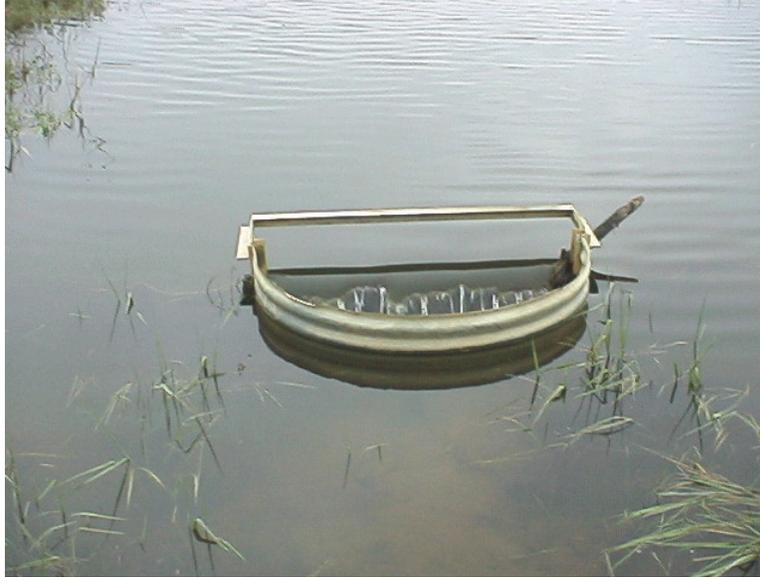
**Olympic Wildlife Area / Hoxit Unit / Site 980299**

**Photo 2.** Unnamed tributary to the Chehalis River. This stand pipe was installed to increase water fowl habitat, creating a total barrier to potential rearing and spawning habitat further upstream on the system.

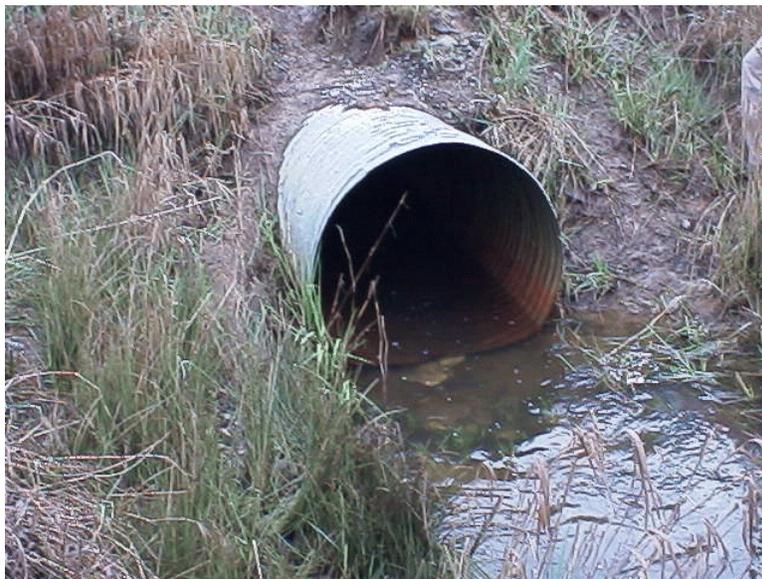
**Photo 3.** Judging by the size of the corrugated steel pipe and the streambed toe width downstream, if the stand pipe configuration were made to be passable and maintain water levels (i.e. fishway) this crossing would be sufficient.

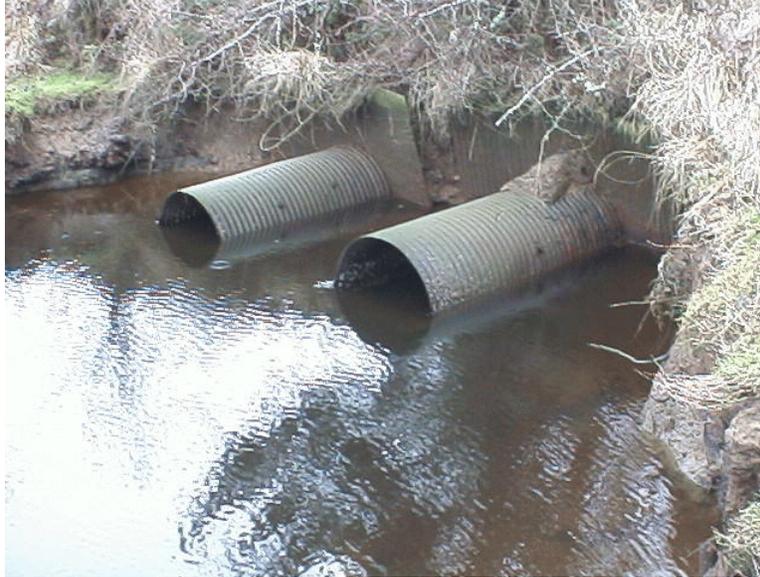
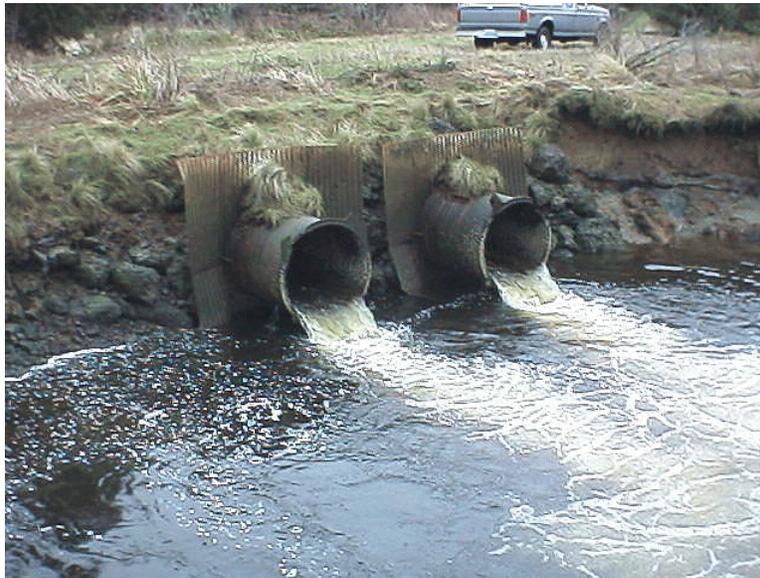
**Olympic Wildlife Area / John's River Unit / Site 980259**

**Photos 4 & 5 .** Beaver Creek (WRIA 22.1271), tributary to John's River. The top photo illustrates the intense erosion that is occurring at the upstream end due to the large tidal fluctuations. The bottom photo illustrates the large outfall drop at any tide level other than high tide and therefore a large plunge pool was created.

The culverts on Beaver Creek (Site 980259, Photos 4 & 5), a tributary to John's River, were originally built with tide gates. Over time, the natural corrosion affects of salt water caused the gates to become inoperable and they were eventually removed. Removing the tide gates took care of part of the fish passage problem, but it did not make the crossing 100% passable. The culverts are still substantially undersized for the velocity of flow caused by tidal fluctuations that occur close to the bay. In order to provide complete passability at all times, the culverts would need to be removed. This would allow for chinook, chum, coho steelhead and resident salmonids to access the additional 1,459 square meters of spawning and 41,886 square meters of rearing habitat upstream of this site. If the crossing is absolutely necessary for access to certain areas of the property, a large squaspipe could be used. Cost is estimated at \$100,000

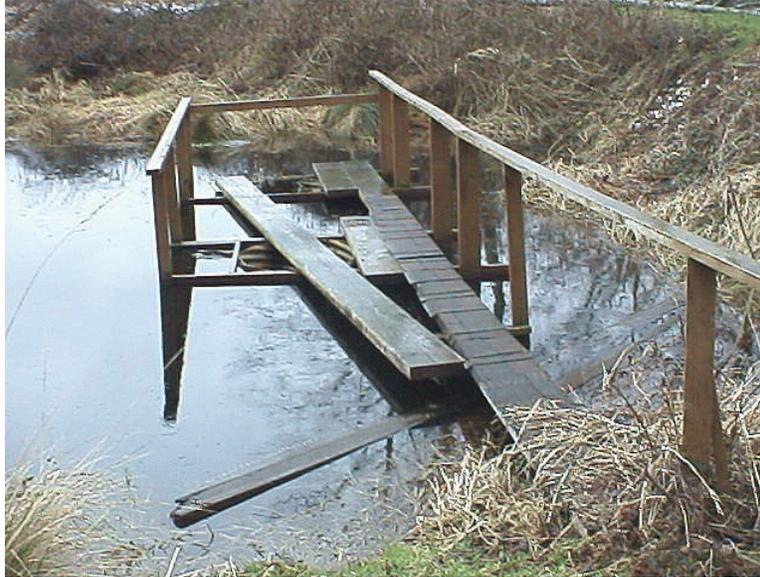
**Olympic Wildlife Area / John's River Unit / Site 980260**

**Photo 6.** The upstream end of double stand pipes installed to maintain increased water levels. The large wetland area upstream of this site was created by building a large dike to improve water fowl habitat. This created a total barrier to additional rearing habitat vital for salmonid survival.

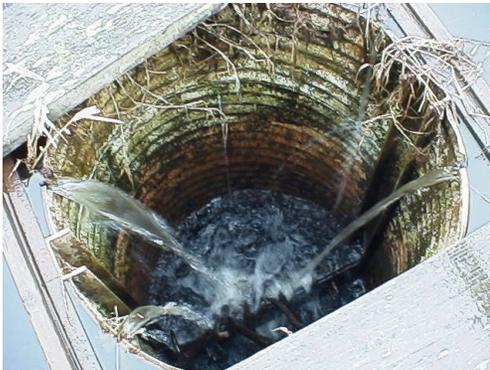
**Photo 7.** View looking down inside one of the Upstream end stand pipes.

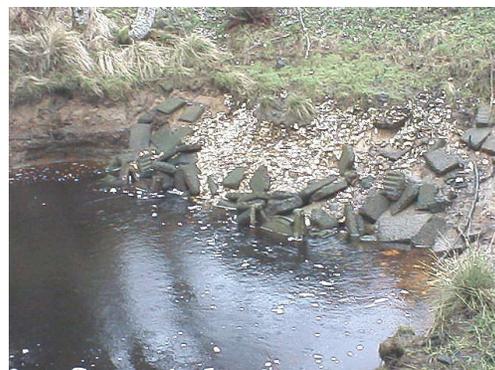
**Photo 8 .** The tide gates on the downstream end add to the fish passage barrier.

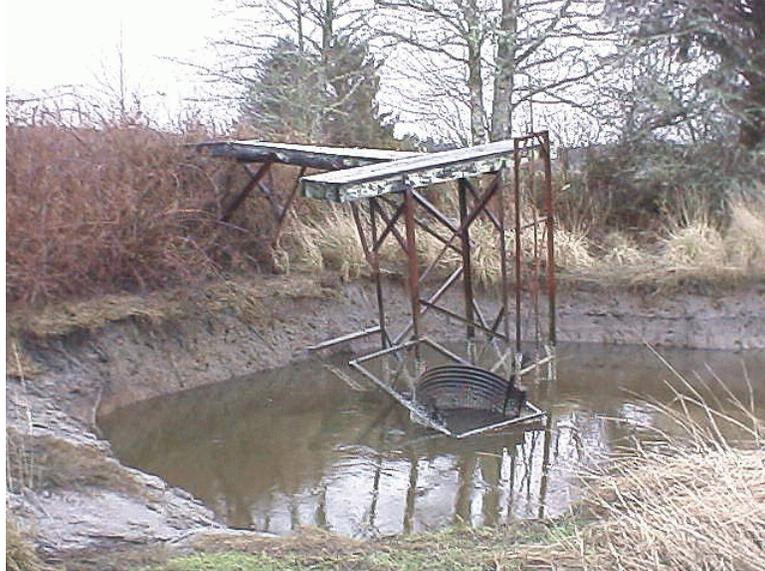
## Olympic Wildlife Area / John's River Unit / Site 980262

**Photo 9.** Unnamed tributary to John's River. The upstream stand pipe structure is failing due to intense tidal fluctuations. The dike is slowly being eroded away. Currently, this crossing is scheduled to be removed and another tidal control structure is to be installed that is passable to fish, at a different location on the dike.

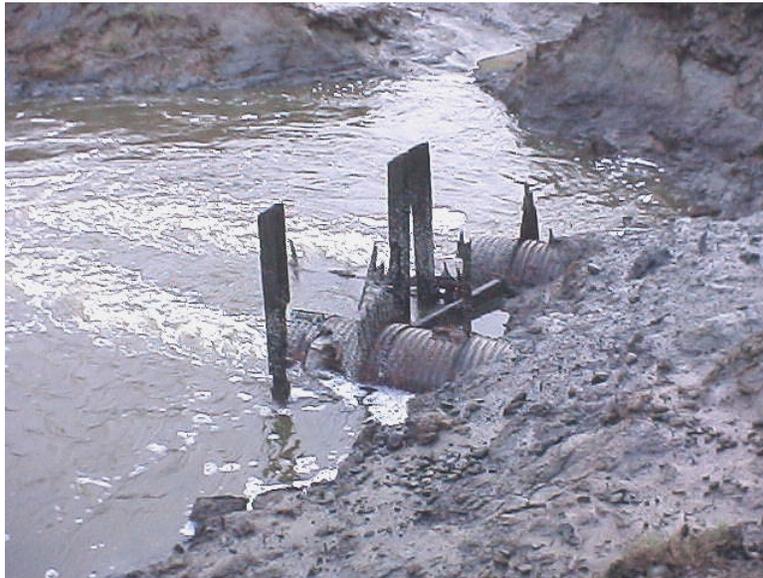
**Photo 10.** The downstream end currently has large tide gates to keep out salt water for crop cultivation and increasing waterfowl habitat. The existing tide gates are currently failing, and therefore another reason for replacement.

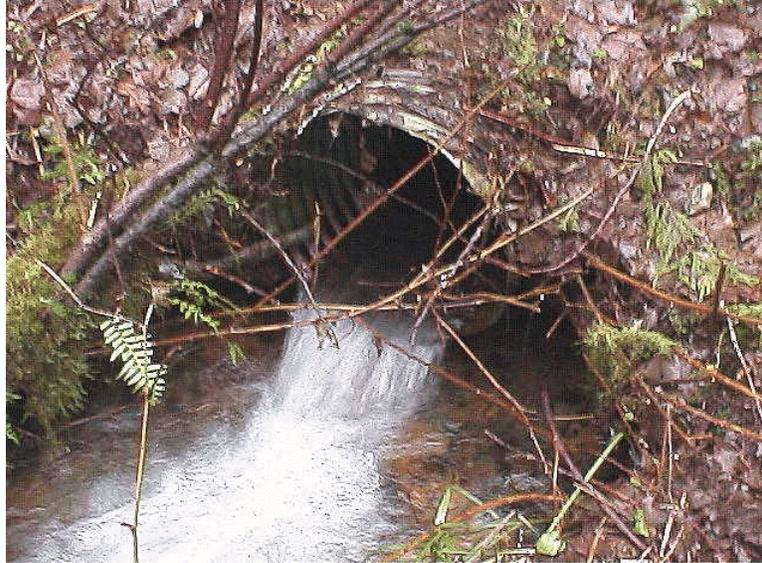
**Olympic Wildlife Area / Olympic Unit / Site 980233**

**Photo 11.** Due to the culvert being undersized and the slope greater than 1%, velocities render this crossing a partial barrier.

The Olympic Unit, covering over 1500 acres, contains numerous stream systems that cross WDFW property. Of the nine fish bearing culverts inventoried, only one crossing warrants repair. The road crossing at site 980233 (Photo 11) has very little fill and the culvert is relatively small in size. Setting in a larger culvert at the correct elevations would provide for increased resident fish migration to and from the 139 square meters of spawning and 313 square meters of rearing habitat. The cost for site 980233 is estimated at \$10,000.

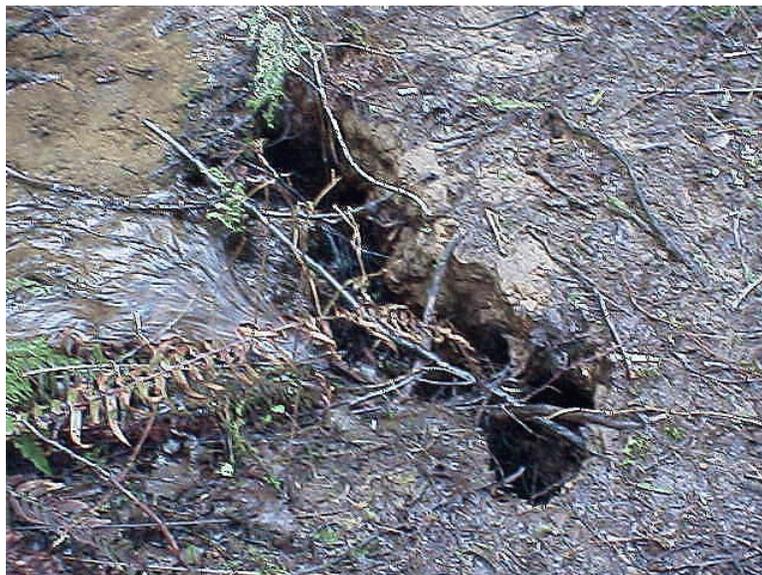
**Olympic Wildlife Area / Smith Creek / Site 980284**

**Photo 12 .** Unnamed tributary to Smith Creek. A perfect example of culverts that are abandoned on salmonid bearing streams. The upstream end has become completely inundated with debris, causing the stream to flow over the road and then erode back down through the road bed creating a total barrier to fish passage.

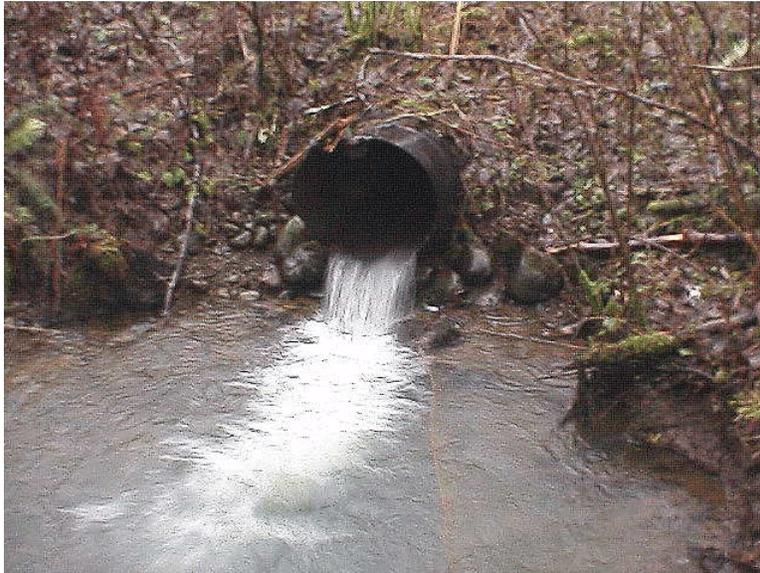
**Olympic Wildlife Area / Wynoochee Unit / Site 980240**

**Photo 13.** Unnamed tributary to the Wynoochee River. This round corrugated steel culvert is a good example of a undersized pipe causing an outfall drop and deep plunge pool to develop.

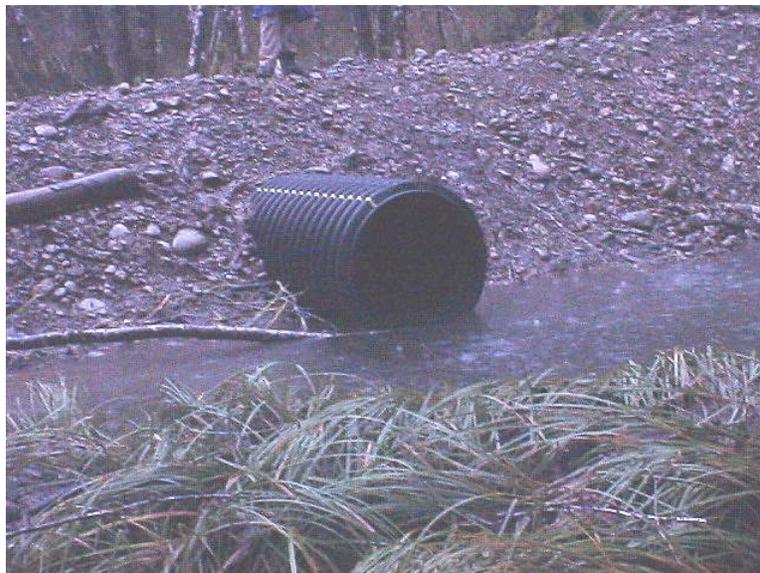
**Olympic Wildlife Area / Wynoochee Unit / Site 980244**

**Photo 14.** Another unnamed tributary to the Wynoochee River. Primarily slope alone made this polyethylene pipe a partial barrier to fish passage.

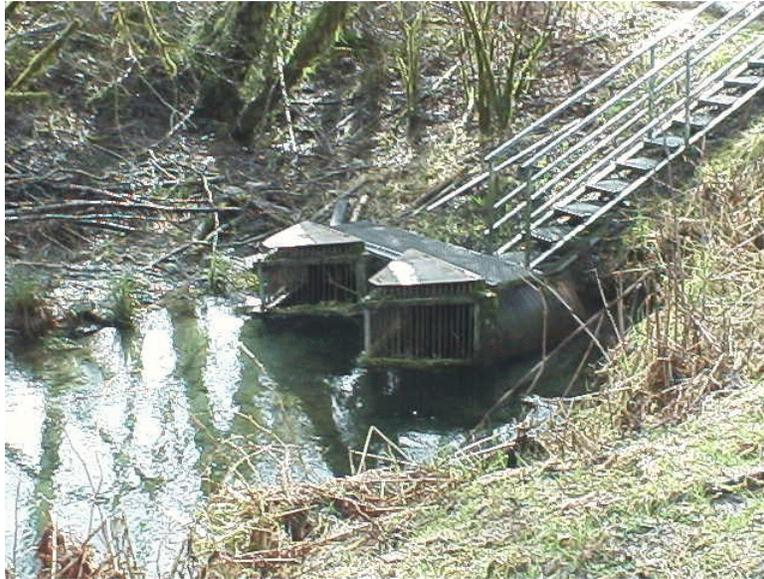
## Region 6 Access Areas / Bogachiel Rearing Pond Access / Site 980294

**Photo 15.** The trash racks at the upstream end of the culverts pose no immediate threat to fish passage. Although twin culverts are used at the crossing, they were considered to be undersized and therefore creating a high velocity problem at periods of increased flow. These culverts are located on the same stream as the Bogachiel rearing pond. The outlet of the pond is screened for hatchery purposes constituting a barrier to upstream migration.

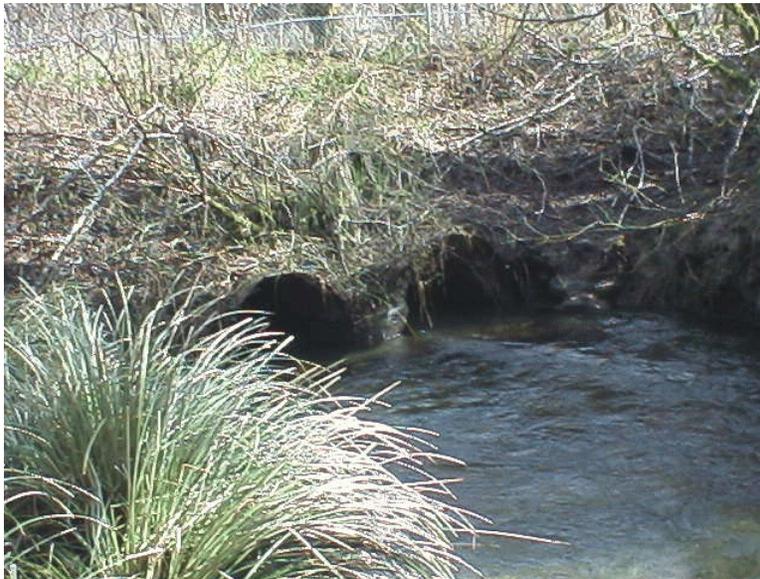
**Photo 16.** The downstream end of the same crossing illustrating plunge pool size created at high flows.

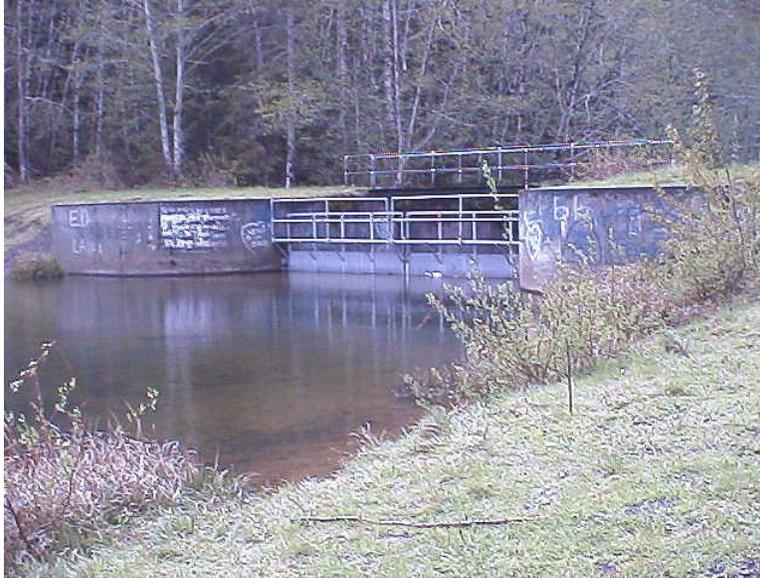
## Region 6 Access Areas / Failor Lake / Site 980317

**Photo 17.** Failor Lake on Deep Creek (WRIA 22.0021) was built by the City of Hoquiam for water storage. Note the existing fish screen to retain fish in the lake.

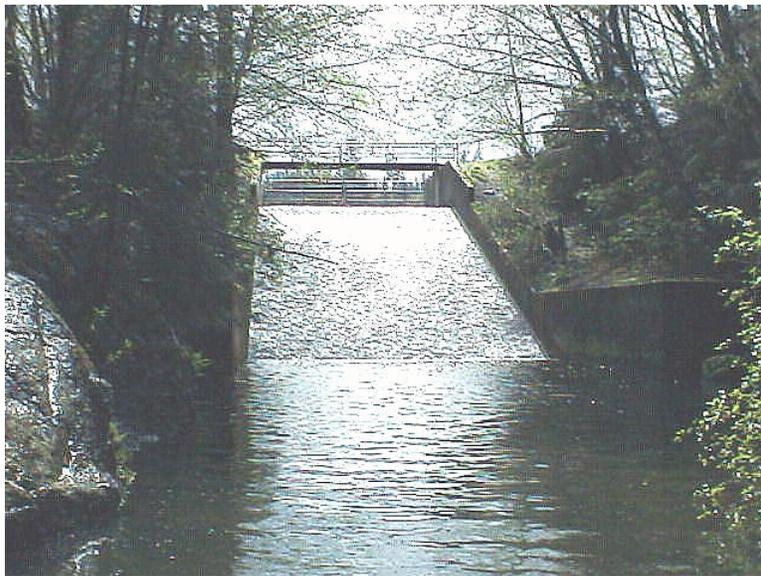
**Photo 18.** Looking upstream at the spillway from the tailrace of the dam. An obvious barrier to fish migration.

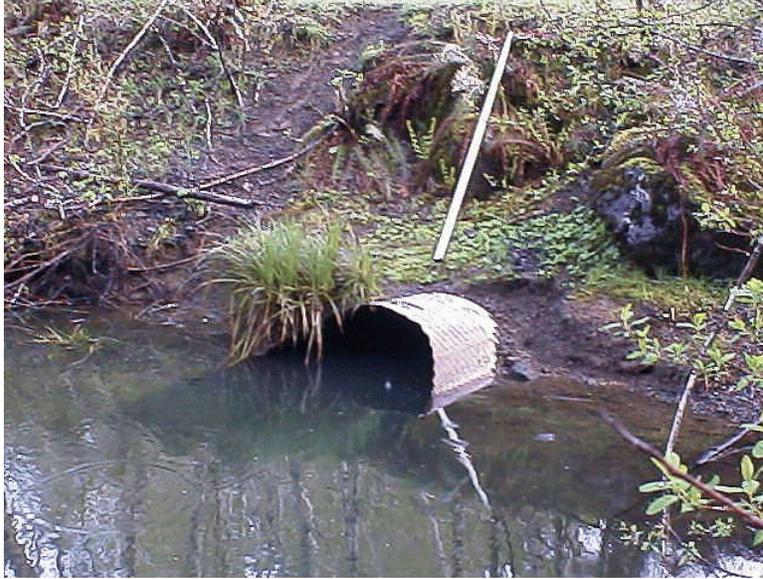
## Region 6 Access Areas / Failor lake / Site 980335

**Photo 19.** Deep Creek (WRIA 22.0021) at the inlet to Failor lake. This crossing is the only fish bearing culvert with significant habitat gain upstream located on the WDFW access area property at Failor Lake. Though it looks completely fine for fish passage, the 40 by 60 foot plunge pool downstream is evidence of velocities exceeding the capacity of the culvert, creating a partial barrier.

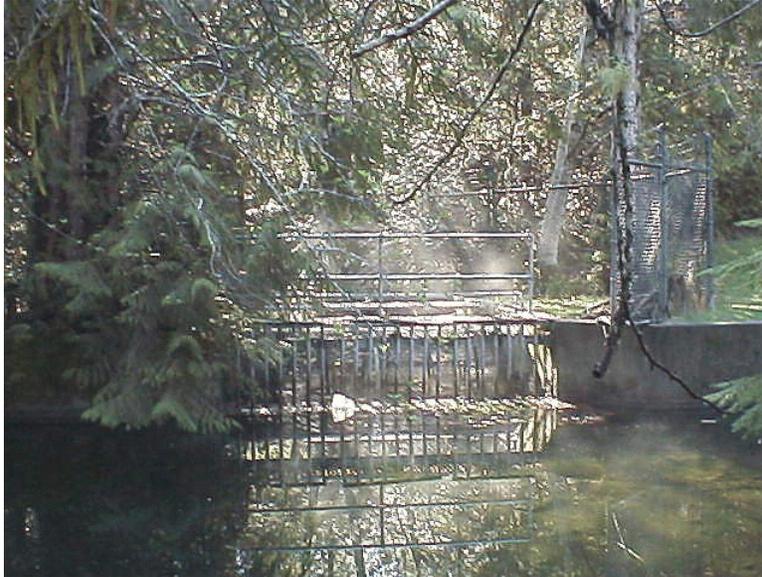
## Region 6 Access Areas / Haven Lake / 980316

**Photo 20.** Unnamed tributary (WRIA 15.0461) to the Tahuya River. Looking downstream from the forebay at the original trash-rack on the barrier lake screen structure.

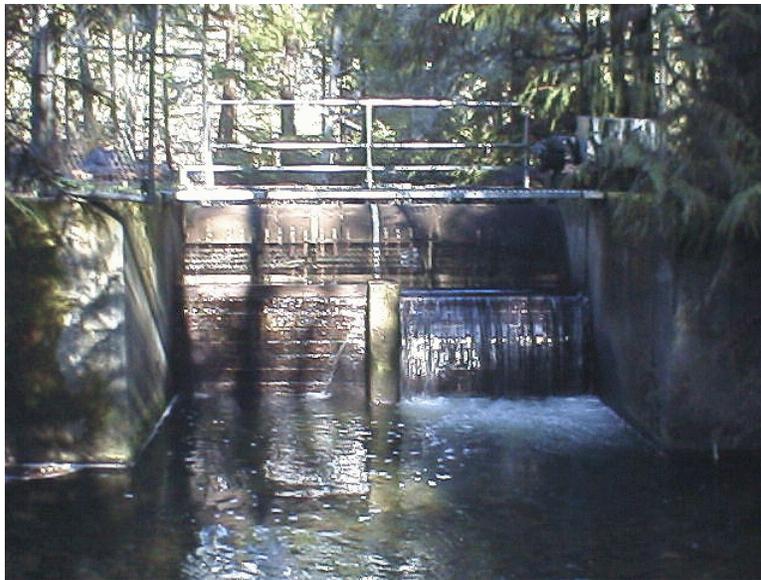
**Photo 21.** The lake screen retains fish in Haven Lake, but at the same time created a total barrier to upstream fish migration. View looking upstream from tailrace of original structure.
