WRIA 40 DIVERSION SCREENING AND FISH PASSAGE INVENTORY REPORT

Submitted by:
Tammy Schmidt
Washington Department of Fish and Wildlife
Habitat Program; Technical Applications Division
Olympia, Washington

November 16, 2006

Diversion Screening and Fish Passage Inventory Report for Colockum Creek, Stemilt Creek and Squilchuck Creek

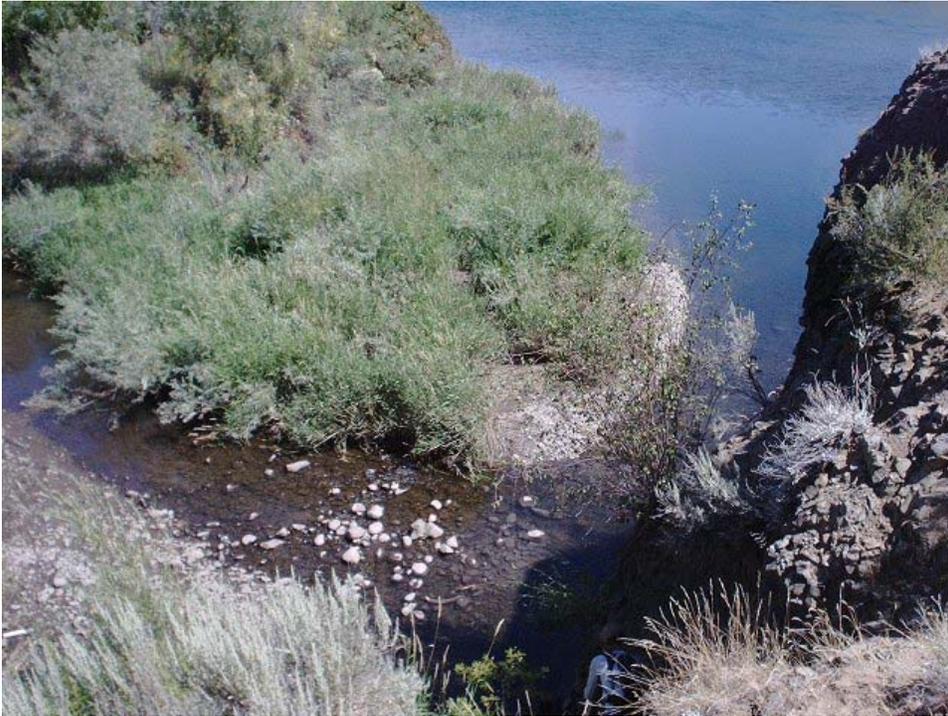
Figure 5. The mouth of Colockum Creek is an unobstructed, low gradient, sinuous channel. Abundant juvenile salmonids were observed in the lower 1,000 m.

The mouth of Colockum Creek is a sinuous, low gradient alluvial fan bordered by brushy understory riparian species (Fig. 5). Several large-scale suckers and numerous juvenile salmonids were observed at the confluence. Two hundred meters upstream, the canyon walls are more confined and canopy cover increases. Numerous trout/salmonids, ½” to 4” in length, were observed in pools and riffles. Chinook rearing occurs in the lower reaches of Colockum Creek downstream of the bridge on Tarpiscan Road for approximately 1,000 m to the confluence with the Columbia River.

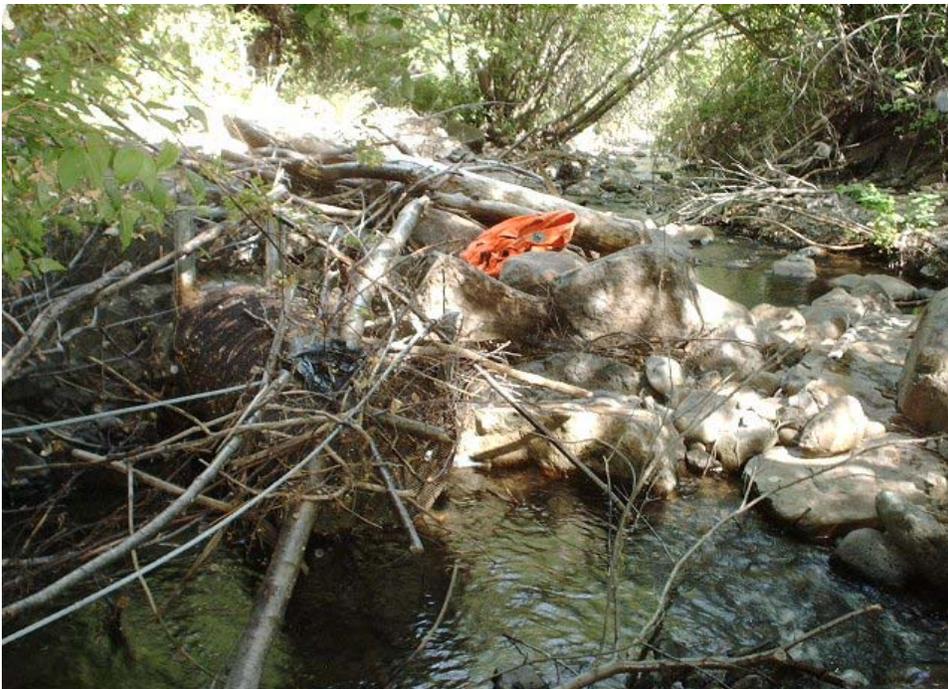
Figure 6. Site 960384, a boulder dam and gravity diversion on Colockum Creek impedes fish passage and lacks proper screening.

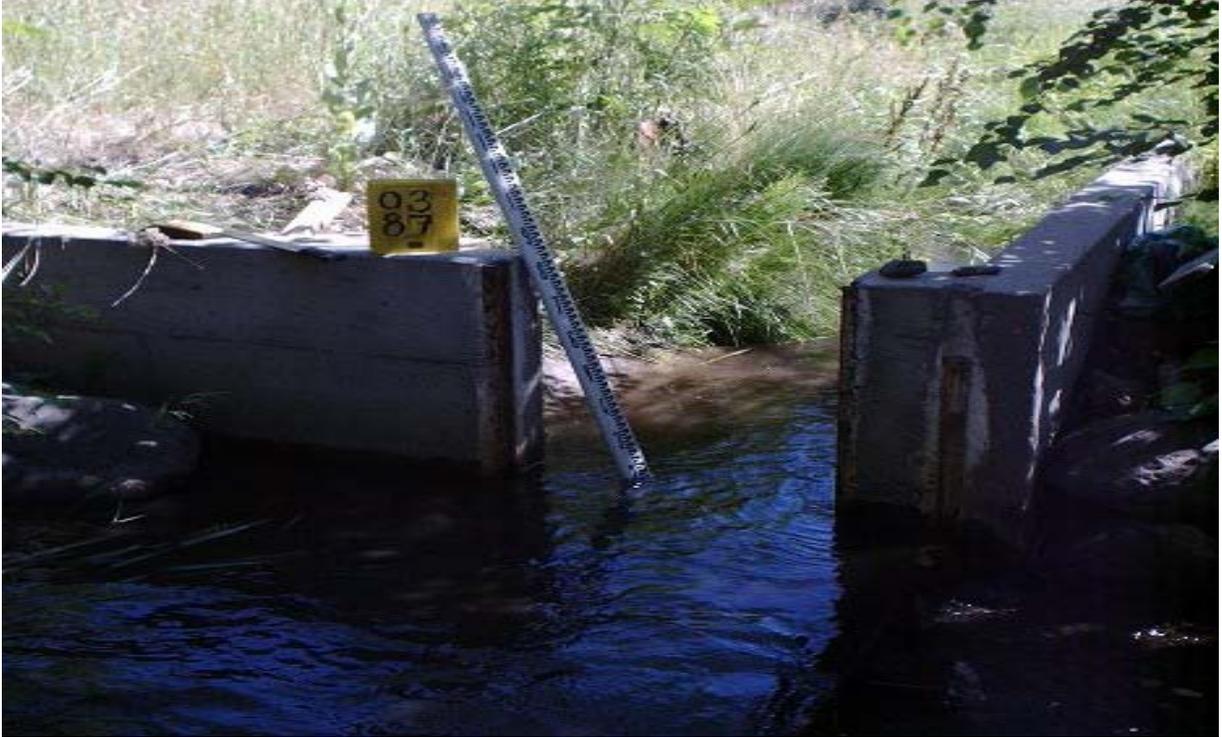
Figure 7. This noncompliant gravity diversion (960387) on Colockum Creek lacks a fish bypass screen. This site received the highest priority rankings for passage (23.47) and screening (7.42).

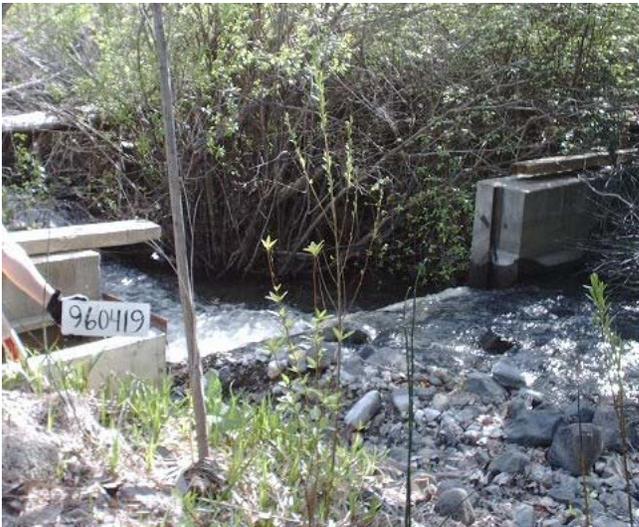
Figure 8. The first barrier (960419) on Stemilt Creek is impassable due to a 1.4 m hydraulic drop over the spillway.

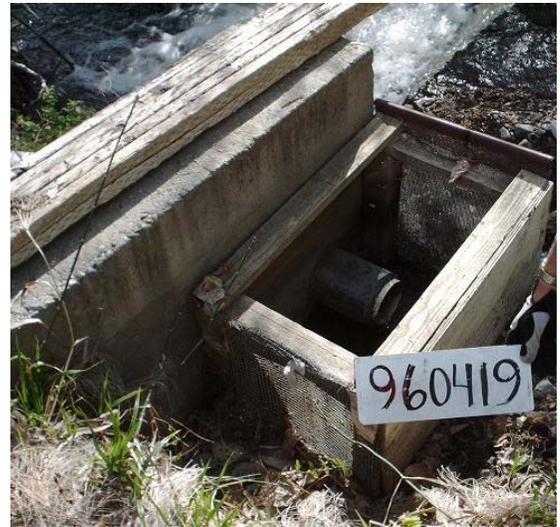
Figure 9. This improperly screened diversion intake (960419) fails to prevent mortality of juvenile salmonids.

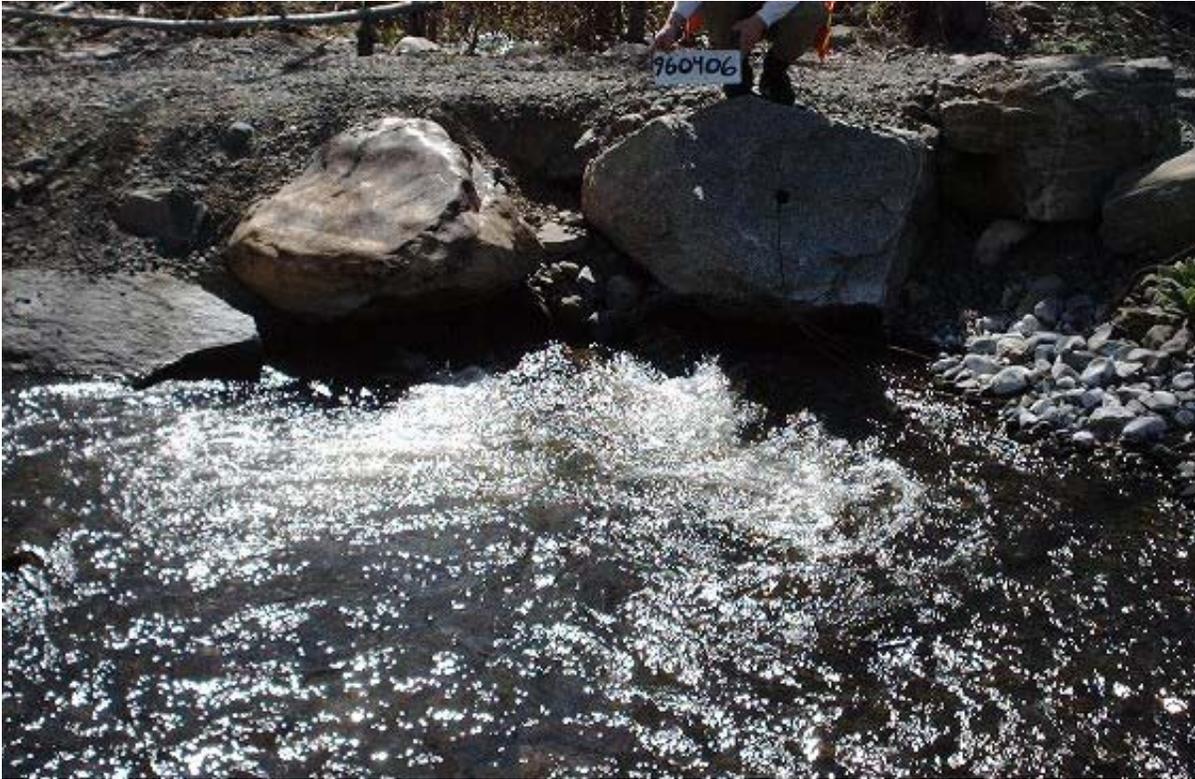
Figure 10. Four undersized 0.26 m smooth steel pipes (960406) block fish passage and promote bank erosion during high flow events. Stemilt Creek flows over this private access road for several weeks during spring runoff.

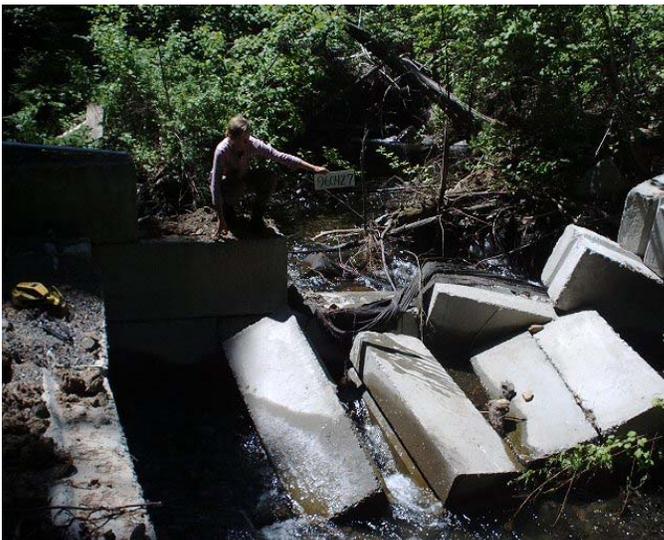
Figure 11. This ecology block dam (960427) for the Clear Lake diversion on Stemilt Creek blew out during high flow runoff in 2006. A concrete dam will replace the current structure and allow for fish passage.

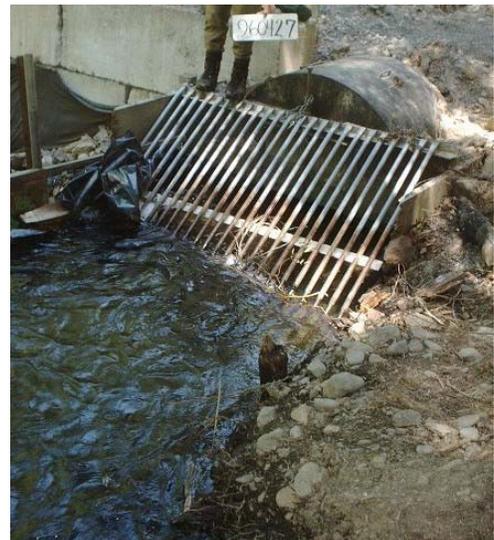
Figure 12. The diversion (960427) associated with the previous photo will have a fish bypass screen installed prior to the 2007 irrigation season.

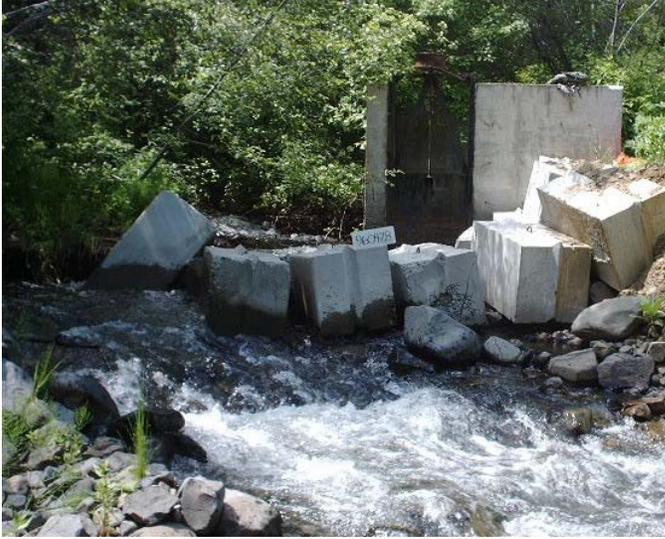
Figure 13. This dam and diversion (960428) for Lily Lake located on Stemilt Creek also blew out during the 2006 runoff event. A concrete dam with a fish bypass screen will replace this structure.

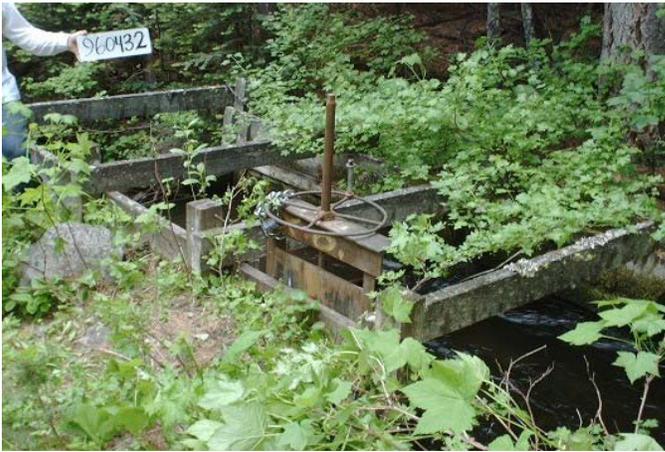
Figure 15. This wooden dam and diversion structure (960432) on Little Stemilt Creek lacks a fish bypass screen and blocks passage due to a 0.8 m outfall drop at the spillway. Several other diversions in the watershed were constructed similarly. One such site inadvertently provides spawning habitat within the structure.

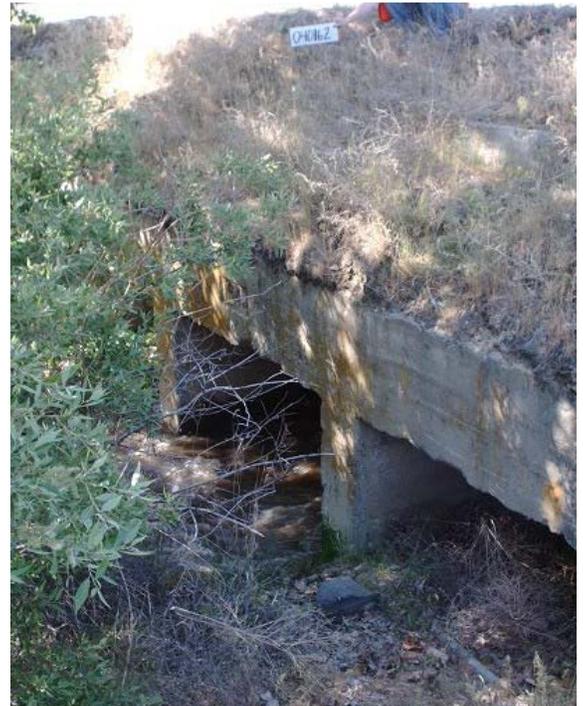
One hundred twenty-five features were inventoried in the Squilchuck watershed. The first encountered barrier on Squilchuck Creek is culvert 040162 located under the railroad yard 133 m upstream of the mouth (Fig. 16). Although this three-celled box culvert is 117 m long, the 1% slope barely fails criteria. Two of the three cells are bed loaded to the extent that no flow enters. The center cell takes all flow and; consequently, is likely to be a velocity barrier. Removing material from the outer two cells may allow the culvert to function as designed. This site received the fourth highest priority index value due to being evaluated as 67% passable.

Figure 16. This box culvert (040162) located under the railroad yard on Squilchuck Creek is a partial barrier due to excessive slope. Two of three cells are obstructed with vegetation and debris.

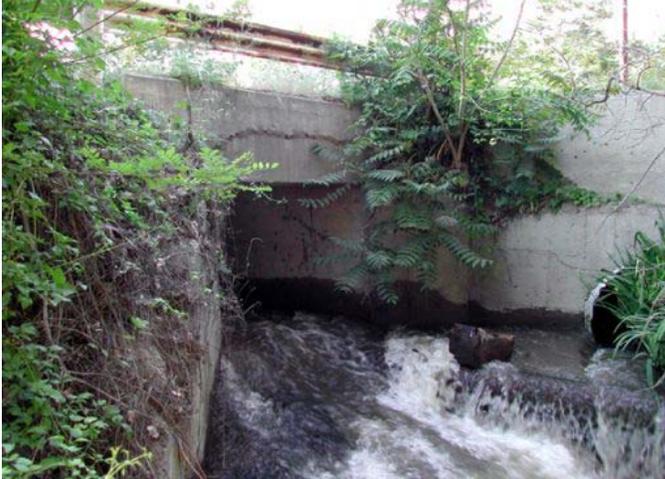
The largest potential habitat gain for salmonids exists upstream of site 970003, a total barrier culvert under S. Wenatchee Avenue (Fig. 17). Correction of this site could open 35,652 m² of rearing habitat and 9,705 m² of spawning habitat for salmonids. WDFW staff observed large numbers of chinook and steelhead juveniles as well as a few coho juveniles within the reach between these two sites. Additionally, three privately owned, six county-owned and five barrier culverts with unknown ownership exist on mainstem Squilchuck Creek.

Figure 17. This 3.0 m wide box culvert (970003) under S. Wenatchee Ave on Squilchuck Creek is a total barrier to chinook, steelhead, coho and resident rainbow/cutthroat trout and received the highest priority ranking.

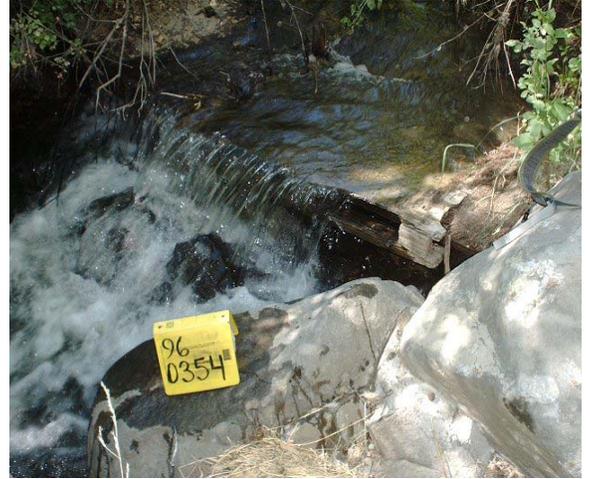
The second largest potential habitat gain for Squilchuck Creek occurs at site 960354; a broken pallet footbridge causing an excessive hydraulic drop that partially blocks all species (Fig. 18). Easy removal of this site could restore access to 34,849 m² of rearing habitat and 9,638 m² of spawning habitat.

Figure 18. A collapsed footbridge crossing (960354) now creates a passage barrier on Squilchuck Creek. This site is one of several debris-causing blockages.

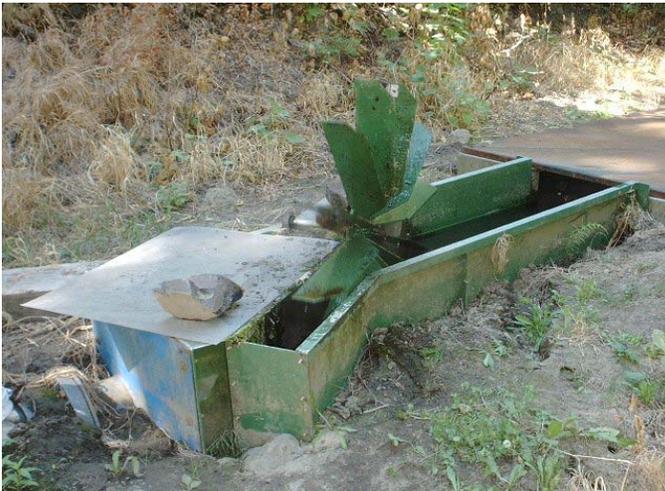
Numerous surface water diversions are present on Squilchuck Creek. All gravity diversions, except one, fail to meet criteria to prevent fish mortality. The single compliant diversion (960491) diverts approximately 700 gpm (Fig. 19). Ironically, the dam for the diversion is a partial barrier to fish passage (Fig 20). The Highline Ditch diversion (960494) requires the installation of a fish bypass screen due its large capacity and year-round operation (Figs 21-22). This diversion received the highest screening priority ranking.

Figure 19. This paddle wheel driven fish bypass screen, called the ORT diversion, associated with the next photo satisfies state law in preventing juvenile fish mortality from surface water diversions.

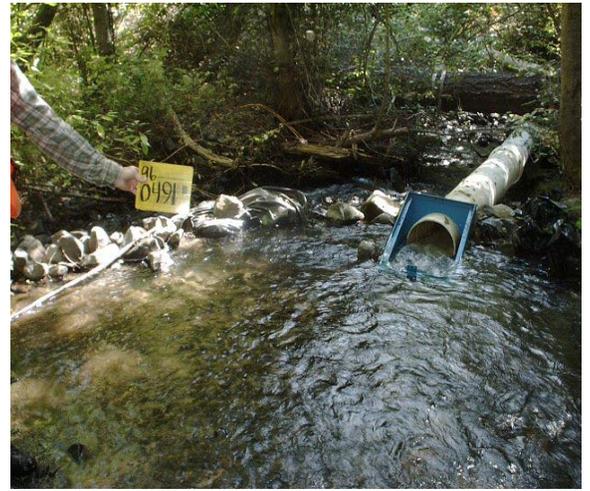
Figure 20. This push up boulder dam (960491) on Squilchuck Creek would be fish passable by removing the visqueen and placing the boulders appropriately to reduce the sweeping velocity. The intake pipe debris screen was lying on the stream bank.

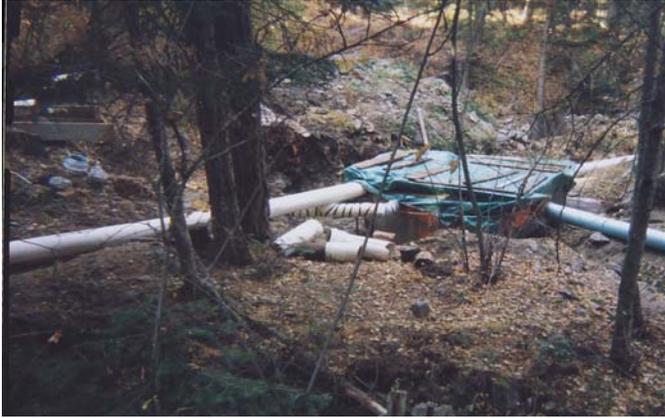
Figure 21. The Highline Diversion (960494) operates year round. The boulder dam at this site was evaluated as 100% passable.

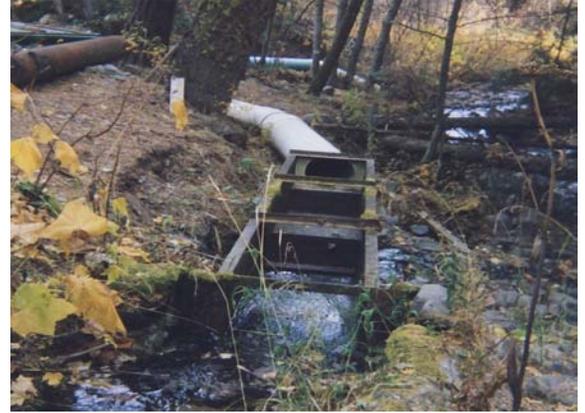
Figure 22. The Highline Diversion (960494) lacks a fish bypass screen making this site noncompliant.
