# Assessment of Salmonid Fishes and Their Habitat Conditions in the Walla Walla River Basin

Annual Report  
1998

DOE/BP-07035-1

August 1999

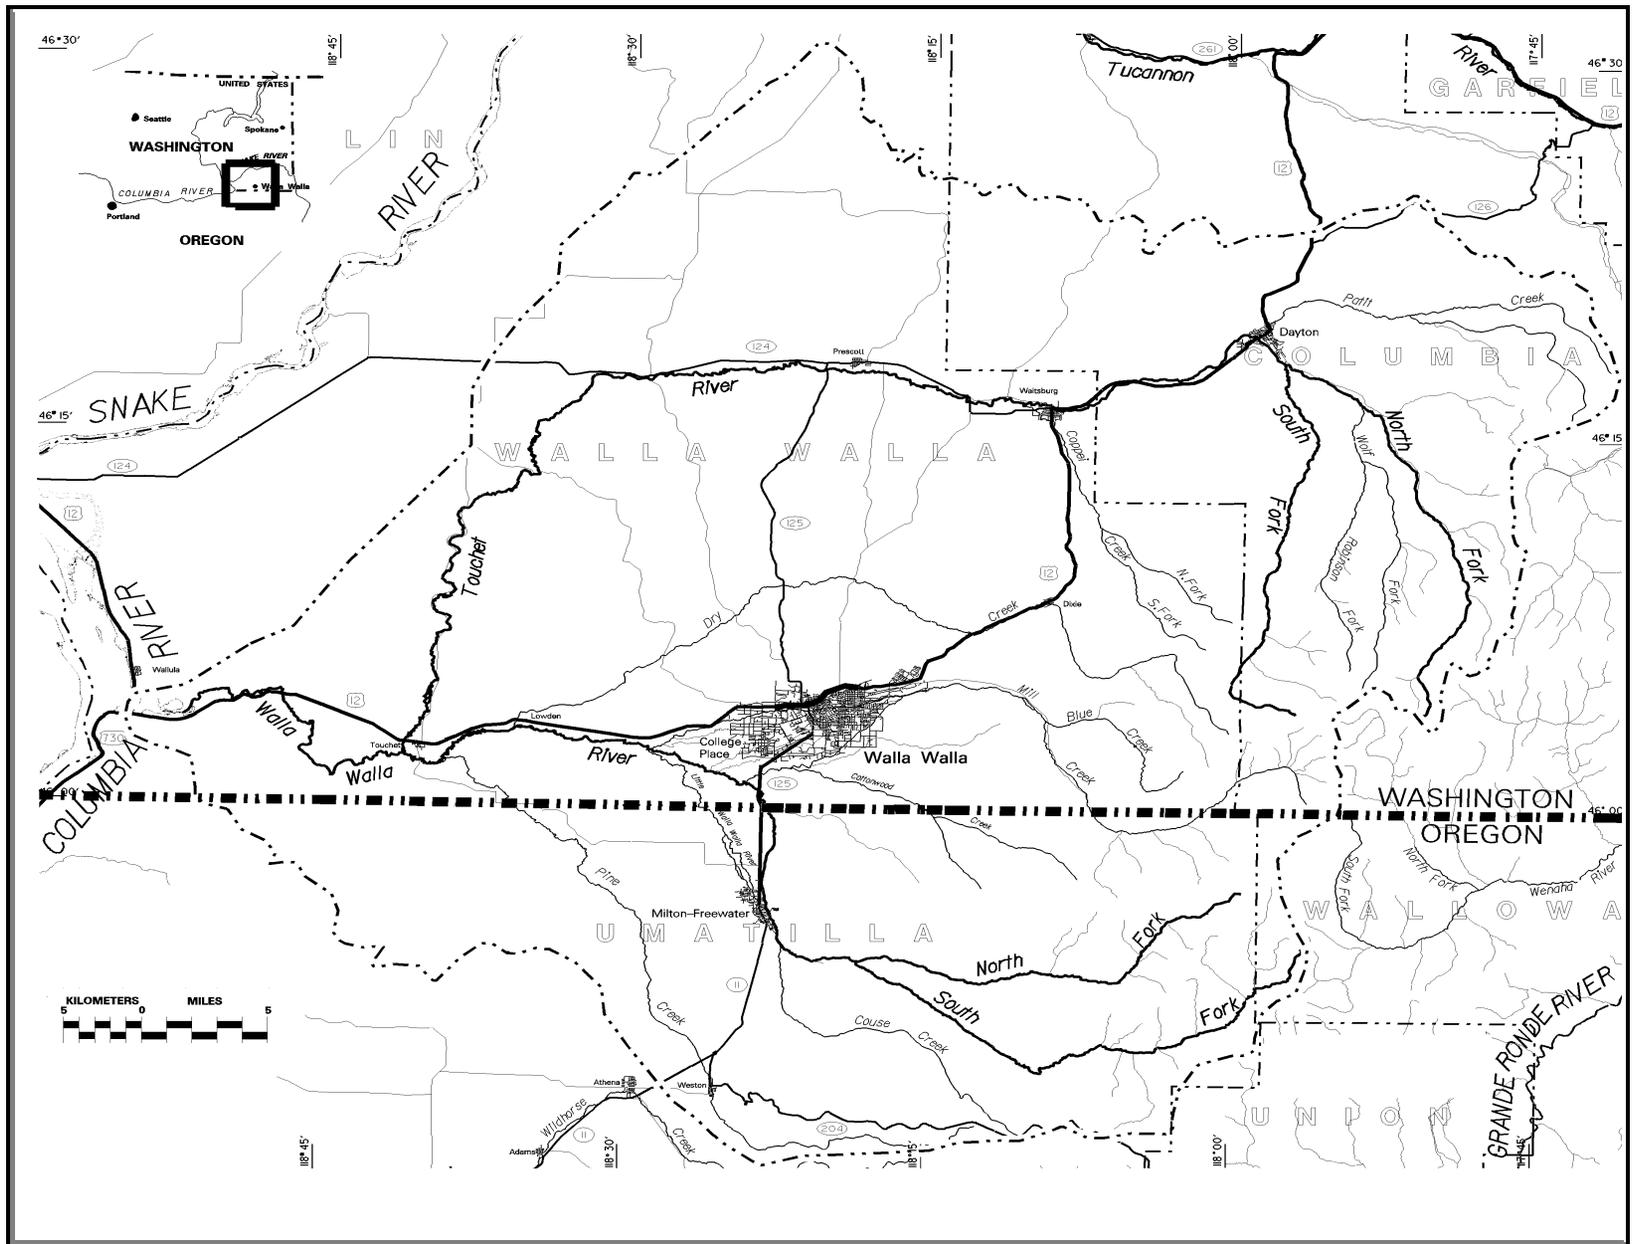
Figure 1. Walla Walla River watershed (modified from map courtesy of USACE, Walla Walla District).

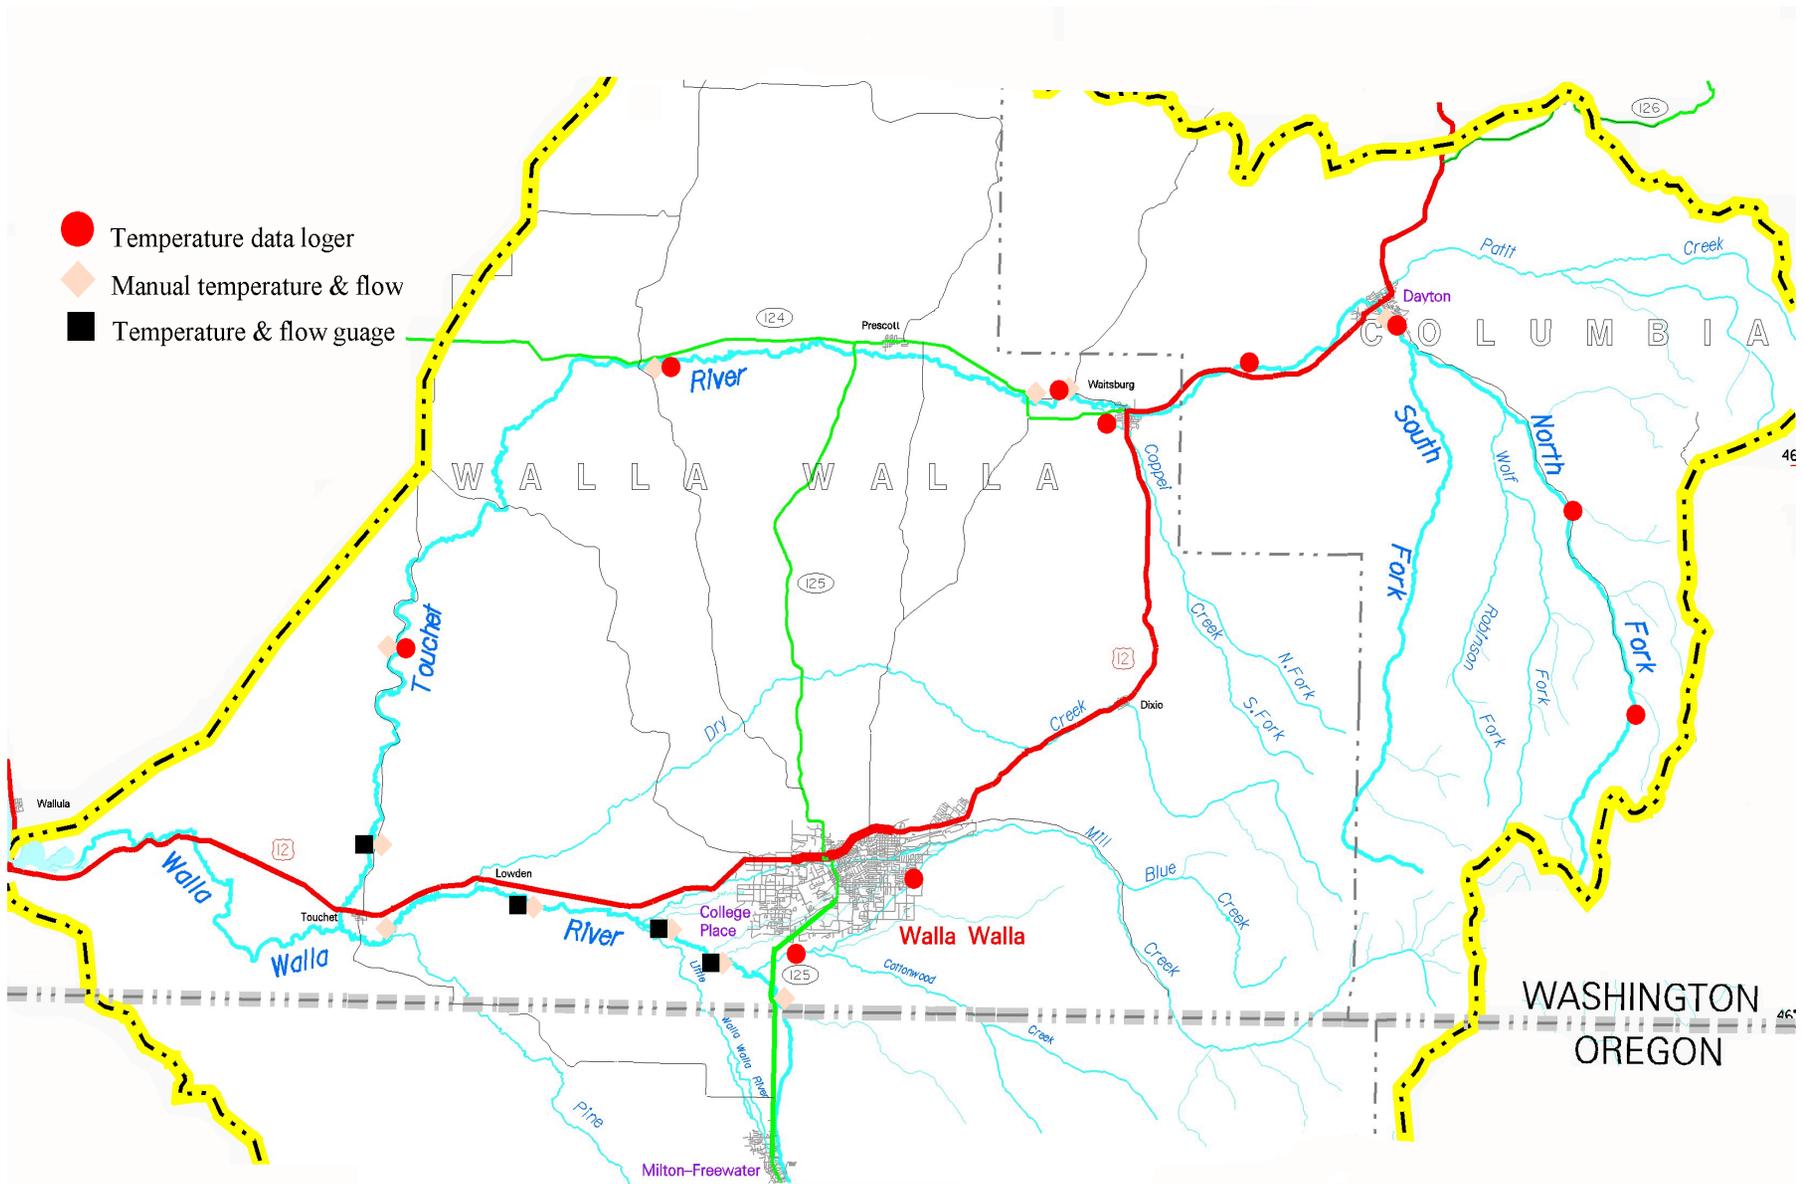
Figure 3. Relative locations of temperature and flow sites in the Walla Walla Basin, 1998.

Temperatures and flows were recorded throughout the two river systems by two methods (Figure 3). The first method was manual data collection. Temperatures were taken with standard field thermometers and recorded on log sheets. Manual discharge measurements were taken according to standard methods (Armour and Platts 1983). Discharge was calculated later in cubic feet per second (cfs) in Quattro Pro© spreadsheets. Manual temperatures and discharge measurements were taken at ten specified sites on a bi-weekly basis (Table 1, Figure 3). Manual temperatures were taken at all sites visited during electrofishing and snorkeling surveys.

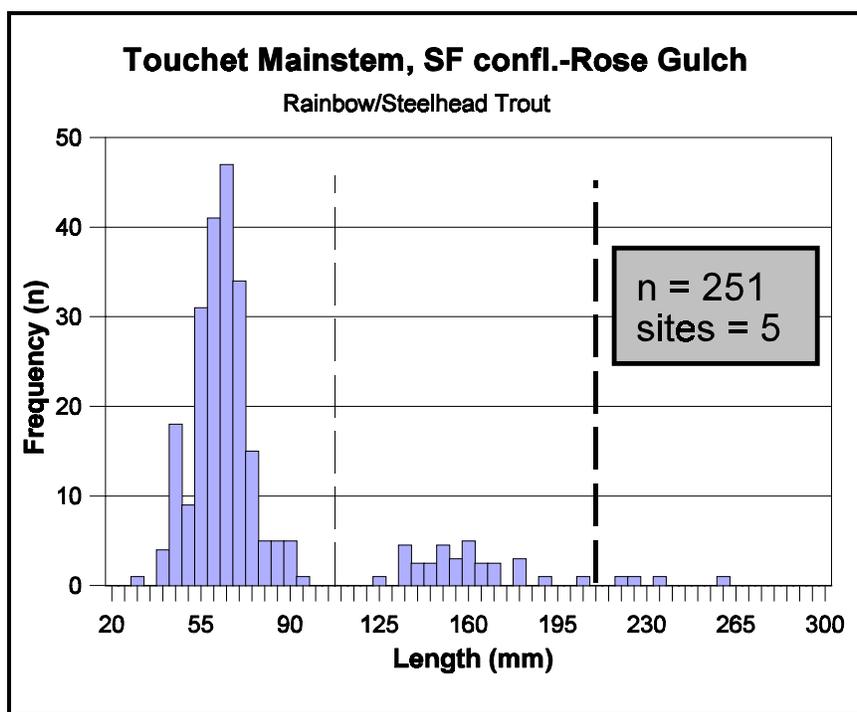
**Figure 4.** An example of a histogram for the mainstem Touchet River (between the South Fork confluence and Rose Gulch) used to distinguish rainbow trout/steelhead age class groupings (0+, 1+, and “legals”) by reach.

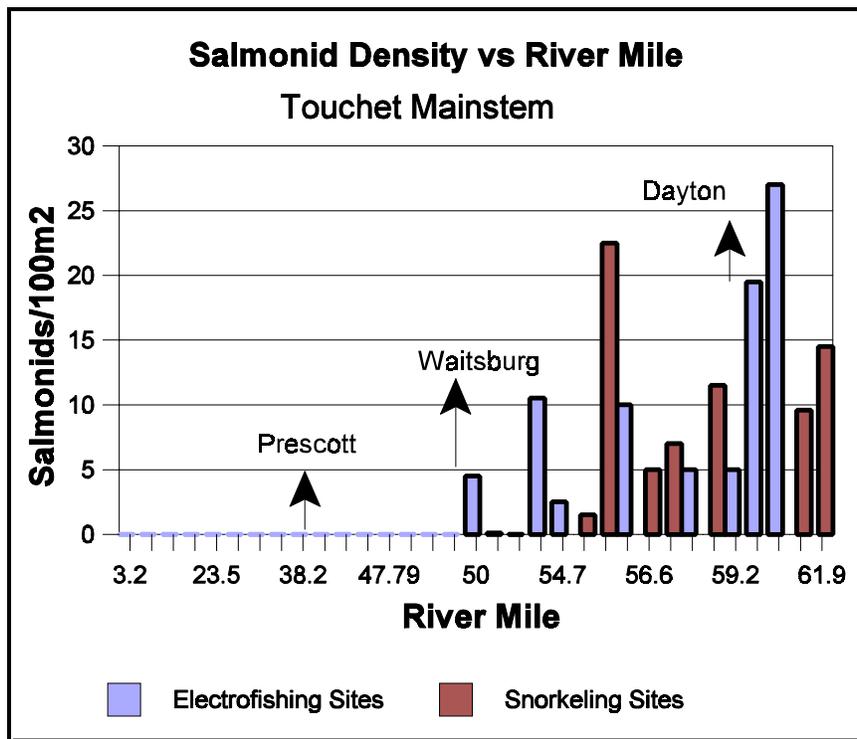
Figure 5. Total salmonid densities on the Touchet River in relation to river mile. River mile is the distance from the river’s mouth (landmarks are named at arrows).

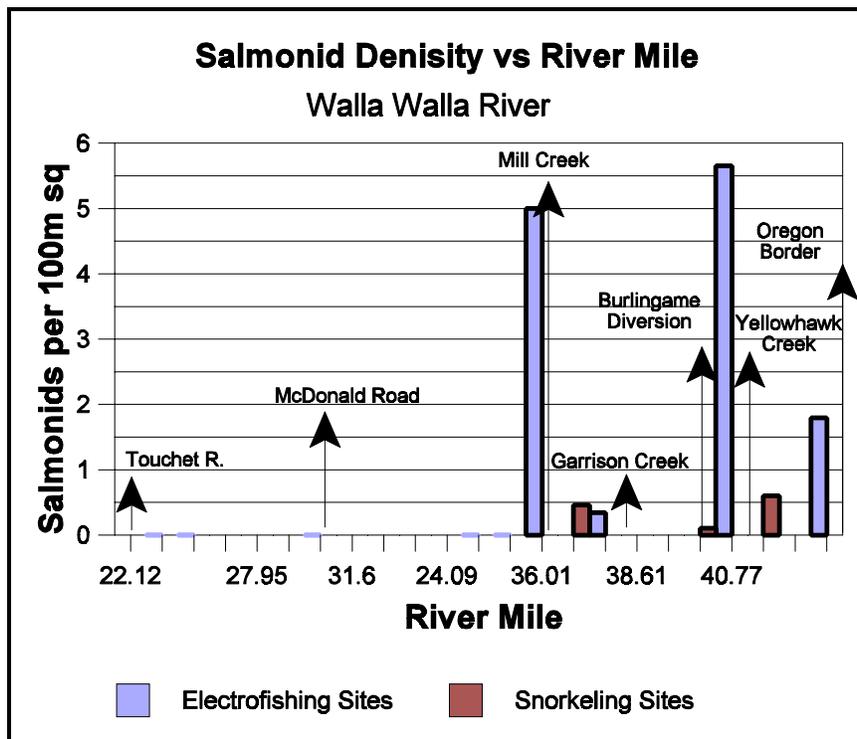
Figure 6. Total salmonid densities on the Walla Walla River, in relation to river mile. River mile is the distance upstream from the river’s mouth (landmarks are named at arrows).

The relationship was much weaker for the Walla Walla River (Figure 6). Patchy concentrations of rainbow/steelhead trout, in areas where ground water recharge increased flows or habitat conditions were more favorable, lead to an uneven distribution in the upper Walla Walla River within Washington. Both rivers showed a bi-modal pattern, where salmonid numbers dropped sharply or disappeared at specific points. These points occur in the area of Waitsburg on the Touchet River; and McDonald Road on the Walla Walla River (Figure 6).

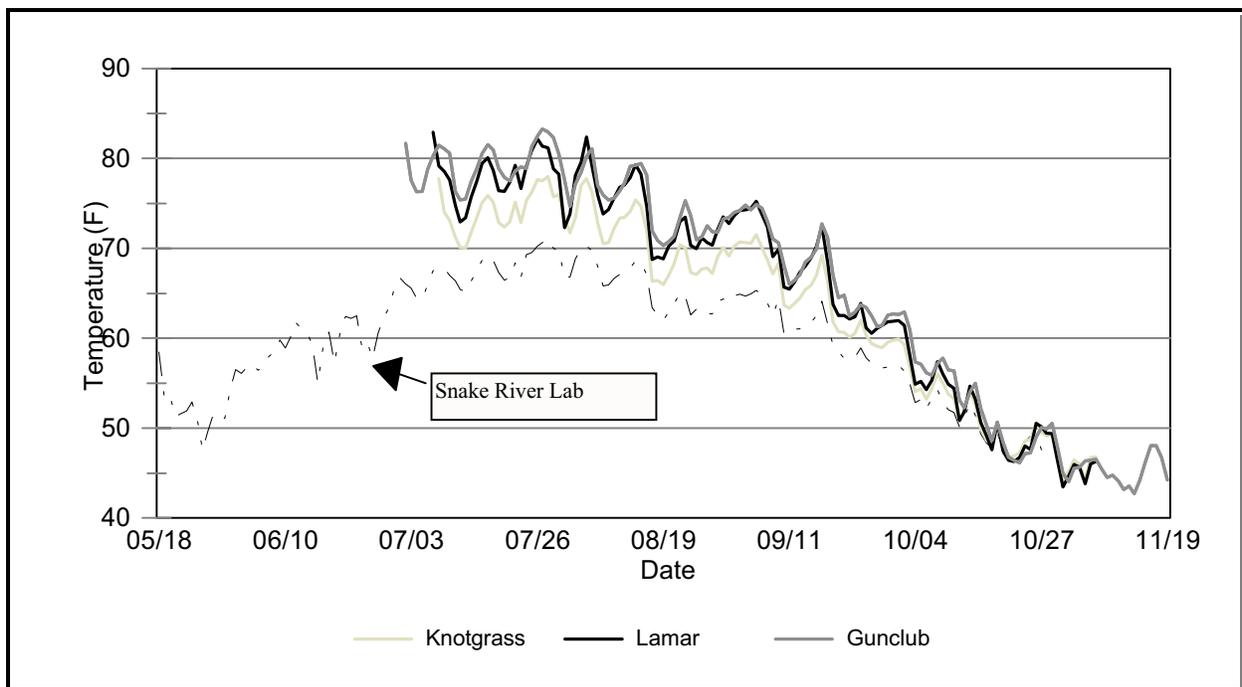
**Figure 7.** Daily mean temperature at four instream monitor sites on the Touchet River. For clarity, sites at Lewis and Clark Trail State Park and Simms Road are omitted.

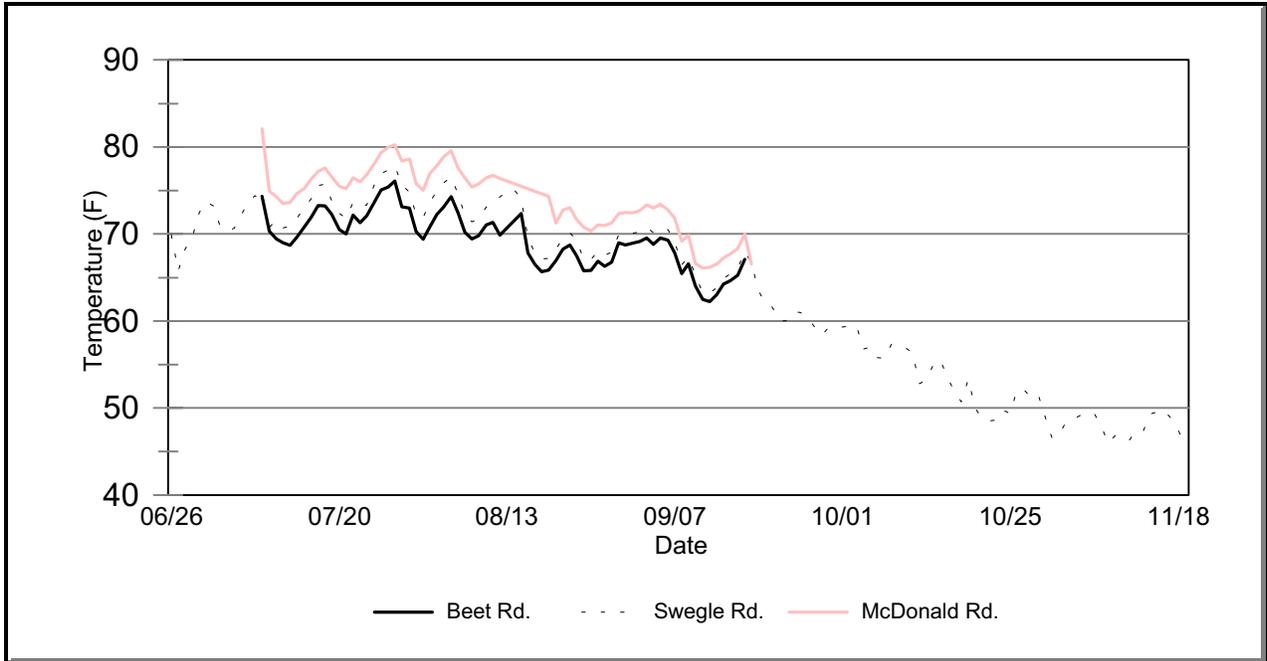
**Figure 8.** Daily mean temperatures at instream monitor sites on the Walla Walla River mainstem, 1998.

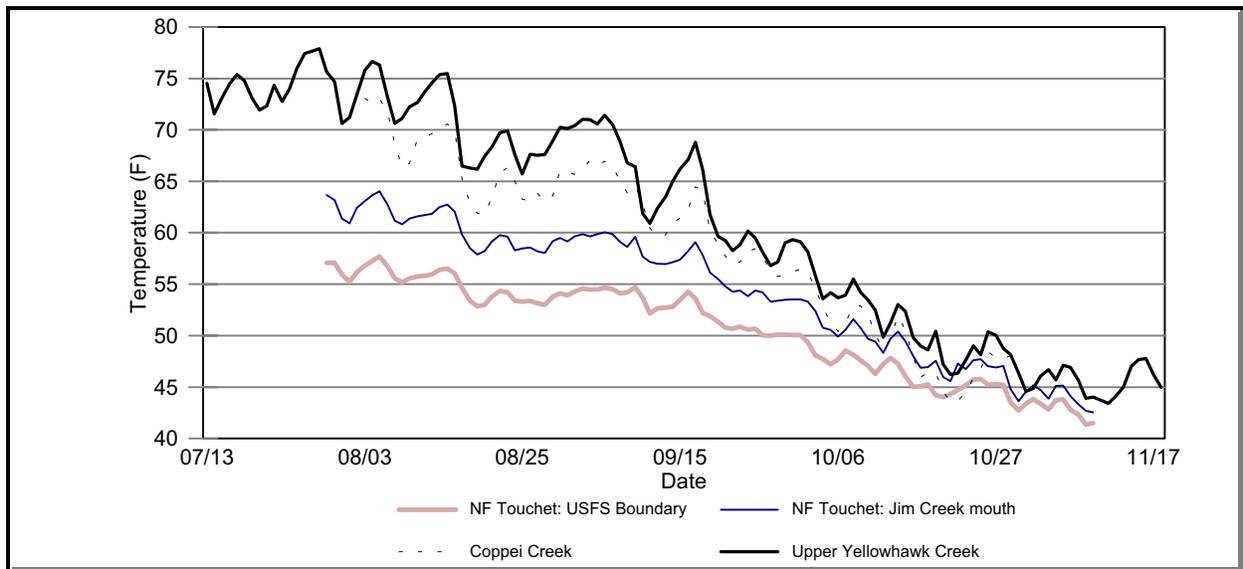
**Figure 9.** Daily mean temperatures on tributary streams. For graph clarity, the lower Yellowhawk site is omitted.

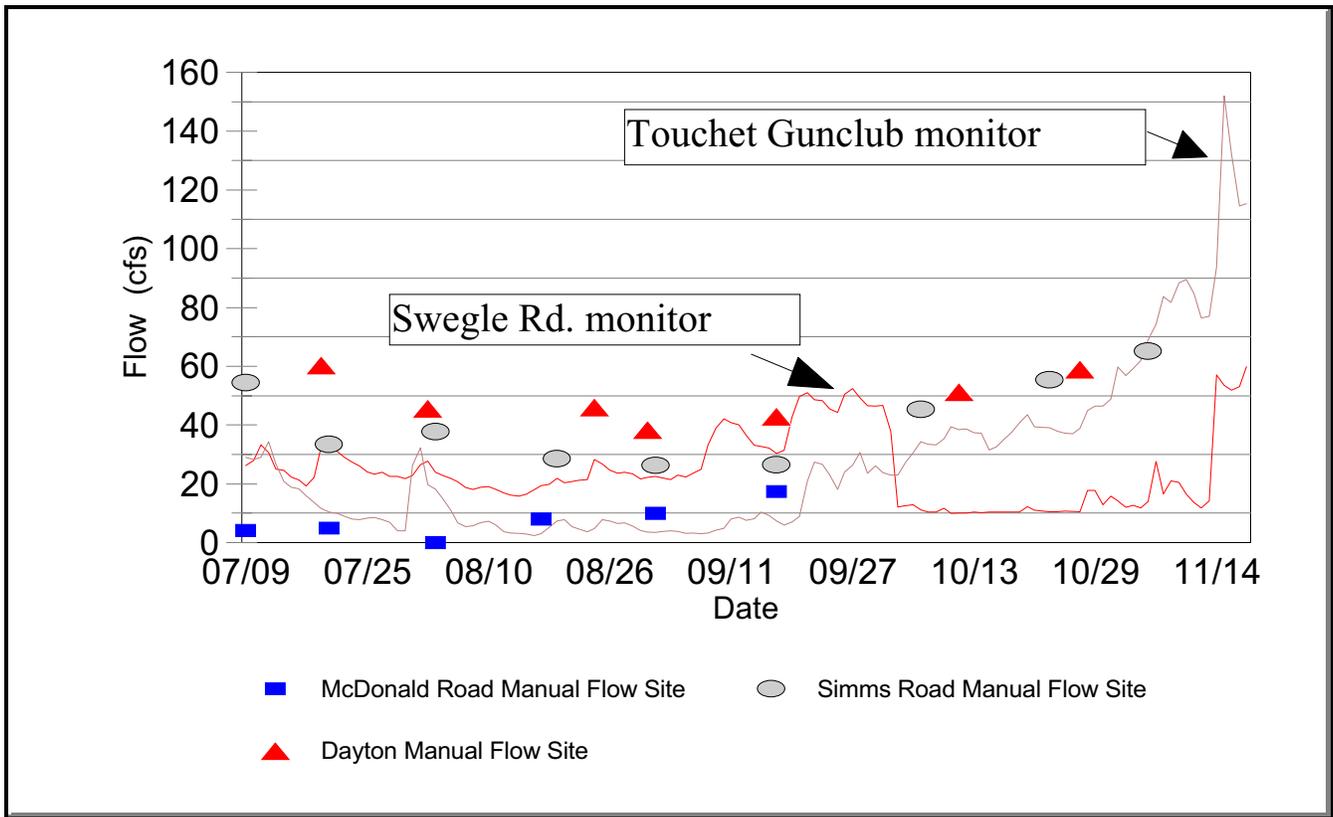
**Figure 10.** Instream flows (in cubic feet per second) at selected sites in the Walla Walla Basin, 1998. Note: The Dayton, Simms Road and Touchet Gunclub sites are on the Touchet River in descending order. The Swegle Road and McDonald Road sites are in descending order on the Walla Walla River. The Simms Road site is approximately nine miles above Hofer Dam, and the Touchet Gunclub site is about one mile below the dam.

A general pattern of gradually declining stream flow from mid-July to mid-September, followed by fairly rapidly increasing flows, predominated in the greater Walla Walla Basin (Figure 10). However, sites in proximity to major irrigation facilities exhibited a more erratic stream flow pattern. Flows were likely influenced by an inter-relationship of climatic events and irrigation withdrawals.

Reduced flows downstream of major irrigation facilities operating in peak mode were observed during the field season. Specific observations included: (1) complete dewatering of the Walla Walla River channel for about one-half mile below the Oregon border, observed from the air; (2) sharp flow reduction below Burlingame Diversion between mid-September and mid-October, as recorded by manual and instream flow monitoring at Beet, Swegle and McDonald Roads (Appendix B); and, (3) an abrupt reduction of flow from 20-40 cfs to less than 10 cfs from mid-July through mid-September below Hofer Dam on the Touchet River, as recorded by the instream flow monitor at Touchet Gunclub (Figure 10, Appendix B).

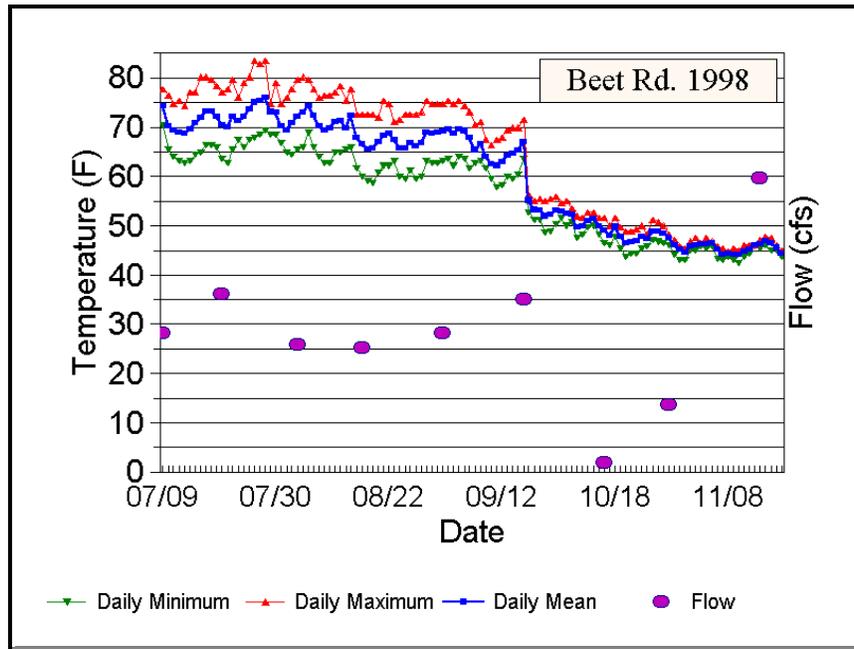
## Temperature Values for Continuous Instream Monitor Beet Road, Walla River, 1998

Summary of Daily Temperature Values for the Continuous Instream Monitor Placed at Beet Road, Walla Walla River, 1998. Manual flows were also measured at the same location.

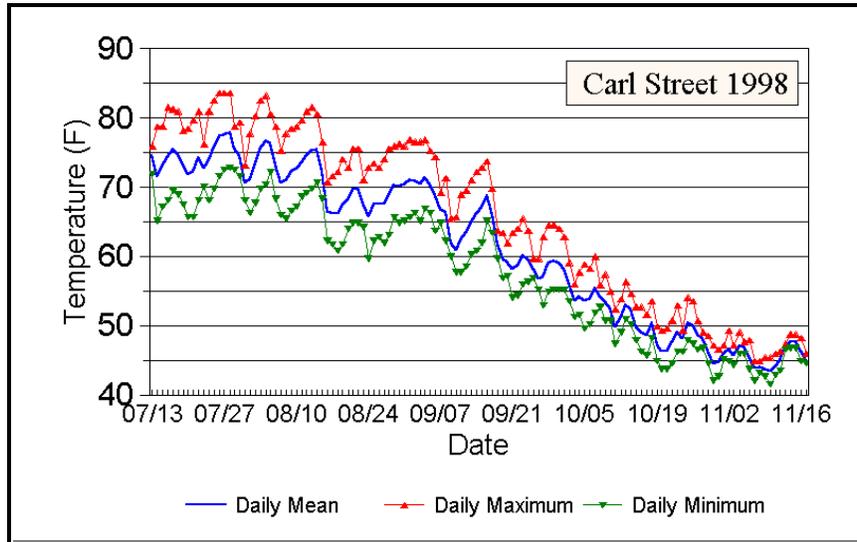
## Summary of Daily Temperature Values for the Continuous Instream Monitor Placed at the Carl Street Site, Upper Yellowhawk Creek, 1998

Summary of Daily Temperature Values for the Continuous Instream Monitor Placed at the Carl Street Site, Upper Yellowhawk Creek, 1998.

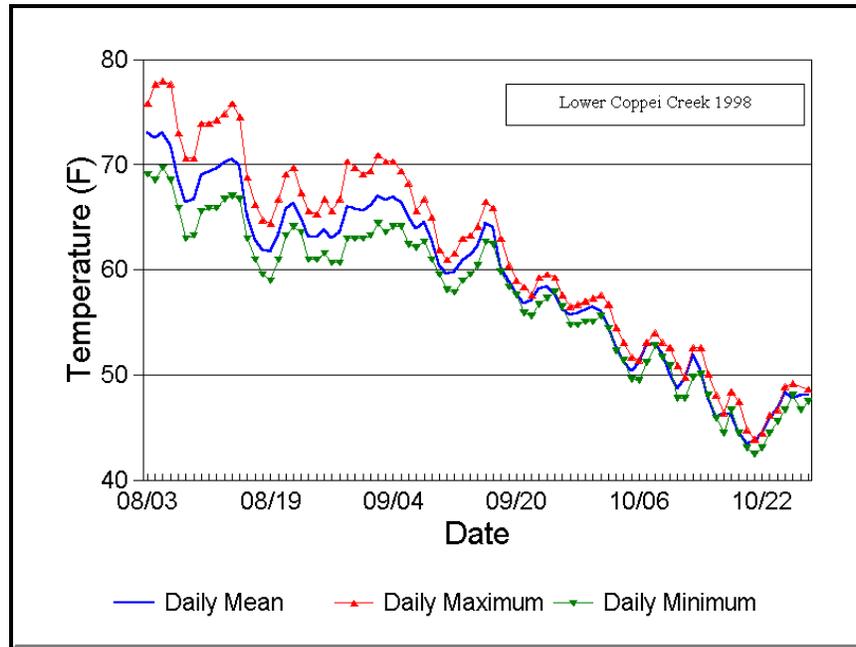
## Summary of Daily Temperature Values for the Continuous Instream Monitor Placed in Lower Coppei Creek, 1998

Summary of Daily Temperature Values for the Continuous Instream Monitor Placed in Lower Coppei Creek, 1998.

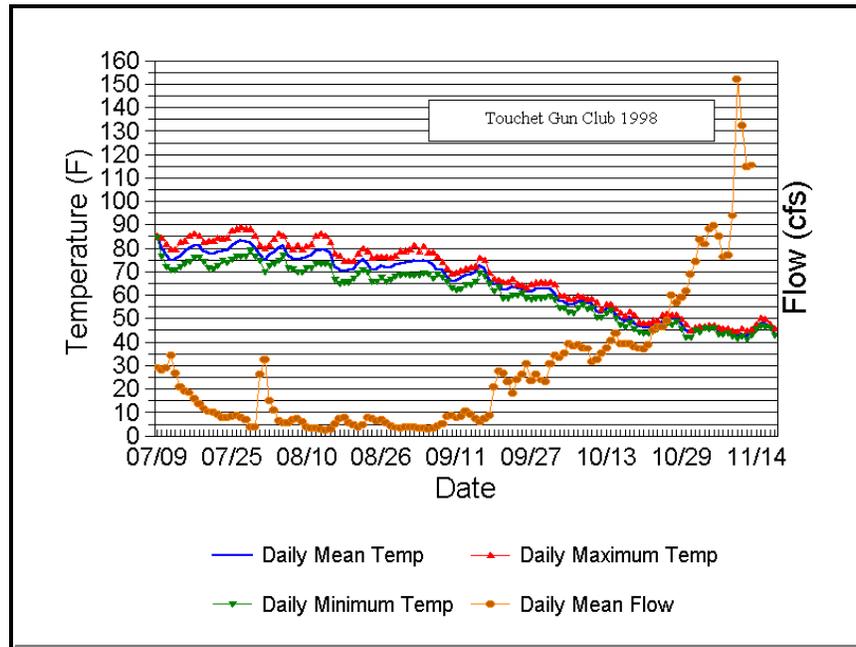
## Summary of Daily Temperature Values and Flows for the Continuous Instream Monitor Placed at Touchet Gun Club, Lower Touchet River, 1998

Summary of Daily Temperature Values and Flows for the Continuous Instream Monitor Placed at Touchet Gunclub, Lower Touchet River, 1998.

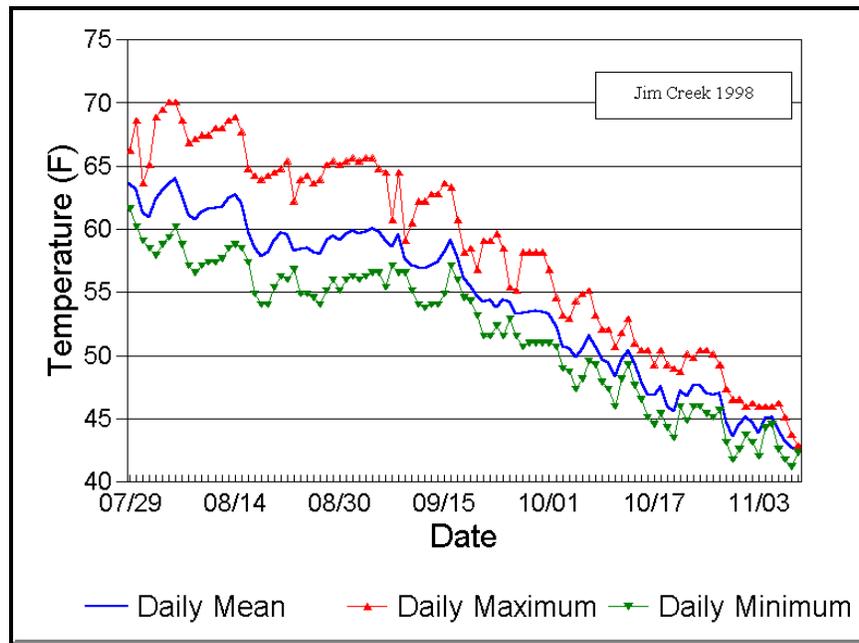
## Summary of Daily Temperature Values for the Continuous Instream Monitor Placed in the North Fork Touchet River, Just Upstream From Jim Creek, 1998

Summary of Daily Temperature Values for the Continuous Instream Monitor Placed in the North Fork Touchet River, Just Upstream from Jim Creek, 1988.

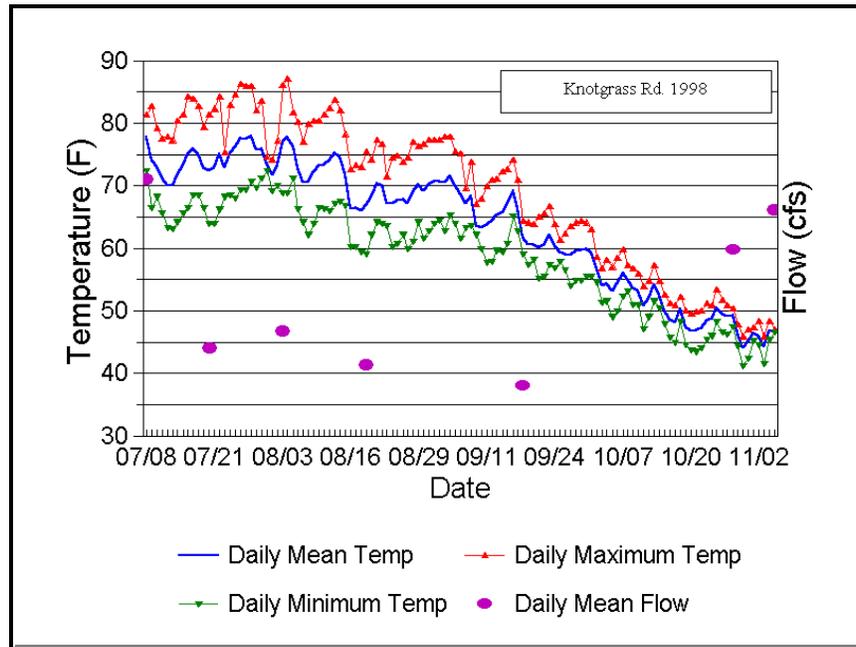
## Summary of Daily Temperature Values for the Continuous Instream Monitor Placed at Knotgrass Rd., Touchet River, 1998

Summary of Daily Temperature Values for the Continuous Instream Monitor Placed at Knotgrass Road, Touchet River, 1998. Manual Flows were also measured at the same location.

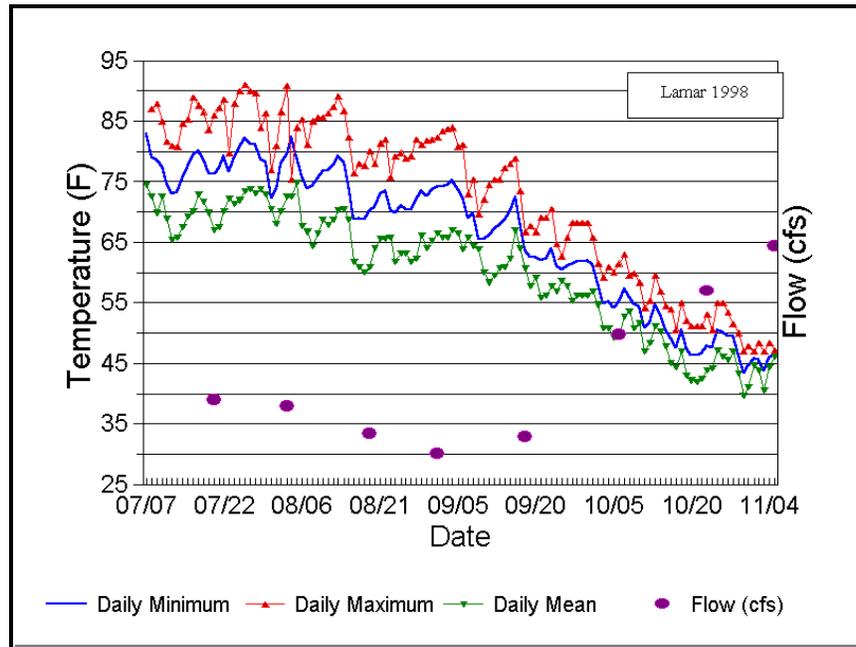
## Summary of Daily Temperature Values for the Continuous Instream Monitor Placed at Lamar Rd., Touchet River, 1998

Summary of Daily Temperature Values for the Continuous Instream Monitor Placed at Lamar Rd., Touchet River, 1998. Manual flows also measured at the same location.

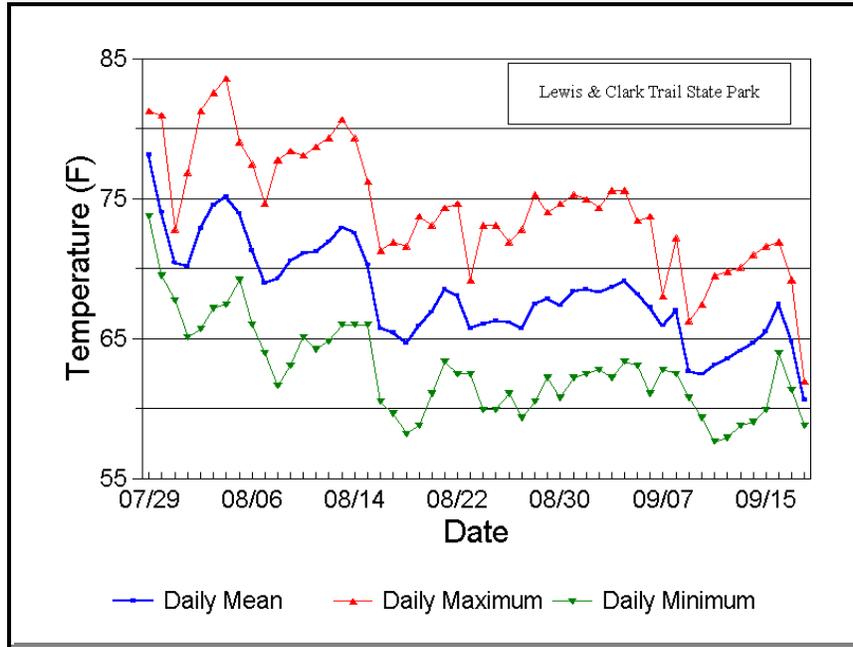
## Summary of Daily Temperature Values for the Continuous Instream Monitor Placed at Lewis & Clark Trail State Park, Touchet River, 1998

Summary of Daily Temperature Values for the Continuous Instream Monitor Placed at Lewis & Clark Trail State Park, Touchet River, 1998.

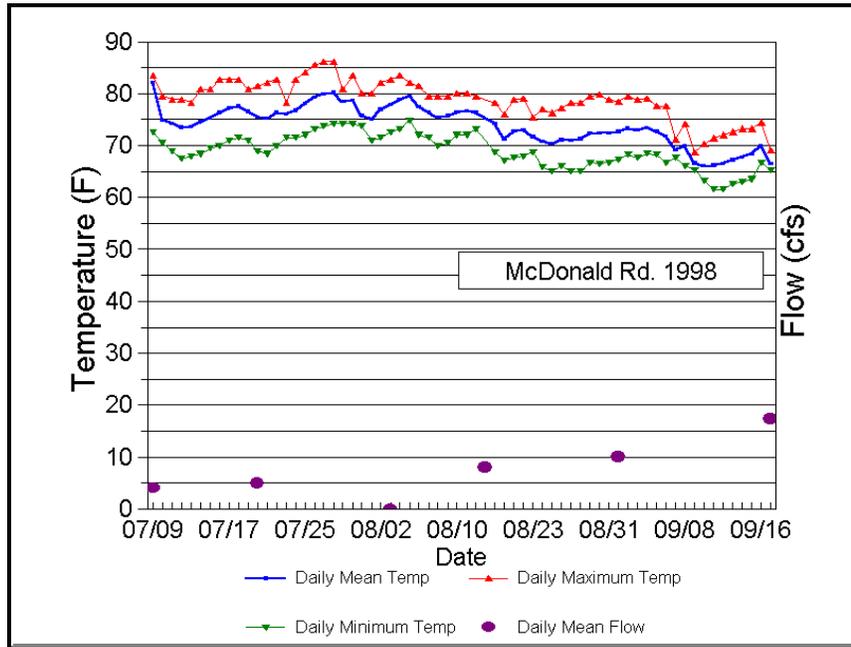
## Summary of Daily Temperature Values Measured by a Continuous Instream Monitor Placed at McDonald Rd., Walla Walla River, 1998

Summary of Daily Temperature Values Measured by a Continuous Instream Monitor Placed at McDonald Rd., Walla Walla River, 1998. Periodic manual flow measurements at the same location.

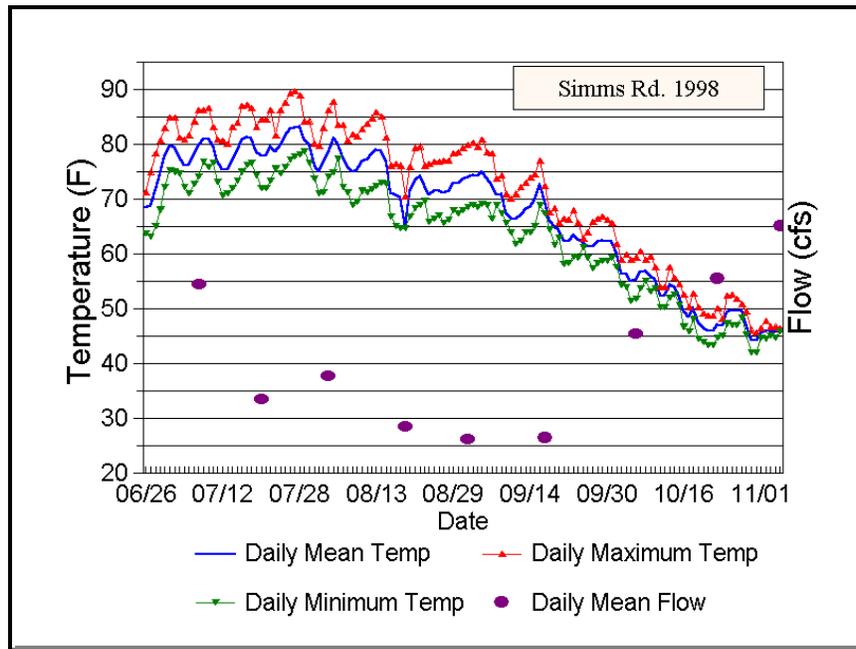
## Summary of Daily Temperature Values for the Continuous Instream Monitor Placed at Simms Road, Touchet River, 1998

Summary of Daily Temperature Values for the Continuous Instream Monitor Placed at Simms Road, Touchet River, 1998. Manual flows also measured at the same location.

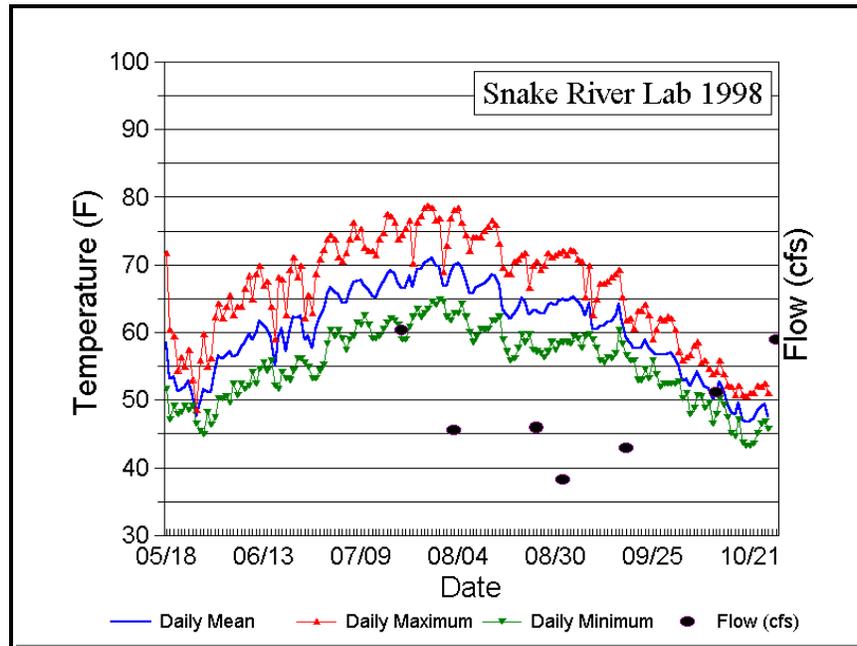
## Summary of Daily Temperature Values for Continuous Instream Monitor Placed at Dayton Steelhead Pond Intake, 1998

Summary of Daily Temperature Values for Continuous Instream Monitor Placed at Dayton Steelhead Pond Intake, 1998. Manual flow measurement nearby.

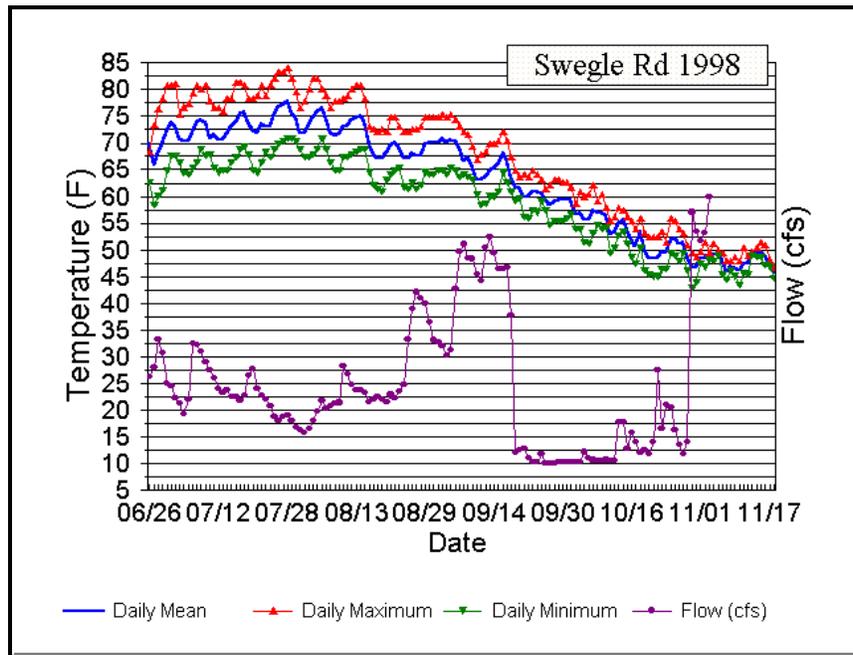
## Summary of Daily Temperatures and Flows for the Continuous Instream Monitor Placed at Sweгле Rd., Walla Walla River, 1998

Summary of Daily Temperature Values for Continuous Instream Monitor Placed at Sweгле Rd., Walla Walla, 1988. Manual flows at same location.

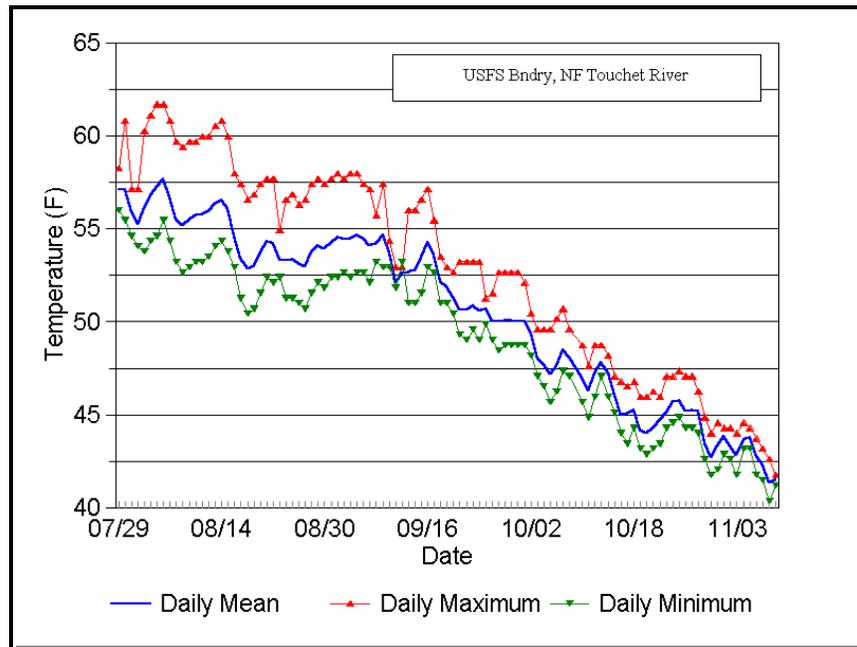
## Summary of Daily Temperature Values for the Continuous Instream Monitor Placed at USFS Boundary, NF Touchet River, 1998

Summary of Daily Temperature Values for the Continuous Instream Monitor Placed at USFS Boundary, NF Touchet River, 1998.

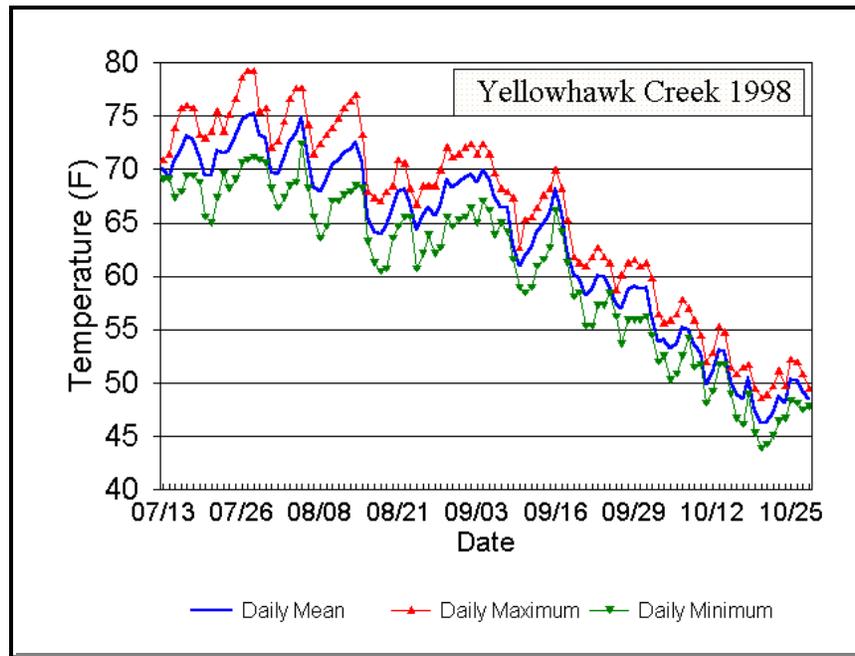
## Summary of Daily Temperature Values and Flows for the Continuous Instream Monitor Placed at Lower Yellowhawk Creek, 1998

Summary of Daily Temperature Values and Flows for the Continuous Instream Monitor at Lower Yellowhawk Creek, 1998.
