# Washington's Hydraulic Project Approval Program Hydraulic Code Implementation Citizen Advisory Group Agenda

## Discussion Guide - HPA Compliance Program

# Allison Cook Compliance Biologist WDFW Region 6

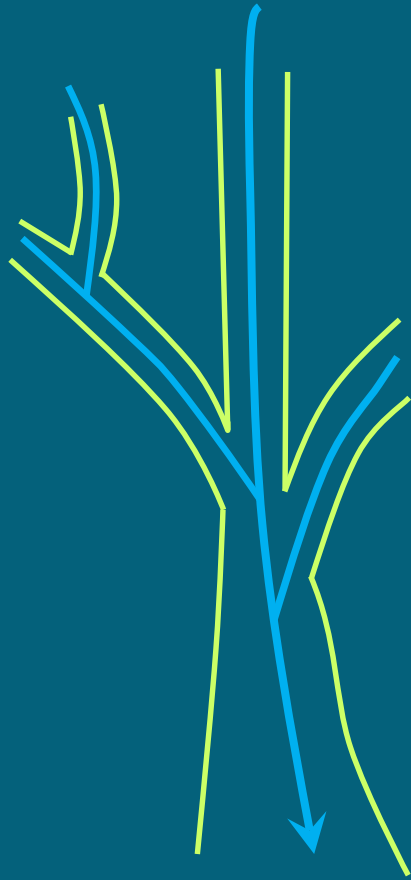
# Estimating Channel Width

$Q$  = bankfull flow

bankfull width =  $a \cdot Q^b$

$a$  and  $b$  have been estimated  
for each ecoregion

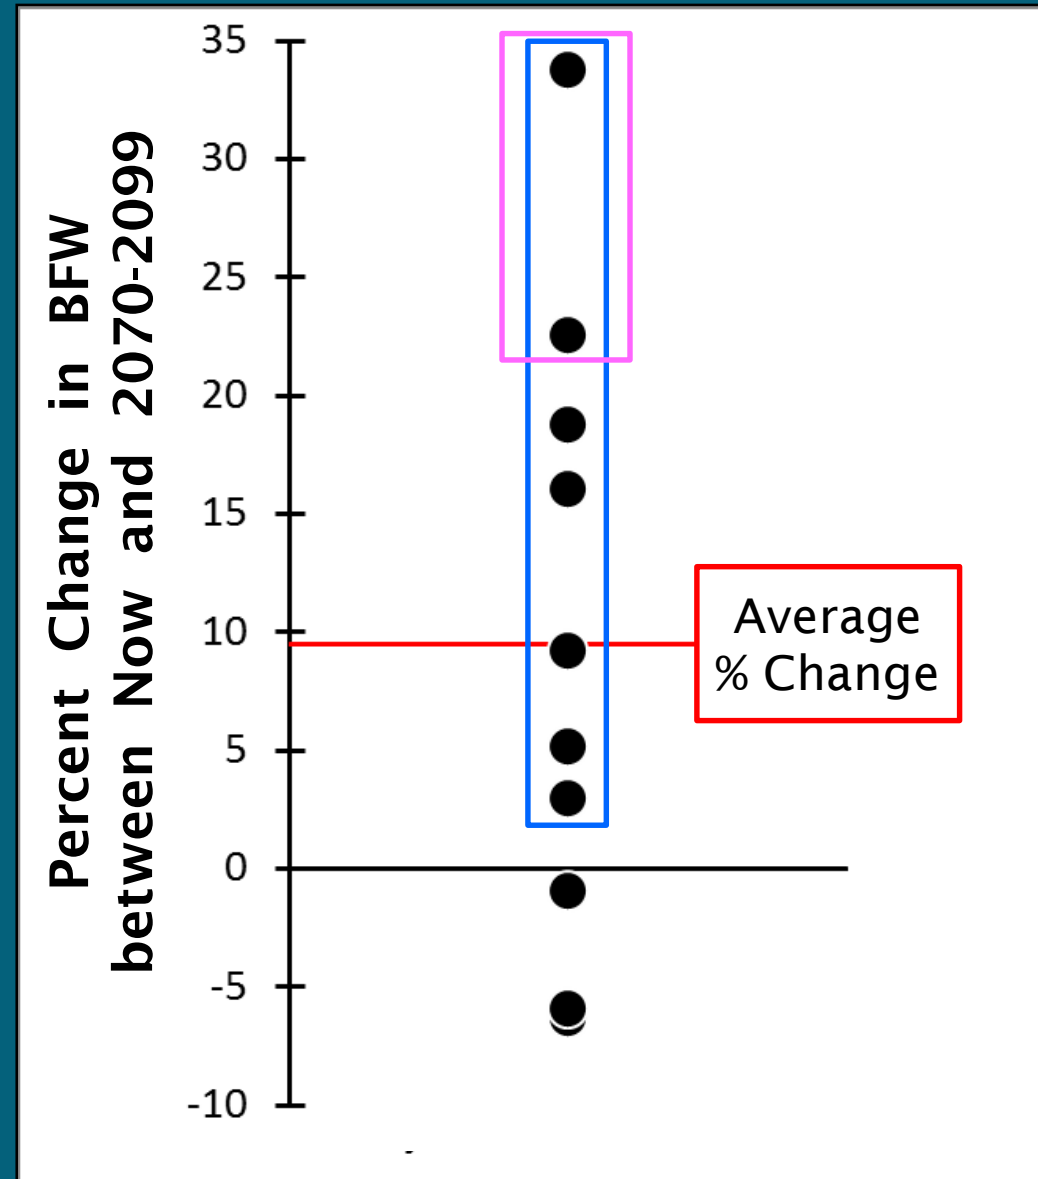
# % Change at a Single Grid Cell

- How large?  
average of 10  
projections:  
% change in  
BFW = +9.5%
- How likely?  
model agreement:  
7 of 10 models  
project an increase  
in BFW
- Uncertainty and Risk

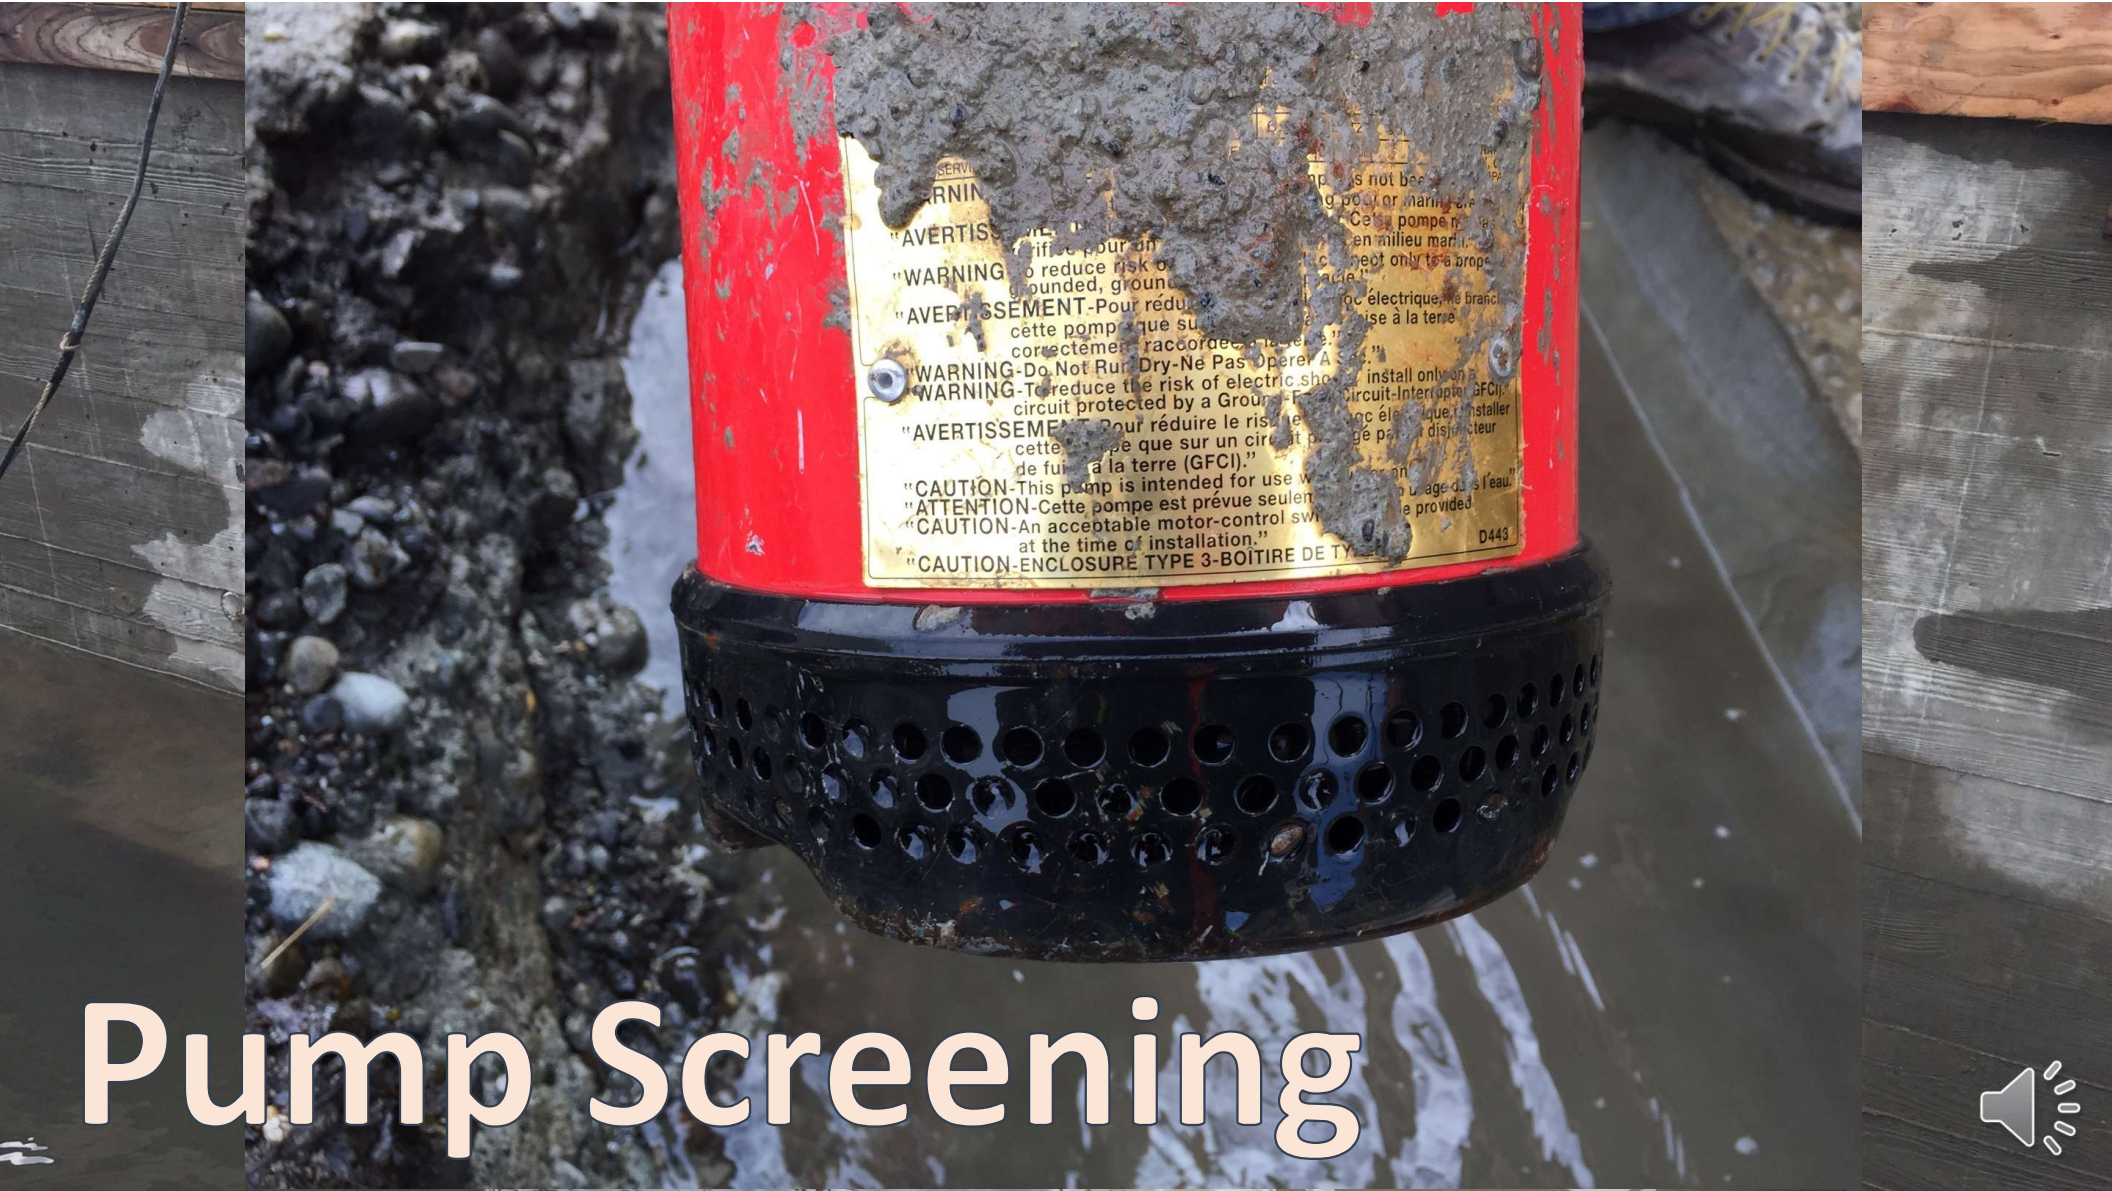
# Pump Screening

"AVERTISSEMENT - Pour réduire le risque de choc électrique, ne branchez cette pompe que sur un circuit protégé par un interrupteur différentiel (ID) ou un disjoncteur différentiel (DD)."  
 "WARNING - To reduce the risk of electric shock, install only on a circuit protected by a Ground Fault Circuit-Interrupter (GFCI) or a ground fault circuit breaker (GFCB)."  
 "CAUTION - This pump is intended for use with an acceptable motor-control switch at the time of installation."  
 "CAUTION - ENCLOSURE TYPE 3-BOÎTIERE DE TYPE 3"

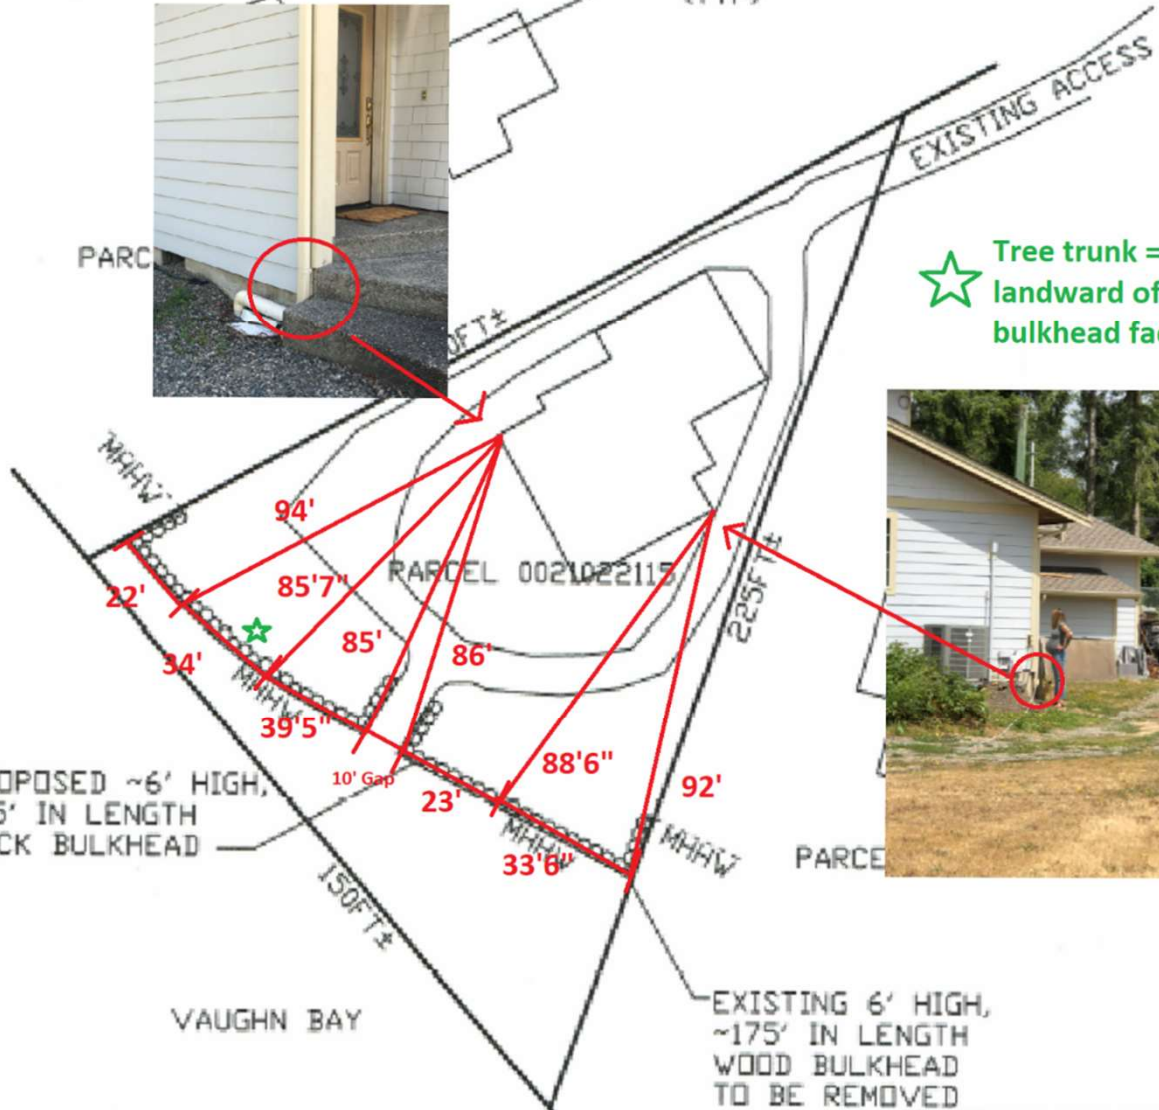
★ Tree trunk = 4ft landward of existing bulkhead face

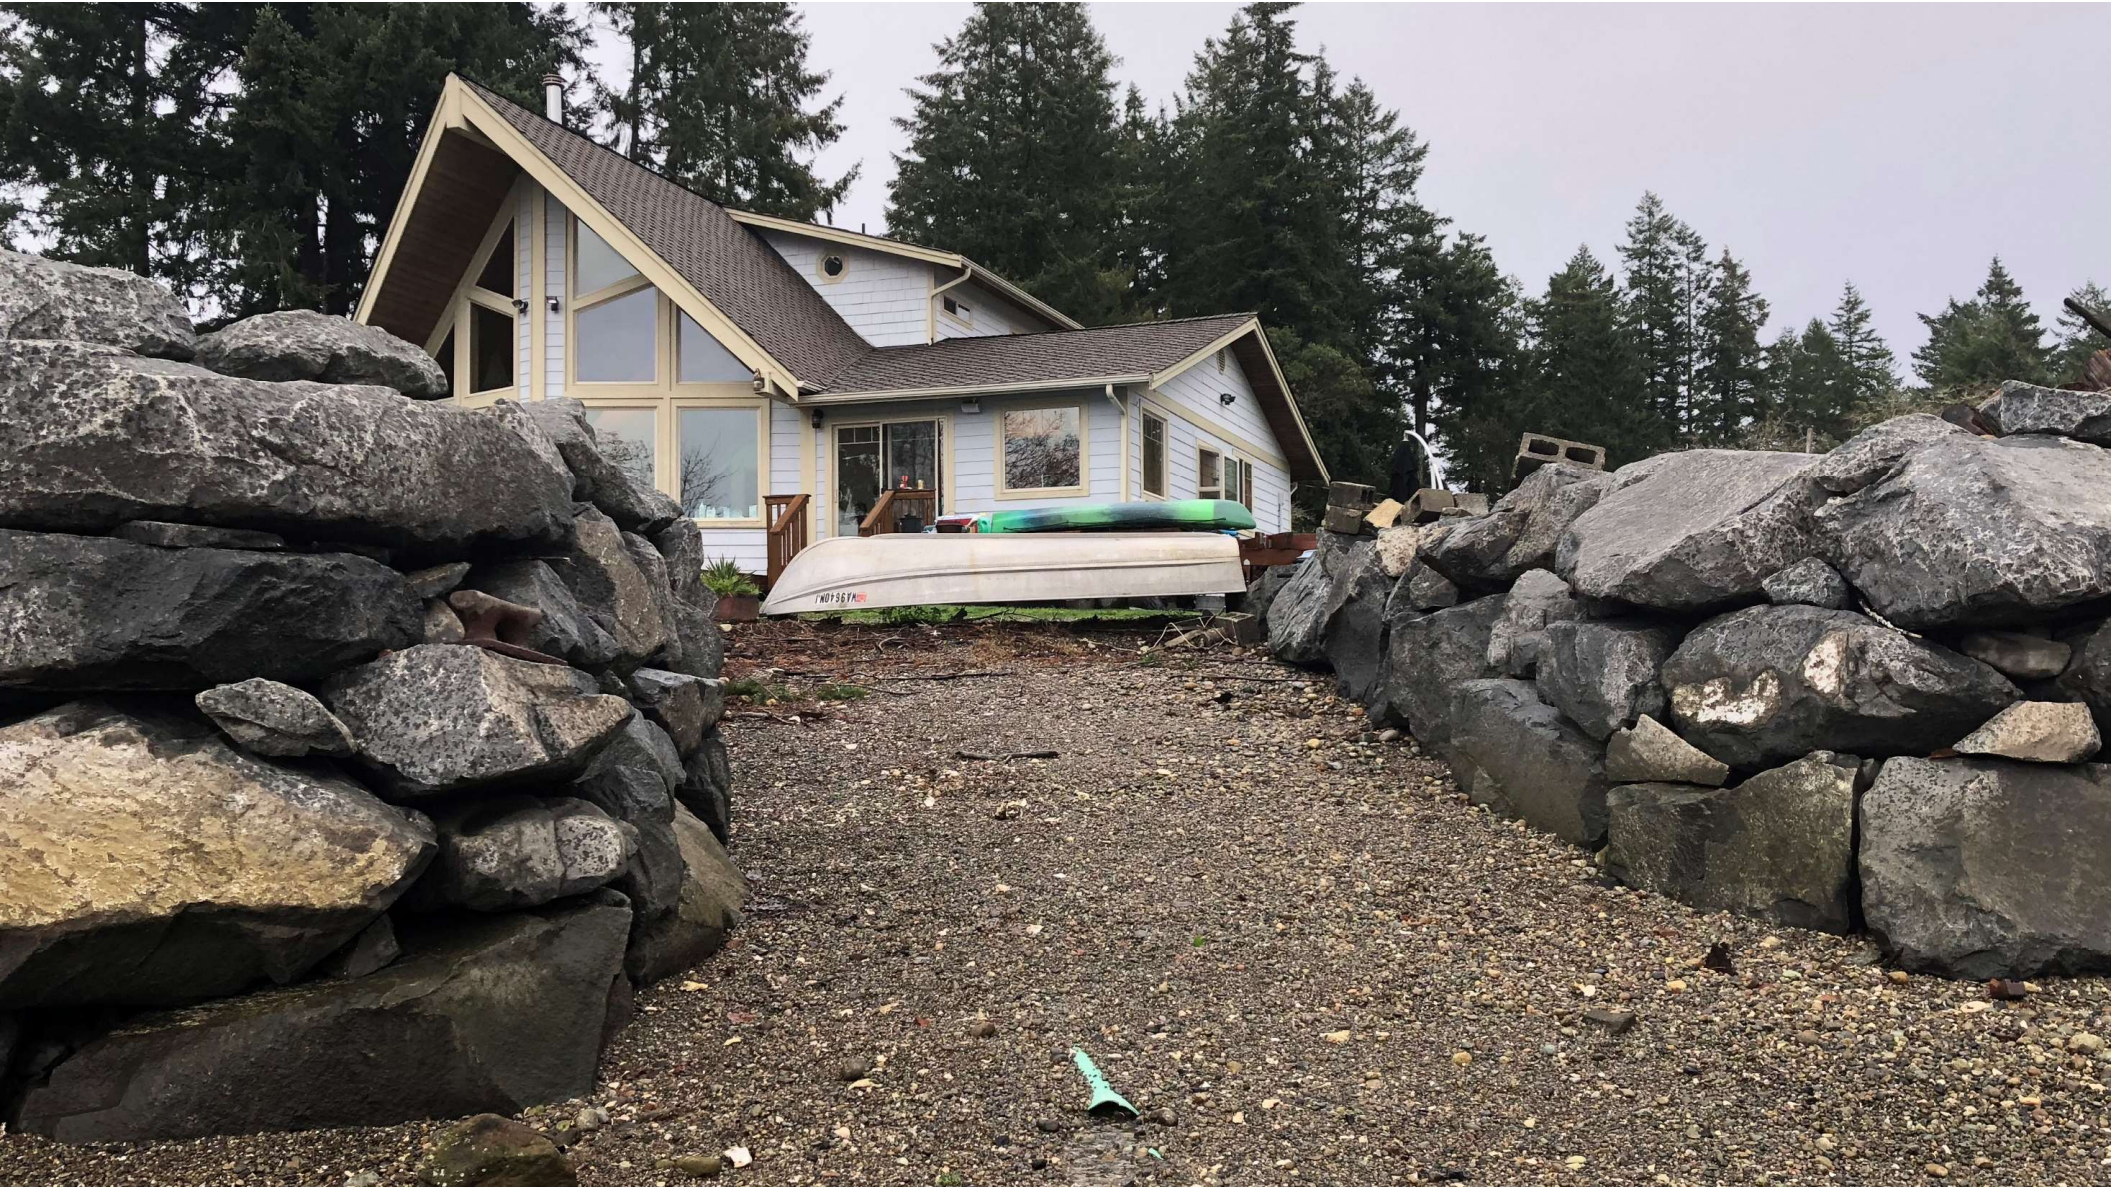
# Final Measurements

CI	Landward
94'	93'		1'		
85'7"	86'6"		1'1"		
85'	85'		0'		
86'	87'		1'		
88'6"	88'6"		0'		
92'	92'6"		6"		
175'	151'		24'

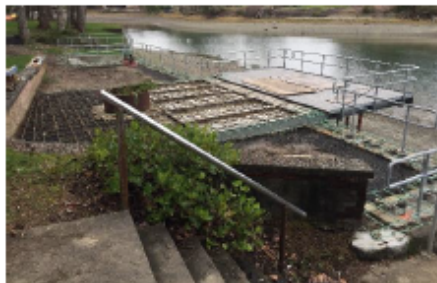
**March 2<sup>nd</sup>, 2018** Allison Cook and David Kloempken conducted a site visit on neighboring property with permission from homeowners. Homeowner of property in question was not home. It appeared a new over-water structure was installed with a pin piles on the beach surface. The face of the bulkhead looked like it had work done on it recently, and the deck surface has rebar forms which appear to be in preparation for concrete pouring. Photos from this site visit attached below.

**March 23<sup>rd</sup>, 2018** WDFW Allison Cook, WDFW Margie Bigelow, WDFW Sergeant Fairbanks, and Mason County Code Compliance Stephen Scott met with [REDACTED] to discuss permitting and mitigation for the work that [REDACTED] had conducted without permits. Upon arrival, we discovered that [REDACTED] had completed pouring concrete after WDFW Officer Jewett had contacted him and told him he needed permits to do the work. WDFW is not authorized with stop work authority. Mason County Code Enforcement, Stephen Scott said that he did not post a stop work order because he assumed [REDACTED] would wait until after our meeting to resume the work on his shoreline. [REDACTED] admitted to replacing the entire bulkhead, along with building the overwater deck and pouring concrete in the riparian area. Photo on left taken March 2<sup>nd</sup>, 2018 before [REDACTED] was done pouring concrete. Photo on right taken March 23<sup>rd</sup>, 2018 showing [REDACTED] continued work and completed the concrete pouring between March 2<sup>nd</sup> and March 23<sup>rd</sup>, 2018 after he had been contacted by WDFW.

Stephen Scott informed [REDACTED] that the overwater structure was not allowed in Mason County's new Shoreline Master Program and that he would have to take it out. WDFW's requirements to bring the structure into compliance are it either to be re-surfaced with 100% functional grating, or removed. WDFW gave [REDACTED] info on how to pursue a Hydraulic Project Approval permit when Mason County makes a final decision on the structure.

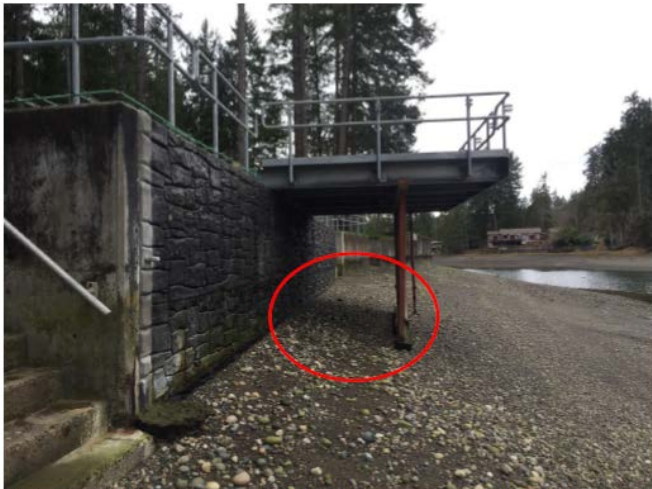
Photo taken by Allison Cook on March 2<sup>nd</sup>, 2018. Shows overwater deck, pin piles, and bulkhead replacement. Shading from overwater structure is identified by red circle in the photo.

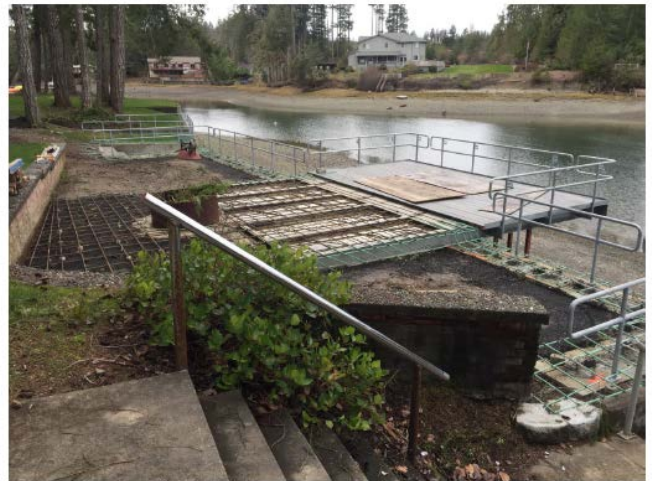
Photo taken March 2<sup>nd</sup>, by Allison Cook. Shows upland view of construction work taking place on overwater structure. Decking surface over water is solid, with no functional grating.
