South Puget Sound Wildlife Area
Fish Passage and Diversion Screening
Prioritization Inventory

Habitat Program
Technical Applications Division
Habitat and Passage Projects Section

Washington
Department of
Fish and Wildlife

August 2003

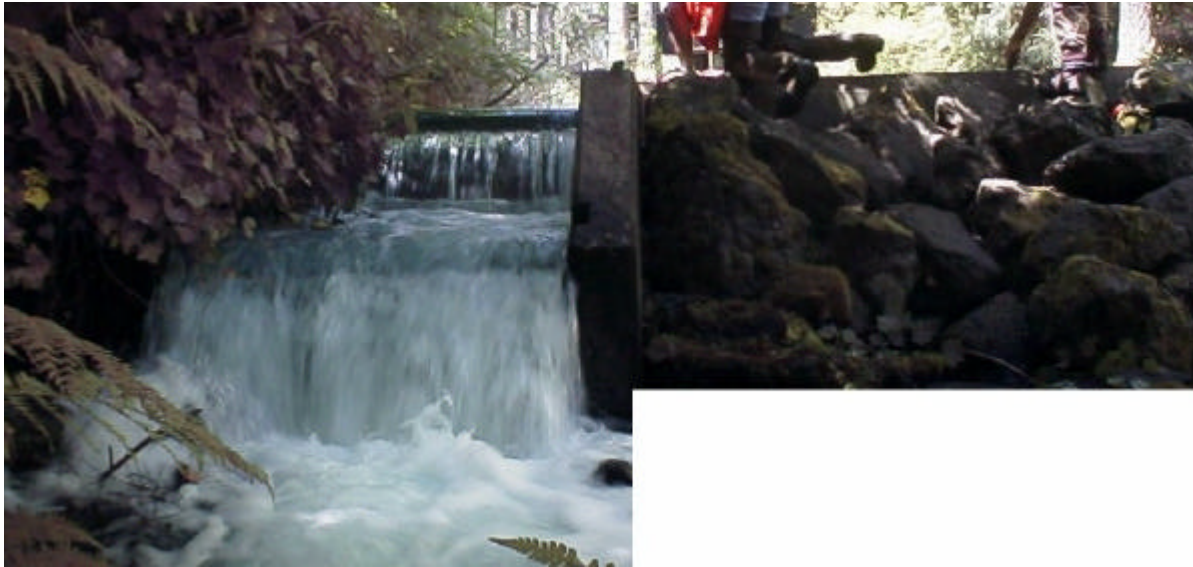
Figure 6. Site 981870. This concrete dam and fishway partially block access to 237 meters of stream habitat. The outfall drops on the fishway are 0.50 meters and 0.51 meters. Trout were observed in the upstream pool. This stream is the outflow from the Lakewood Fish Hatchery.

Site **981870**, is 85 meters upstream of the first dam. This second dam, equipped with a fishway, is a partial barrier due to outfall drops of 0.50 meters and 0.55 meters out of the weir pools. The fishway has three slots for stop planks but only two are used. Even if the third slot were used, the drops would still exceed the maximum allowable outfall drop of 0.24 meters, and it would cut the length of each pool in half.

Because the WLA boundary extends to the middle of the stream, the second dam is half on WLA land and half on private land. Since the stream has diverted around the right bank side of the first dam (WLA side), it is now entirely on private land (Kessler 2003). Ownership needs to be verified. The landowner having adjacent property along this stream is considering removal of at least one of the downstream dams (Jenkins 2003).

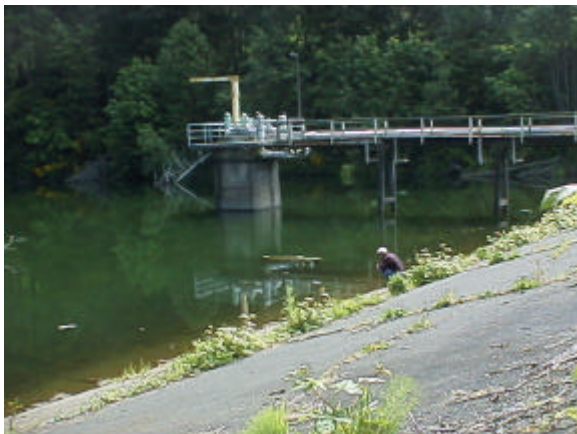
Figure 7. Site 981735. Eden Creek Dam, Reservoir and pump equipment. Water is pumped to a water treatment plant.

The Eden Creek dam, site **981735** and the Butterworth dam, site **981737**, are total barriers. Two passable culverts are located downstream of Eden Creek dam. Just downstream of the dam, site **981736**, is a 0.76 meter diameter pipe. The dam controls the flow and the culvert is backwatered at high tide. There is no drivable road at this site or any obvious reason for the culvert to exist. The second culvert, site **981733**, under Coastal Road, is a bottomless arch, 2.5m wide by 0.95m high. It is also tidally influenced and does not require repair.

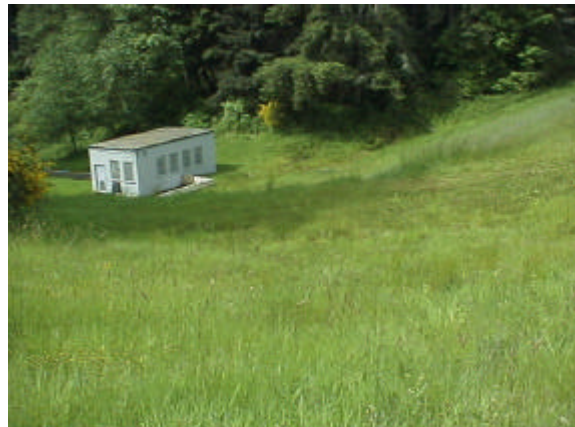
Figure 8. Site 981737. Building at base of Butterworth dam. Water flows from Butterworth reservoir down to Eden Creek reservoir.

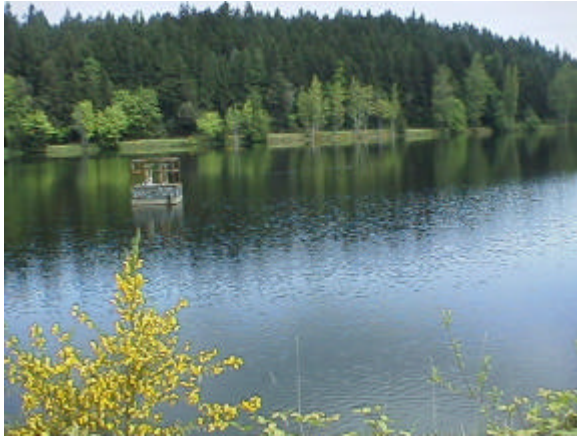
Figure 9. Site 981737. Offshore intake for Butterworth Reservoir which pipes water down to Eden Creek Reservoir.

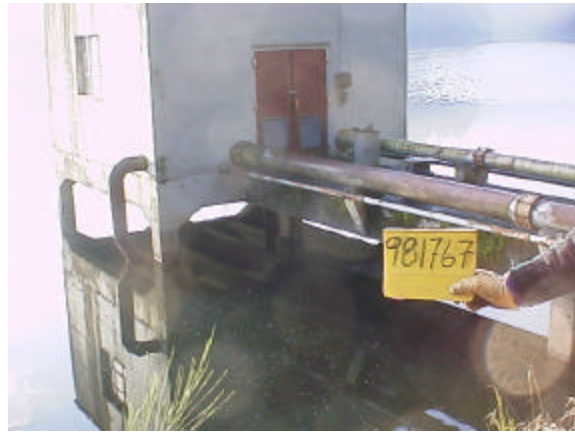
Figure 10. Site 981767. Offshore intake pumps Butterworth Reservoir water to the North Facility Complex.

An offshore pump house on Butterworth Reservoir, site **981767**, pumps water to the north facility complex.

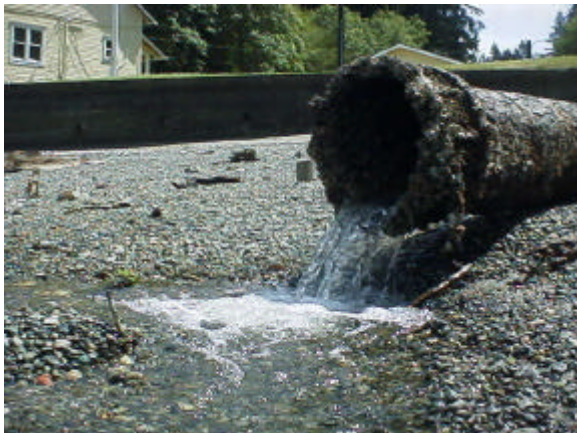
Figure 11. Site 981751. Luhr Creek barrier culvert outlets directly into Puget Sound. This 40 meter long, 0.31 meter diameter culvert is a total barrier to fish passage.

Spring-fed Luhr Creek flows out of the forested hills on the northwest side of McNeil Island into Pitt Passage. The first barrier encountered is a culvert, site **981751**, under Coastal Road at the stream's outlet into Puget Sound. The downstream end of this 0.31 meter diameter culvert is tidally influenced. Due to slope and velocity, this culvert is a total barrier.

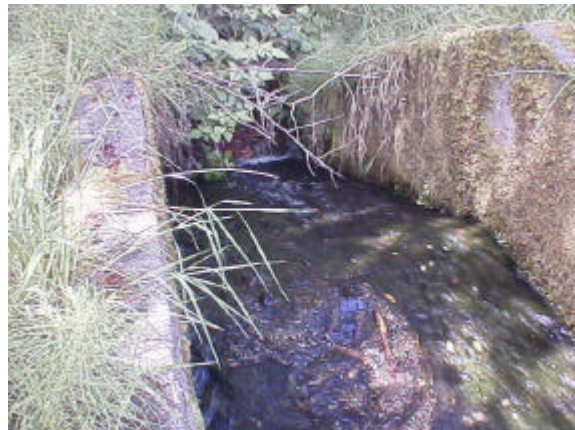
Figure 12. Site 981750. About 60 meters upstream of site 981751 is Luhr Creek dam and spillway. The spillway, pictured above, is a total barrier due to slope and sheetflow.

Approximately 60 meters upstream is a barrier dam and pump diversion at site **981750**. The earthen dam has a sloping concrete spillway that is a barrier due to insufficient water depth (sheetflow) and slope. The pump is located in a pump house on the dam and the intake is in the reservoir. Screening and pump information was unobtainable. Water is pumped through an underground aqueduct to Butterworth Reservoir. The outlet into Butterworth Reservoir, site **981766**, is not screened and could pose a hazard to resident fish in the reservoir as it provides a flow that may be attractive to trout.

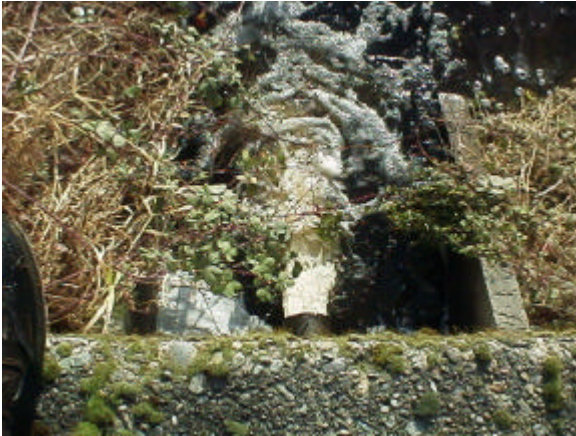
Figure 13. Site 981766. Looking down on the aqueduct outlet into Butterworth Reservoir, which originates in Luhr Creek Reservoir. This is submerged at higher lake levels.

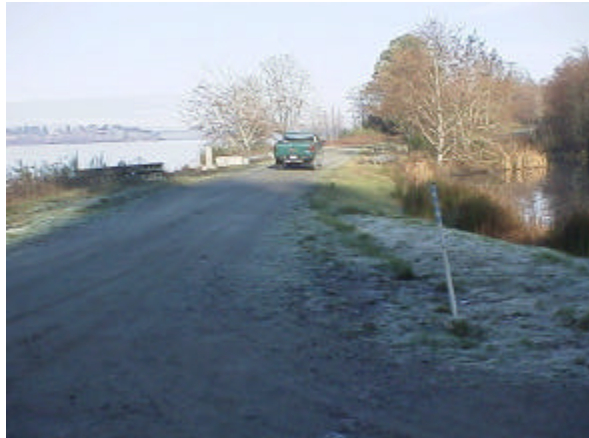
Figure 14. Site 981753. Coastal Road/Floyd Cove Dam. Reservoir on right, Pitt Passage on left. Overflow standpipe and culvert spill water into Sound.

Coastal Road becomes the dam, site **981753**, impounding water at Floyd Cove. A culvert under the road acts as a spillway for the dam with the outfall going directly into Puget Sound at high tide and falling onto the beach at low tide. Outfall drop ranges from about 0.20 meters at high tide to 2.5 meters at low tide. A pump building contains the pump equipment and the intake, not visible, is apparently offshore in the reservoir. Pump information and intake screening could not be determined.

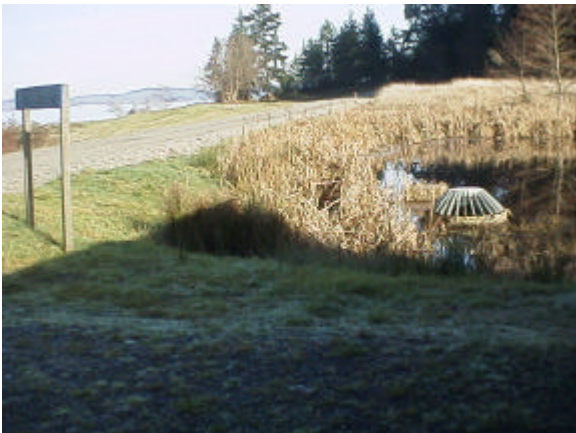
Figure 15. Site 981757. Bradley Reservoir on right with standpipe overflow. Puget Sound at upper left.

Coastal Road again doubles as a road and a dam creating Bradley Reservoir, site **981757**. A standpipe and culvert control the water level in the reservoir. The creek is labeled Bradley Creek on the map but the sign in front of the pump station labels it as Bodley Creek. An error made in transcribing the name led to the now official name of Bradley (Kessler 2003). Pump equipment was inaccessible, and screening could not be determined for the intake in the reservoir. Along the south end of the reservoir, Still Harbor Shore Road bisects the pond. The road appears to be an old logging road. At the time of the survey, the road was flooded over and no culvert was evident. Two small streams flow into Bradley Reservoir. Both are considered not fish bearing, as they are less than 0.61 meters (2.0ft) wide measured at the ordinary high water mark.

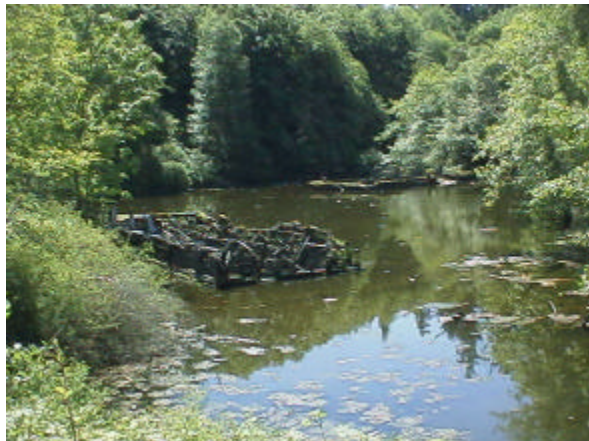
Figure 16. Site 981770. Milewa Creek Reservoir is about 1.0m above the high tide line of Puget Sound. An overflow culvert spills water into the Sound.

Milewa Creek Reservoir is another reservoir created by Coastal Road damming Milewa Creek. The dam at this site, **981770** has an overflow culvert that is a total barrier due to outfall drop. No water is pumped from this reservoir. One small, non fish-bearing stream enters the reservoir.

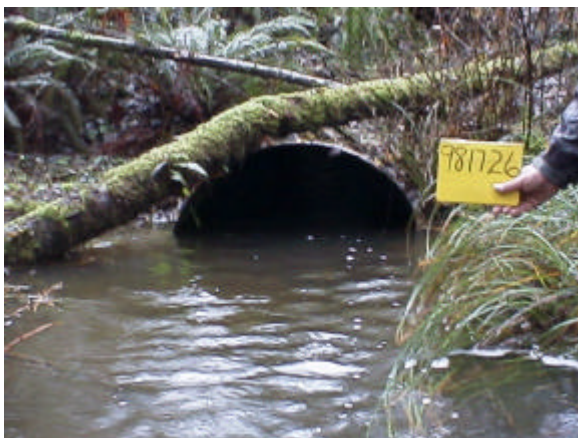
Figure 17. Site 981726. Unnamed tributary to Scatter Creek. This 1.12 meter diameter culvert is a barrier due to a 1.35 percent slope.

The culvert at site **981726** is a partial barrier to fish passage due to a 1.35% slope. Downstream of the culvert, this low gradient stream flows along the toe of a hillslope through mixed second growth forest. Near the confluence with Scatter Creek several very old, overgrown beaver dams appear to be a barrier to fish passage as salmon fry were observed just downstream in Scatter Creek but not upstream of these beaver dams. Upstream of the culvert, the stream and a tributary, flow out of forested hills with several more beaver dams which are not barriers. One additional barrier, site **981729**, exists on the tributary beyond the WLA boundary. At the boundary this tributary has recently been ditched. The barrier culvert, on private land has a limited amount of habitat gain (<200m) before becoming non fish-bearing.

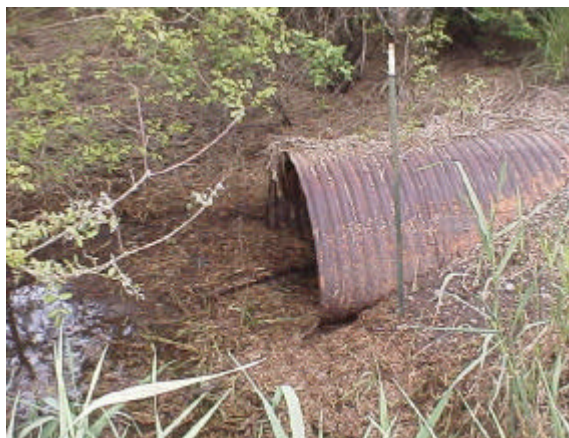
Figure 18. Site 981727. Unnamed stream with limited habitat gain. Stream goes subsurface downstream in very porous soil.
