Sunnyside Wildlife Area Fish Retrofit

Habitat Program
Salmonid Screening, Habitat Enhancement
and Restoration (SSHEAR) Section

October 2002

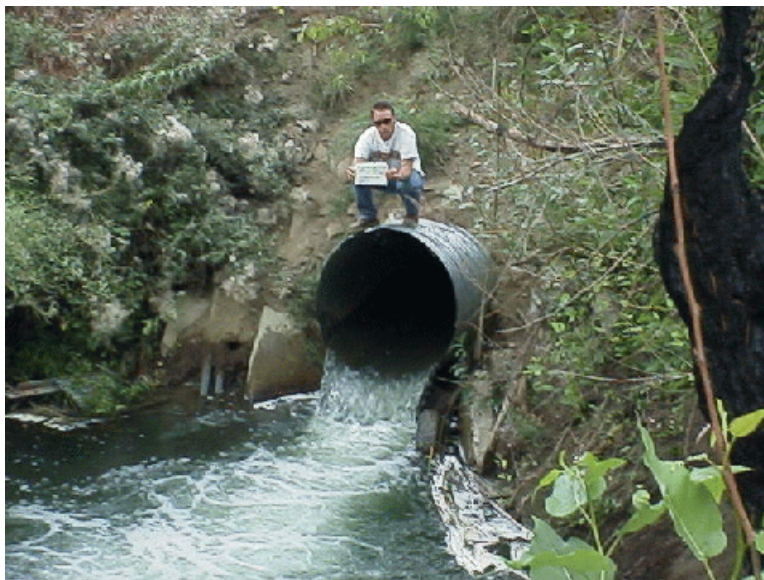
Sunnyside Wildlife Area / Sunnyside Unit / Site 981382

Photo 1. Lowest barrier culvert on the DID #7 drainage. Although the culvert slope is less than 1%, this culvert is a barrier due to excessive outfall drop and high velocity. It is also undersized.

A total of 13 features (seven culverts, one dam and five pump diversions) were identified during inventory efforts and the physical survey of the DID #7 system. All seven culverts were evaluated as undersized and are partial barriers to fish passages. Two fish passage barriers lie within the unit boundaries. The lowest feature on the drainage is barrier culvert site 981382 (photo #1). The second barrier feature is dam site 981380 (photo #2 & 3), located 726 meters upstream. One additional feature, a newer unscreened pump diversion (Site 981378, photo #4), also lies within the unit boundary approximately 15 meters upstream of 981380.

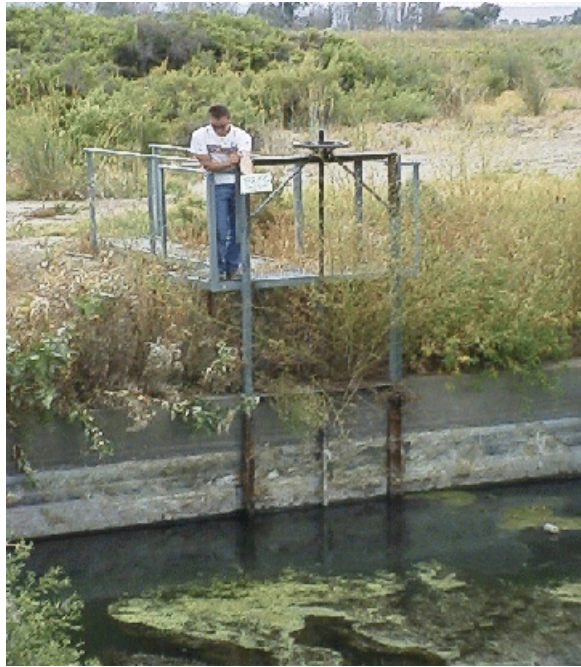
Sunnyside Wildlife Area / Sunnyside Unit / Site 981380

Photo 2. Upstream end of the diversion dam. Site is a partial barrier due to control structure. With the screw gate partially open and the current flow conditions, the culvert (spillway) was determined to be passable at time of evaluation.

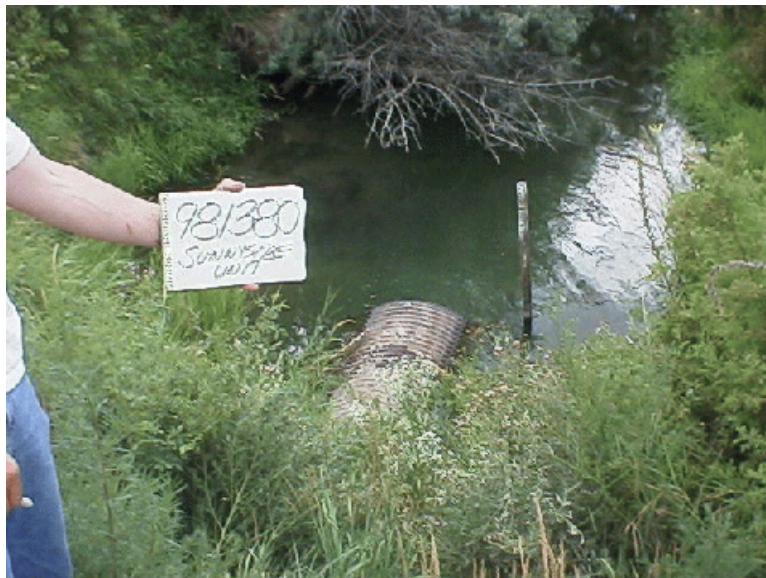
Photo 3. The downstream end of culvert at **Site 981380** better illustrates size of culvert in comparison to channel width. Notice the makeshift flow gauge used to monitor and manipulate water levels.

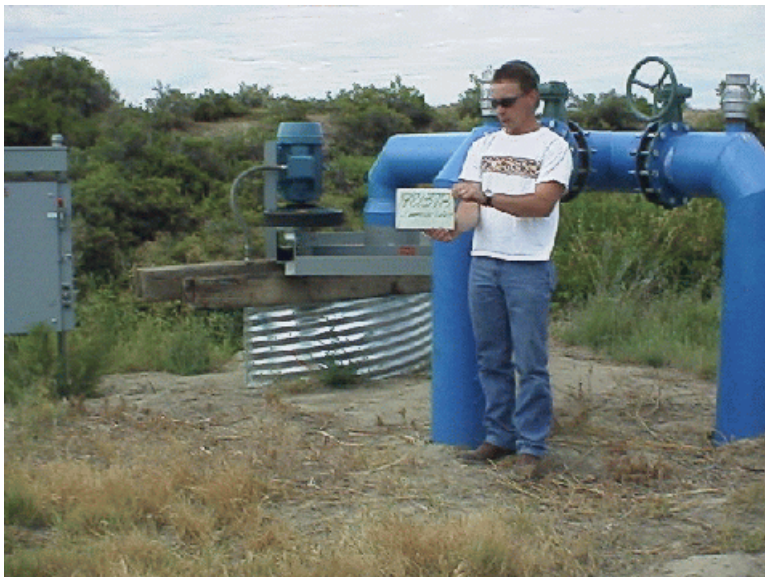
Sunnyside Wildlife Area / Sunnyside Unit / Site 981378

Photo 4. Example of a “lift” pump diversion configuration. Recently installed on the Sunnyside Unit for controlling water levels of Bos Lake and/or Horseshoe Pond, this pump system has an unscreened intake submerged in DID #7.

One thousand meters upstream of Site 981378, a non-fish bearing tributary, contributing approximately 10% flow, enters on the left bank. This tributary enters into a backwater channel area from a visible culvert passing under Wendell-Phillips Road. The tributary exits an irrigation piping system, with no natural drainage east of Wendell-Phillips Road (therefore determining non-fish bearing status). Another 58 meters upstream of the tributary, located underneath a farm road, is an undersized culvert requiring repair (Site 981407). There is an inadequately screened pump diversion (Site 981408) used for irrigation located immediately upstream on the right bank.
