Water Crossing Design Guidelines

Introduction to 2013 Water Crossing Design Guidelines

Hydraulic Project Implementation and Effectiveness Monitoring

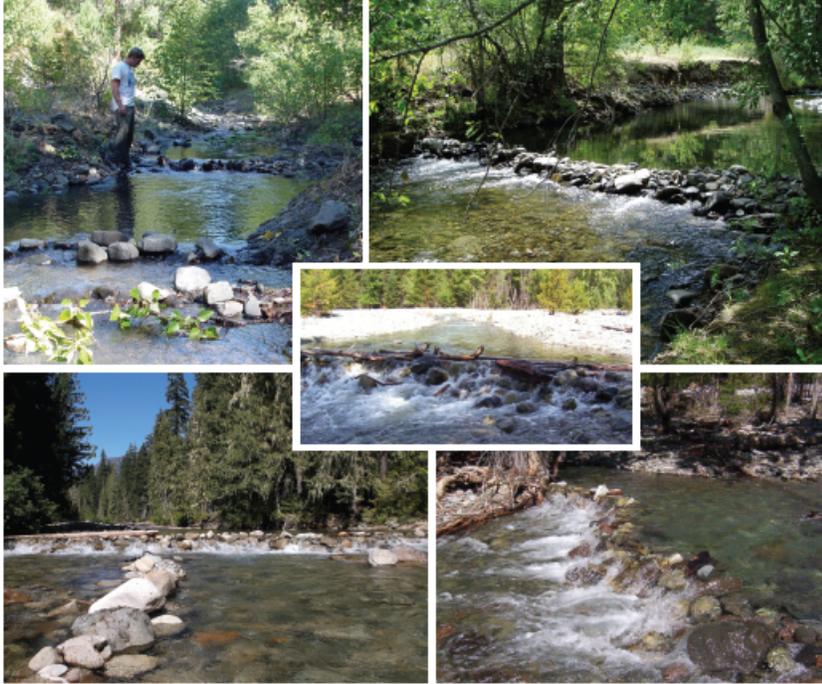
LET 'EM PASS! Rock Dams Block Fish

Rock dams like these block fish and are illegal.

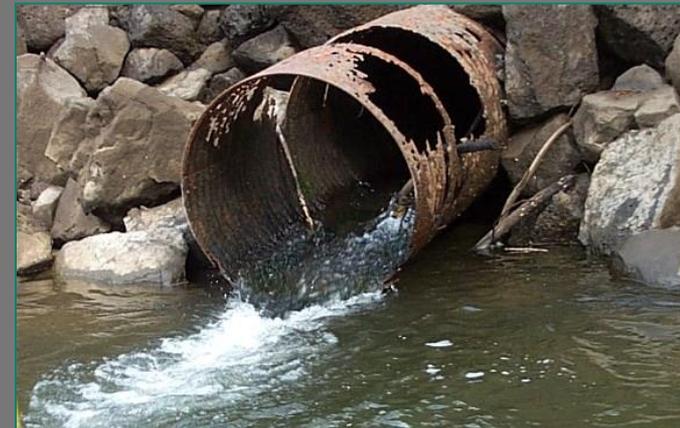
North Fork Secret Ck.

Under-sized culvert halts sediment and debris transport, induces u/s channel widening and d/s channel scour.

Upstream channel width more than twice the culvert width.

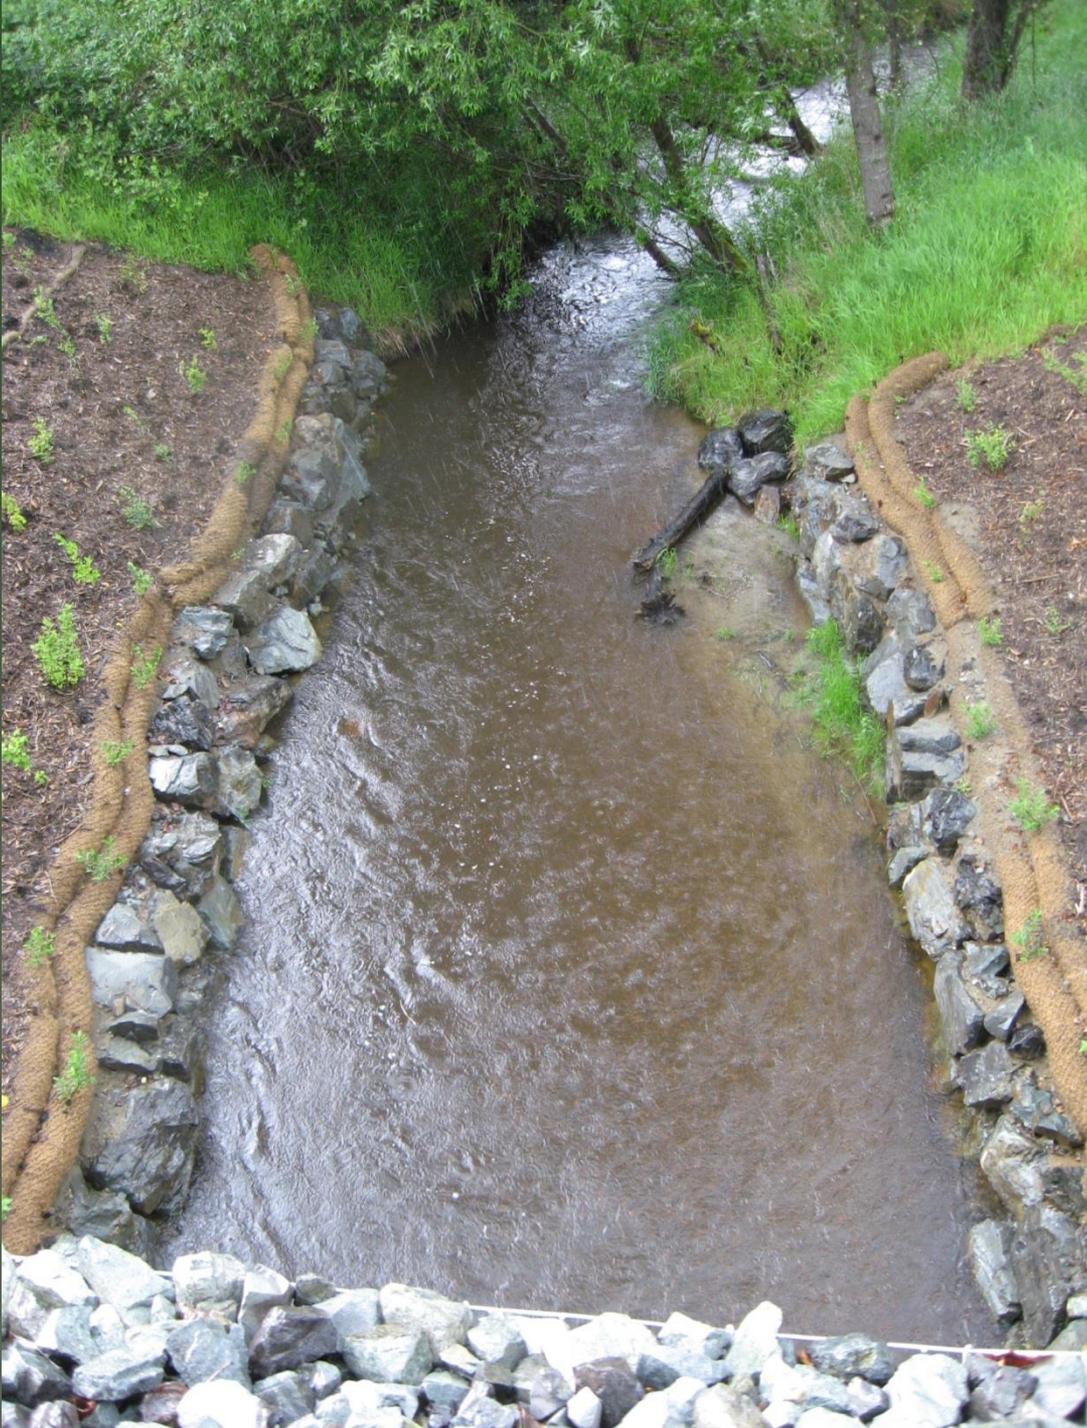
Figure 7-1a. Option 1: Downstream Grade Control

Figure 7-1b. Option 2: Upstream Regrade

Channel-steepening options.

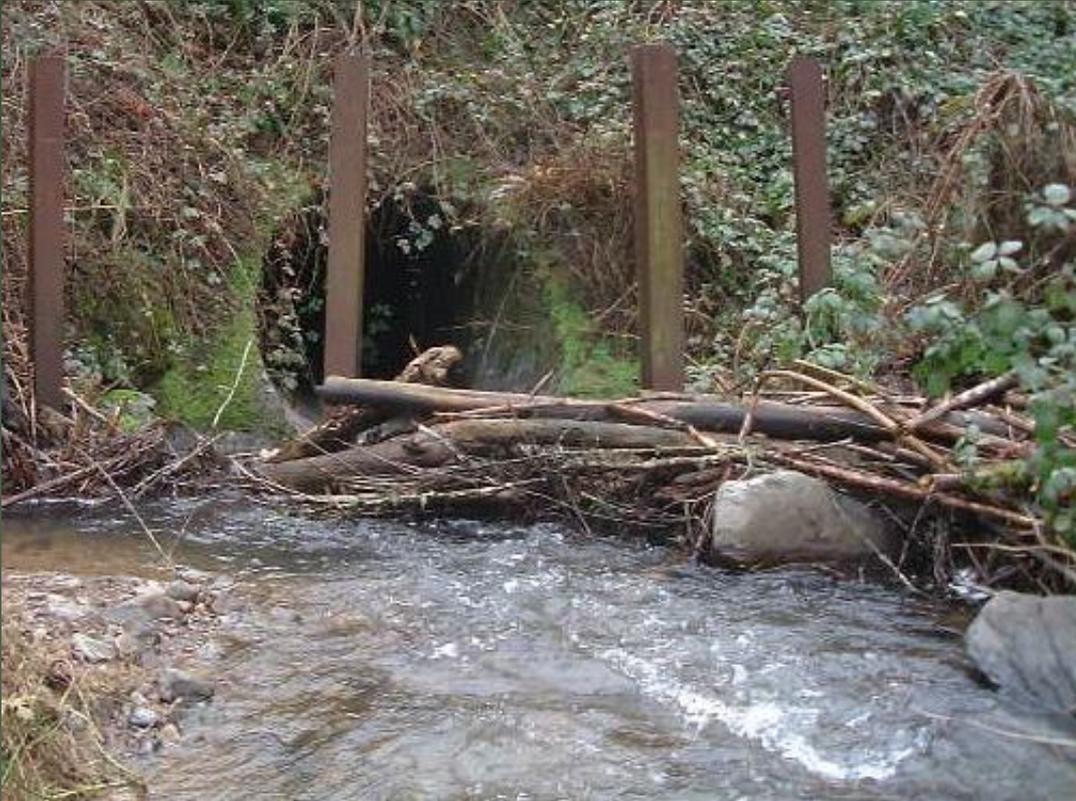
Debris Passage

- What size and type of debris moves through the system?
- Geomorphic approach means channel $>$ BFW
- Continuity of channel function (debris passage) greatly reduces problems
- Debris prone systems best suited for bridges

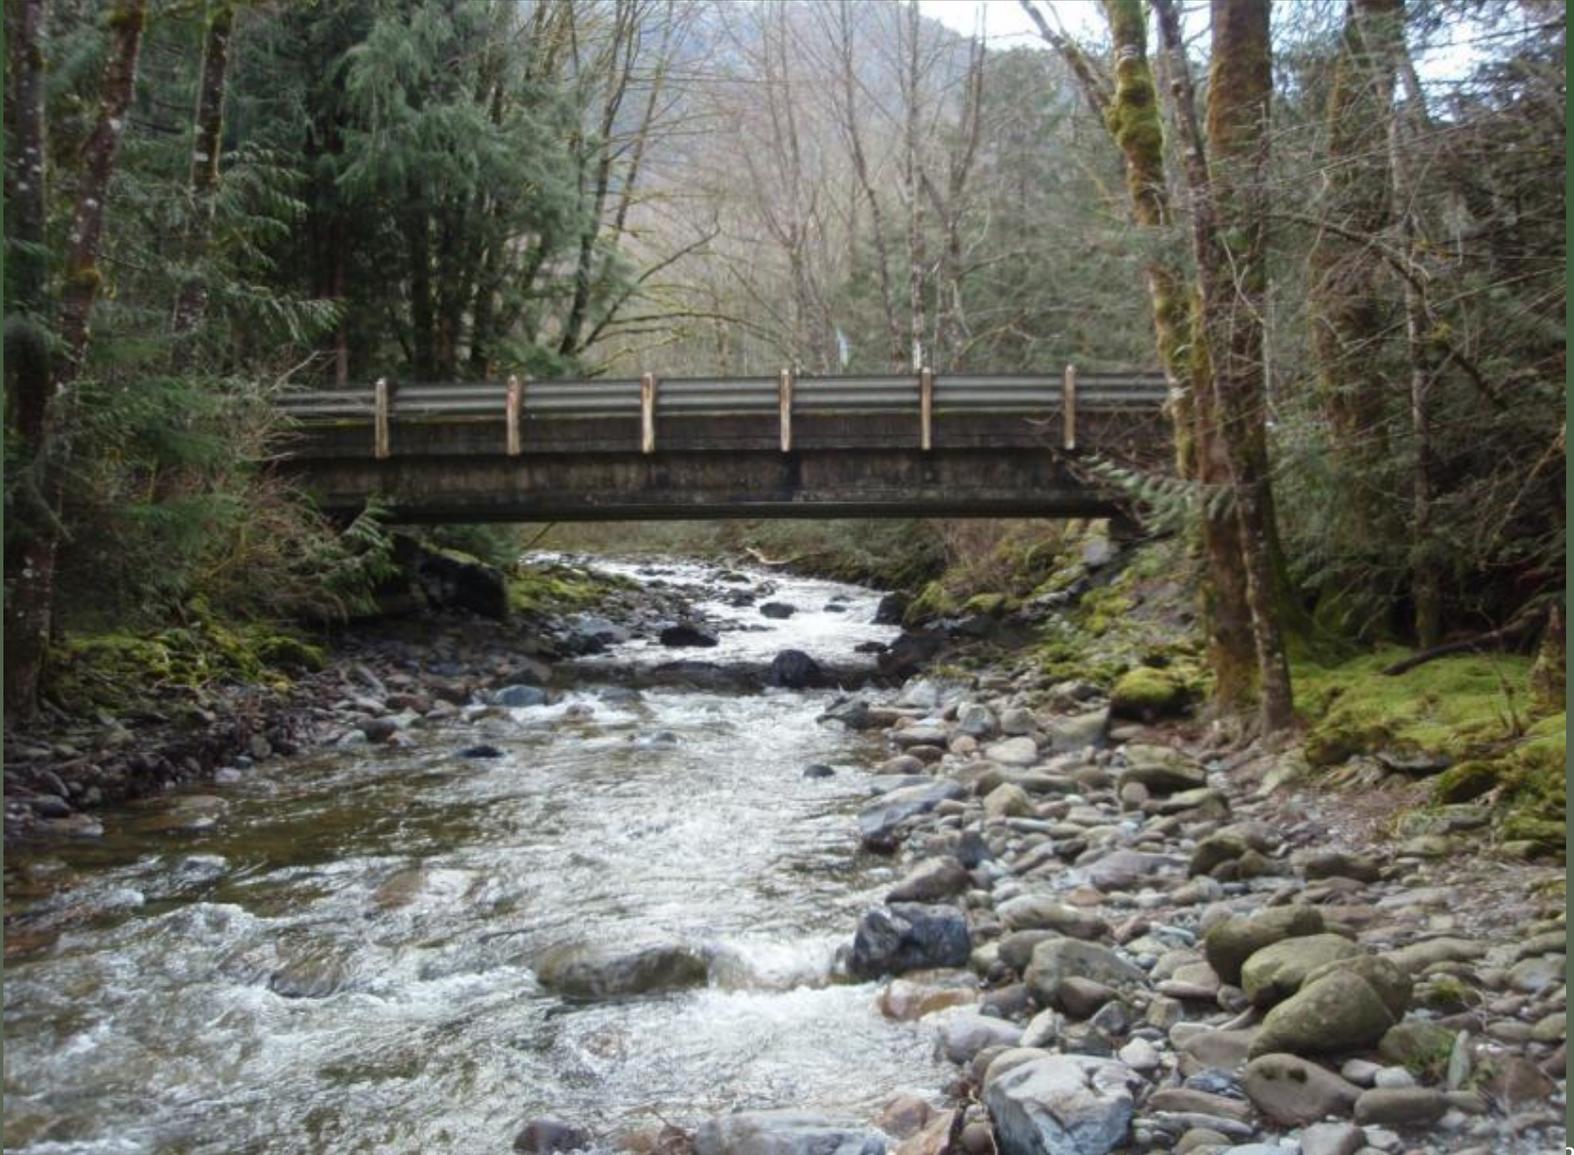
Confined channels

Bridges over confined channels can be based on BFW, but with a factor of safety.
